**Chemical Process Safety**  
**Professor Shishir Sinha**  
**Department of Chemical Engineering**  
**Indian Institute of Technology Roorkee**  
**Lecture – 50 Jaipur Terminal Fire, India**  
**October 29, 2009**

Now, welcome to this module related to the fire and we are going to discuss a case study of Jaipur terminal fire took place at IOCL terminal facility at Jaipur on 29th October, 2009 and after the flex (())(0:45) this is one of the most dangerous most devastating and most capped catastrophic accident related to the fire. So let us have a background of this particular facility by the description of the facility.

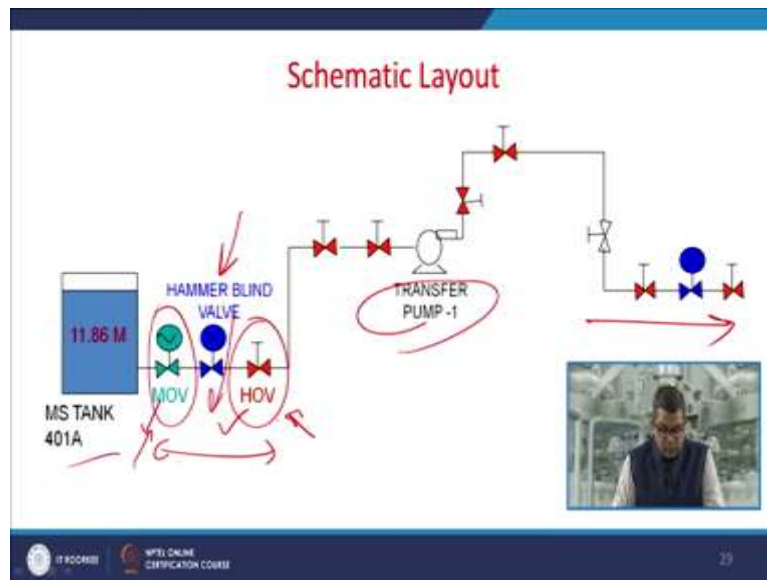
So, this is the schematic layout, this was an Motor Spirit tank and that was the MOV and this is the HOV and this one is the hammer blind valve so and this was the transfer pump and this is again the same scenario, so the problem took place in synchronising all these three steps.

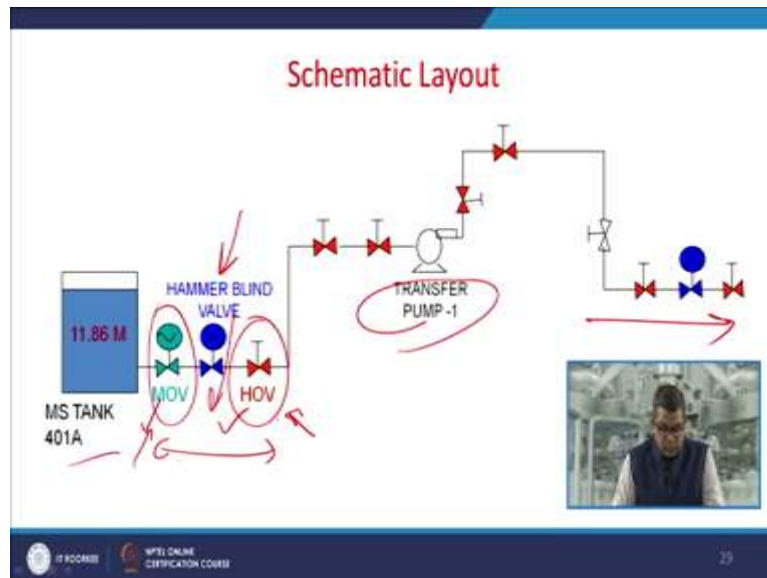
Standard Operating Sequence	Likely Sequence
1. Ensure MOV and HOV are closed	1. MOV opened first.
2. Reverse the position of Hammer Blind Valve	2. Hammer Blind Valve opened
3. Open the HOV	3. Leakage started.
4. Open MOV (initially inching operation to establish no leakage from Hammer Blind Valve body)

So, now the standard operating sequence was to ensure that a MOV and HOV this and this both are closed then reverse the position of hammer blind valve so that you can have a desired scenario then open the HOV this one, then open the MOV initially inching operation to establish the leakage from Hammer blind valve body now the likely sequence says the MOV opened first. However, desired was the HOV but initially MOV opened first and then hammer blind valve this was opened that is in the second step and then because of lack of the synchronisation the leakage started.

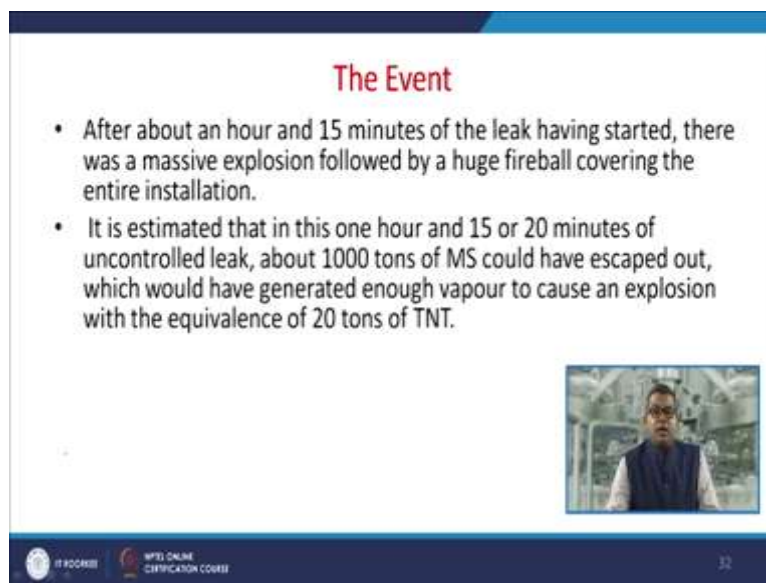
- After about an hour and 15 minutes of the leak having started, there was a massive explosion followed by a huge fireball covering the entire installation.
- It is estimated that in this one hour and 15 or 20 minutes of uncontrolled leak, about 1000 tons of MS could have escaped out, which would have generated enough vapour to cause an explosion with the equivalence of 20 tons of TNT.

So, after about an hour and 15 minutes the leak having started there was a massive explosion followed by huge fireball covering the entire installation. So it is estimated that in this one hour and 15 to 20 minutes of uncontrolled leak about thousand ton of motor spirit could have escaped out, which would have generated enough vapour to cause an explosion with equivalence of almost 20 tons of a TNT.

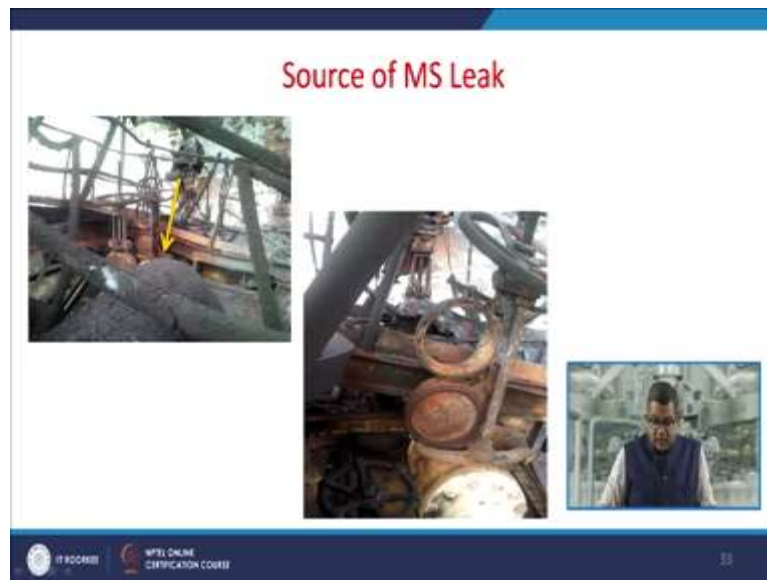
Now, this was the source of motor spirit leak, now you can visualise there are hand operated valve motor operated valve and this one is the blind, blank, now this is the mean scenario so it was not been inserted properly while the transfer took place.

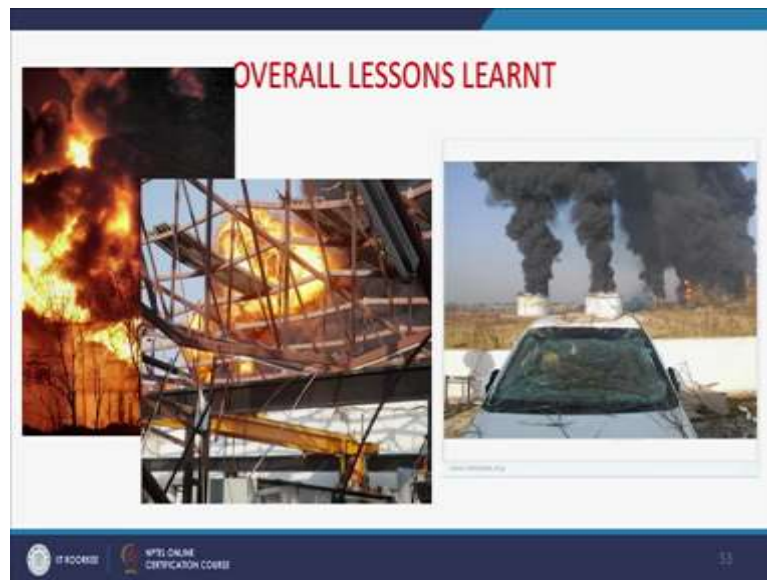
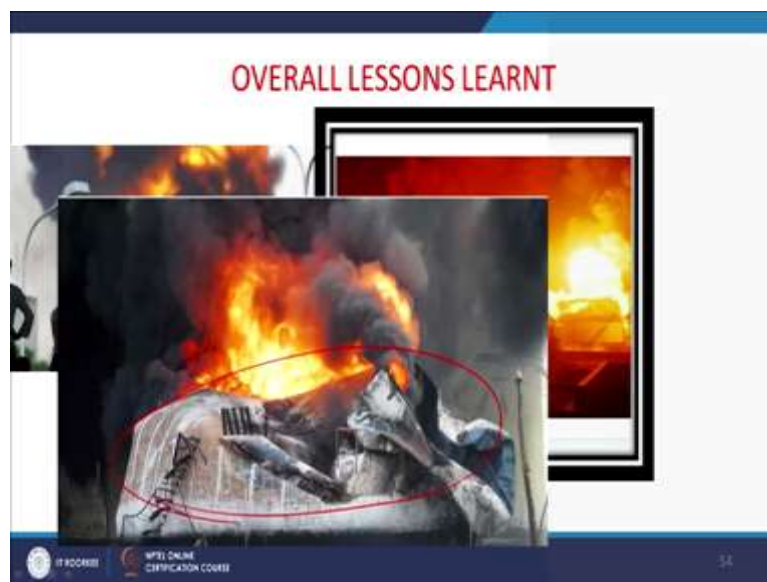
Now you can have a look of the gravity of this particular accident through these photographs. Now these tanks they were burning and the car in the nearby location it is burnt out. Now you can see that this is the storage tank facility how much pressure being built up so that it the entire tank which is so strengthen installation is collapsed.

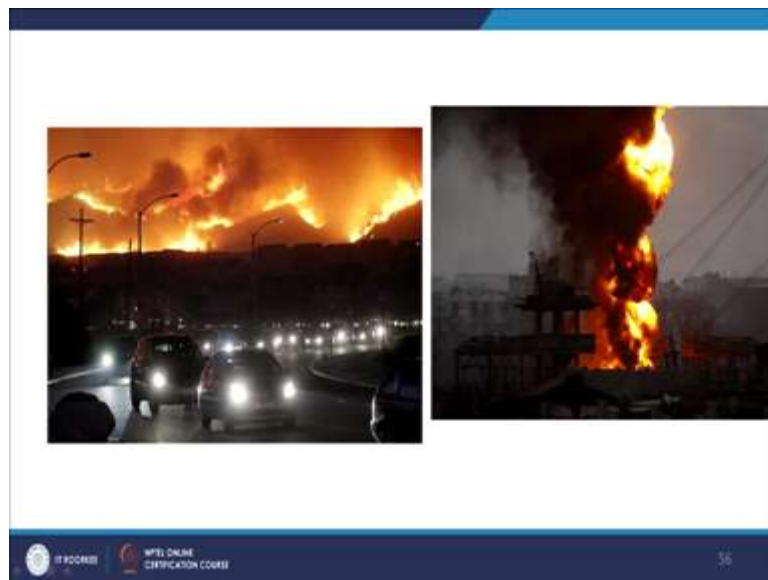
Now, this is the highway nearby that installation so you can see the gravity of this particular accident.

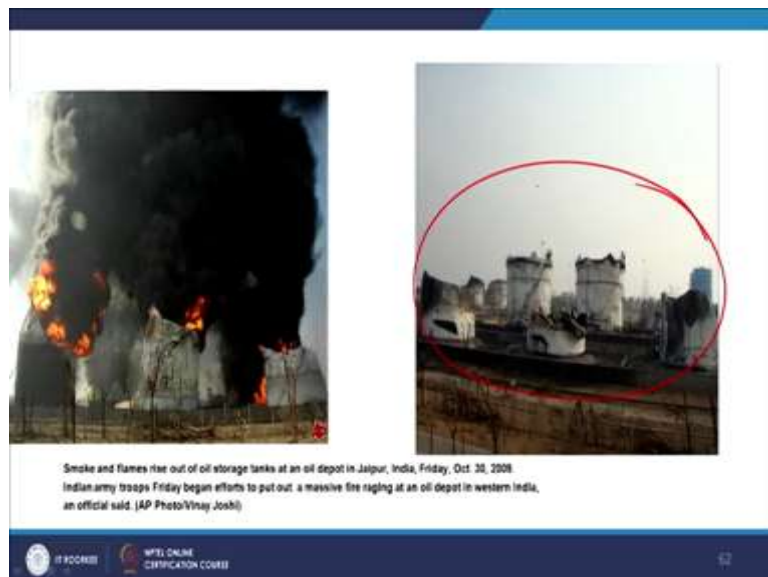
Now, you can see that after the accident this was the scenario of the all tanks those who were there at the time.

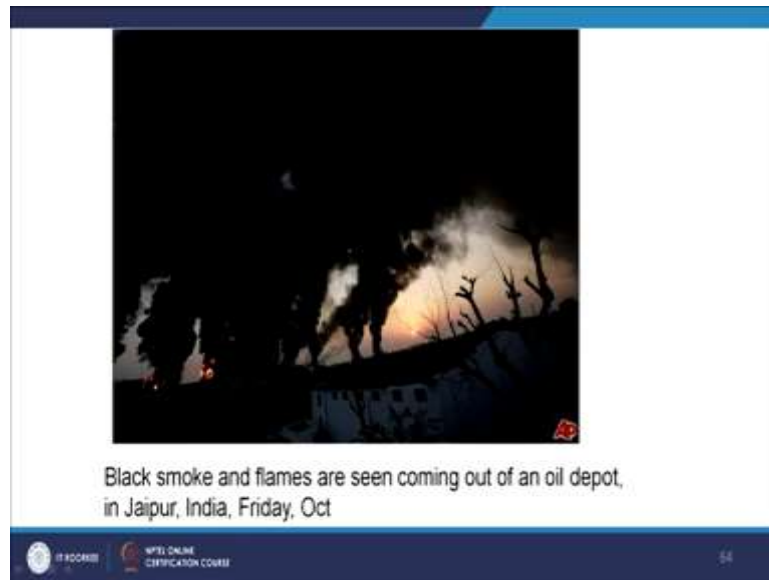
So, you can see the black smokes and flame they are seen out of an oil depot of the Jaipur. So, by this particular case study we have studied that this is the main you can say the latest of in the fire and explosion accident and again by not observing the standard operating protocol this this kind of a major accident they may take place in any kind of establishment. Thank you very much!
