**Chemical Process Safety**  
**Professor Shishir Sinha**  
**Department of Chemical Engineering**  
**Indian Institute of Technology, Roorkee**  
**Module 11**  
**Lecture 51**  
**The Flixborough UK Cyclohexane Disaster**  
**(June 01, 1974)**

**Introduction**

Flixborough disaster was an explosion at a chemical plant owned by Nypro (UK) Ltd.

Occurred in Flixborough, England on Saturday, 1st June 1974 at about 4.53pm.

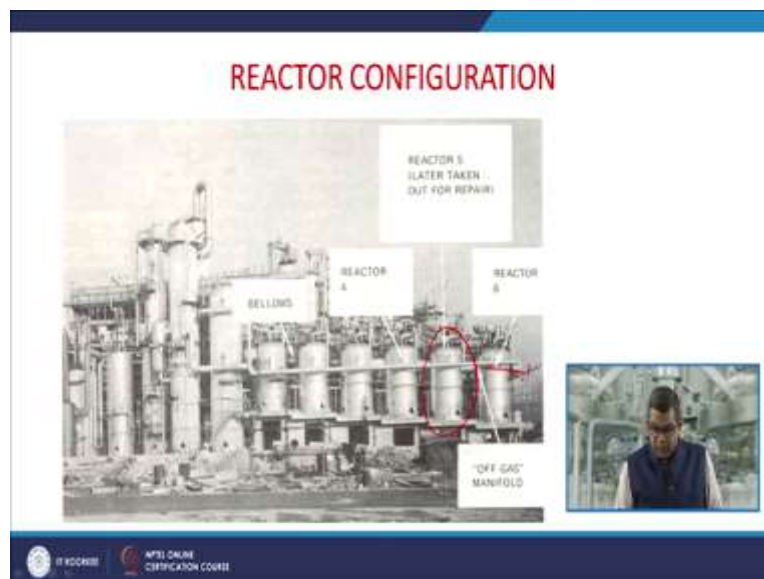
Now you can have a more closer look of this a particular reactor battery. So these were the 6 reactor and this was the off gas manifold and this was a problematic reactor.

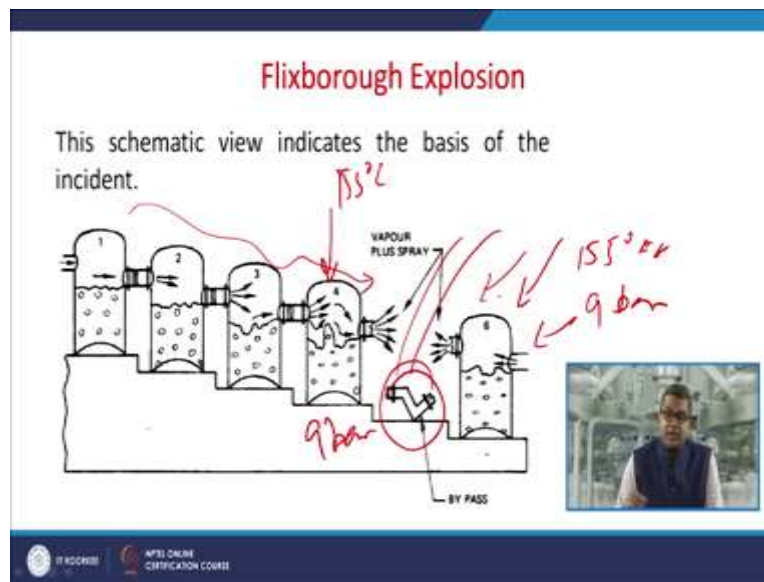
Now this is the schematic view of this indicate the basis of the incident. Remember this was running at 155 degrees Celsius and again the temperature of a (105) 55 degrees Celsius, 9 bar pressure and it is again having the 9 bar pressure. So the entire content and when this was broken, this bypass line was broken, then you may assume that the entire material they may come out because every reactor was running under pressure.

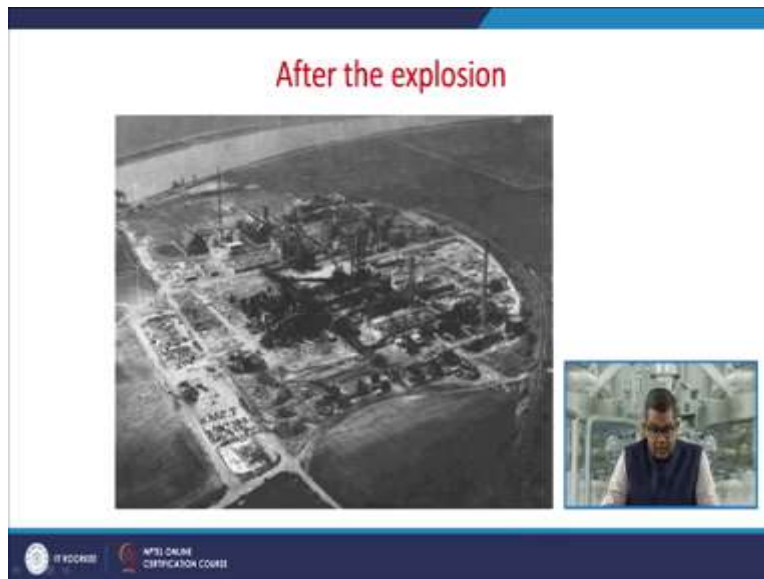
Now this you can see that before the explosion the plant was having this type of thing and this is after the explosion.

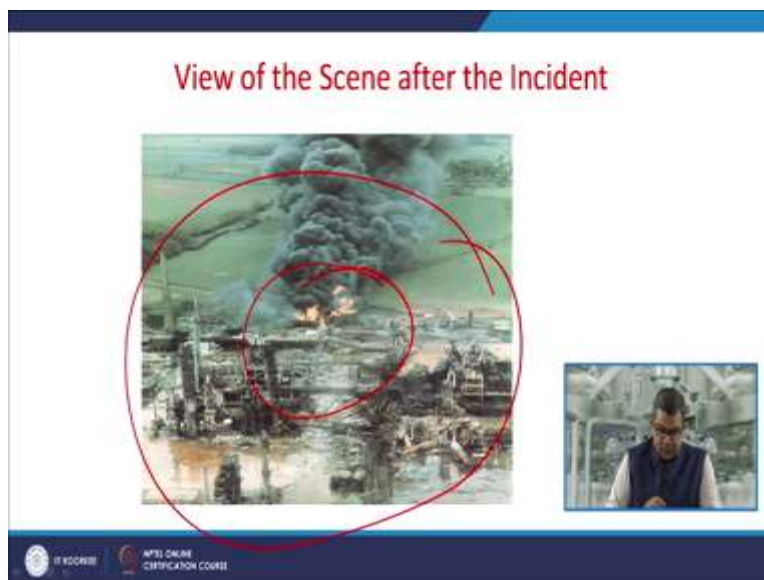
Now this is, you can see the view of the entire plant arena after the incidence, so this one is the main fire zone and you can see that the entire plant was destroyed at the moment.

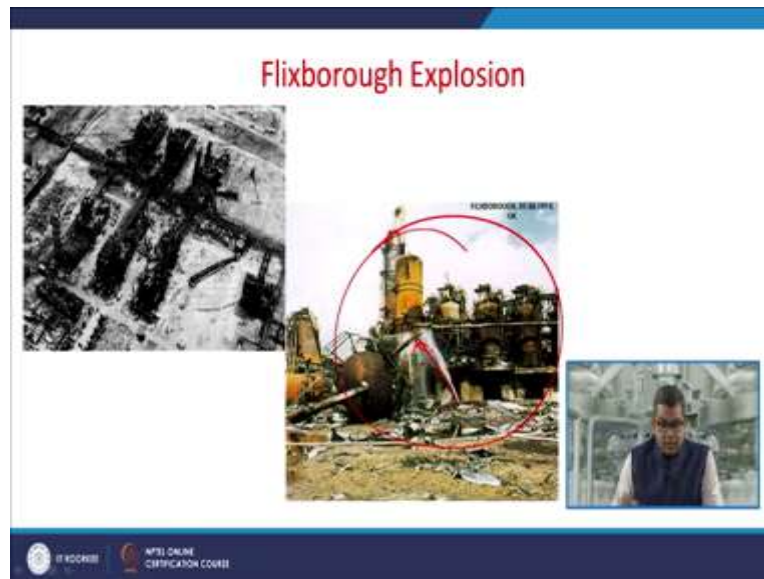
Now this is the reactor battery and they try to just extinguish the fire.

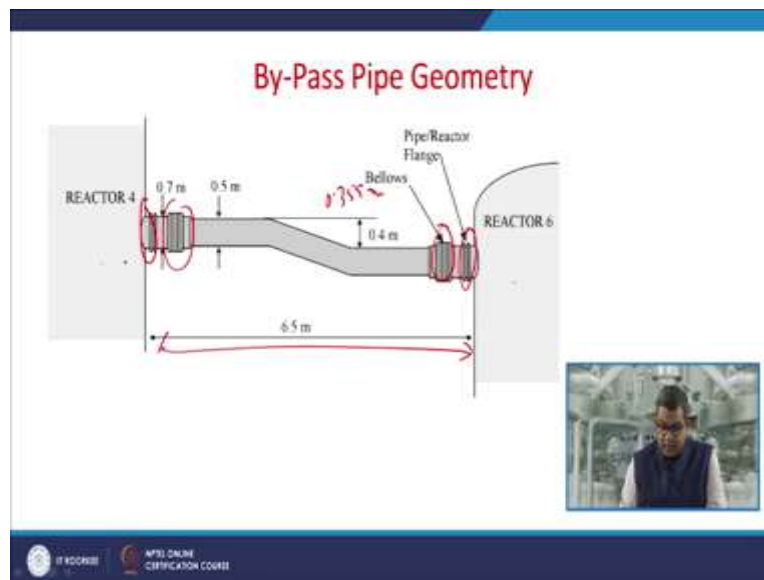
Now this was the bypass pipe geometry, this was a reactor 4 and this was a reactor 6, they were supported by these bellows and the pipe reactor flanges and the distance was almost 355 meter just to suggest that reaction kinetics and the distance of these two reactors, remember reactor 4 to reactor 6 was 6.5 meter.

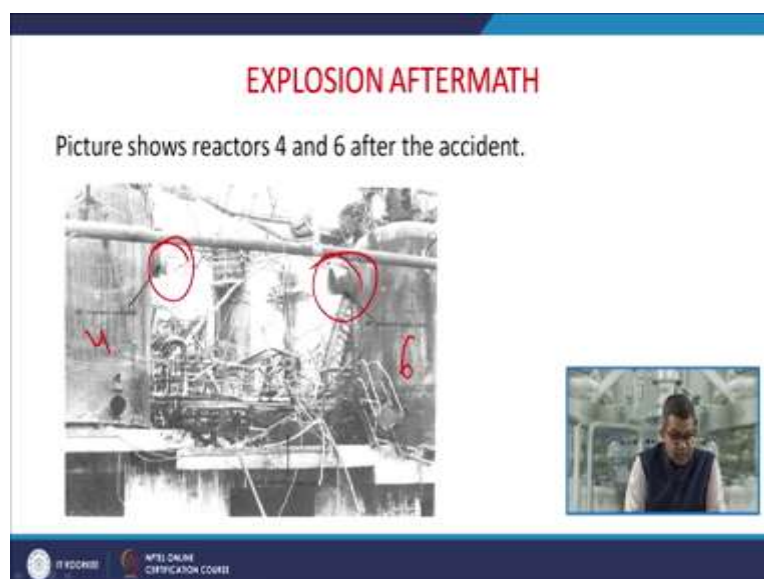
Now these are the pictures shows that a reactor 4 and 6 after the accident, so you can see these are the openings where the things were connected. So this was the (reaction) reactor number 6 and this was the reactor number 4.

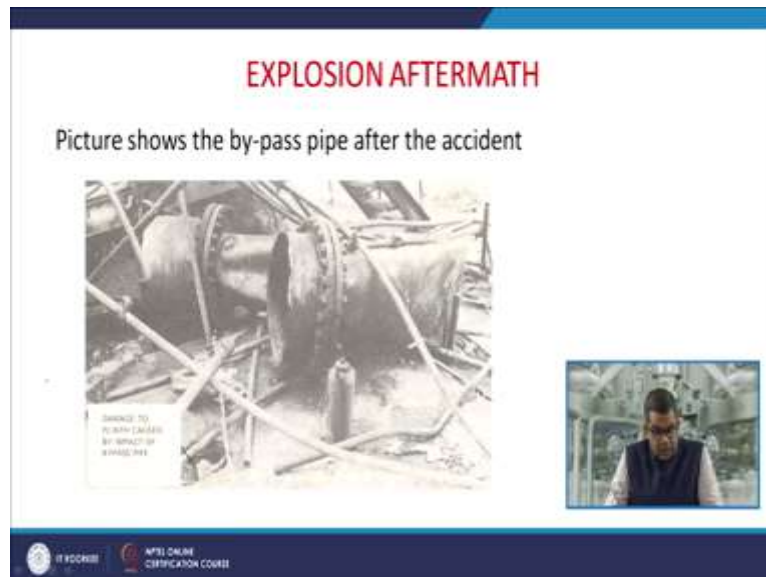
A 20 inch diameter temporary by-pass pipe Jack-knifed and failed under thermal expansion stress.

So a 20-inch diameter temporary bypass line or jack-knifed, this is like this where the pipelines they are supported, so jack-knifed and failed under the thermal expansion stress, now because both of the reactors they were operated at higher temperature. So again, the thermal (expression) expansion test or stress tests need to be performed. So, about 42 of 120 tons of cyclohexane escaped into the congested reactor supported structure. Now the jack-knifed were like this, so they approximated around 40 to 100 tons or 120 tons of cyclohexane they escaped into this arena. So within 2 minutes of the vapor, the minutes the vapor cloud ignited and detonation class of vapor cloud explosion took place.

Now this is the bypass pipe after the accident, so you can see the damage over here.

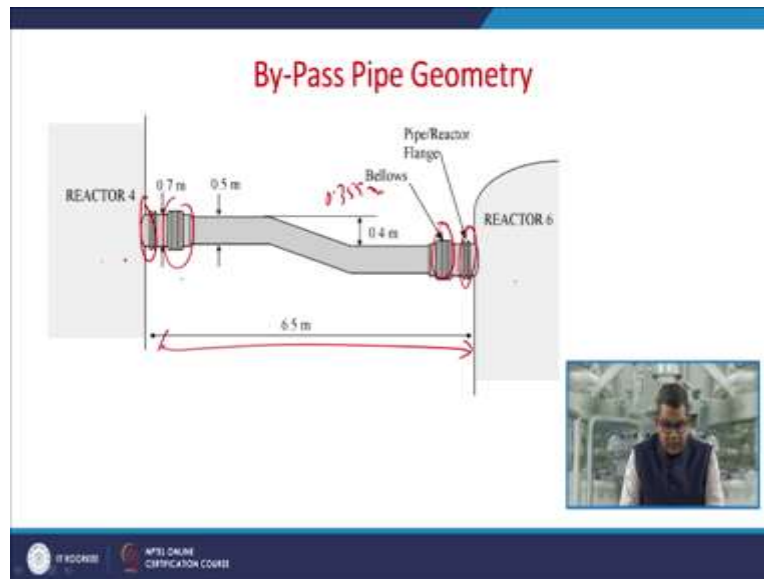
Now you can see in this particular figure that whenever the flow is transferred from this way. So the load would be on the higher side of this particular pipe junction.
