**Chemical Process Safety**  
**Professor Shishir Sinha**  
**Department of Chemical Engineering**  
**Indian Institute of Technology, Roorkee**  
**Module 11**  
**Lecture 54**  
**Bhopal Gas Tragedy**  
**(December 03, 1984)**

**Bhopal Gas Tragedy**

Occurrence: 3<sup>rd</sup> December 1984.

Company: Union Carbide Corporation.

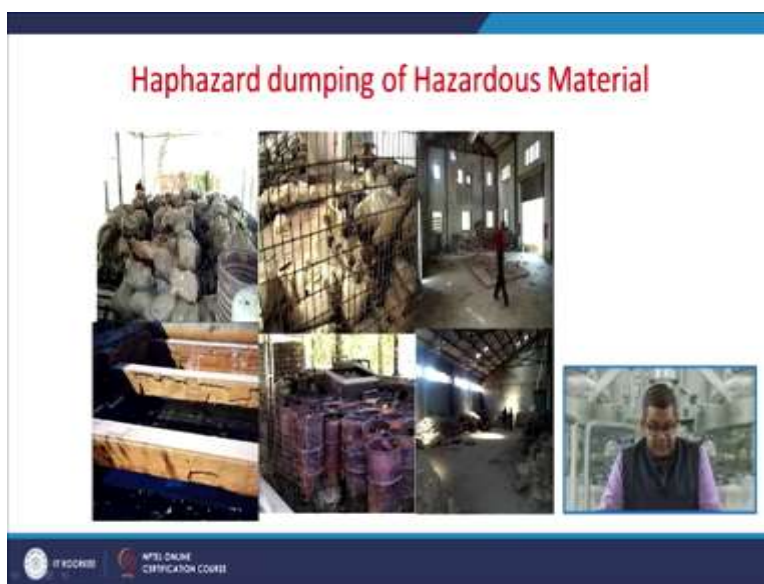
So you can have a look up these haphazard dumping of hazardous materials like this so they were not following the proper protocol of storage of for these chemicals.

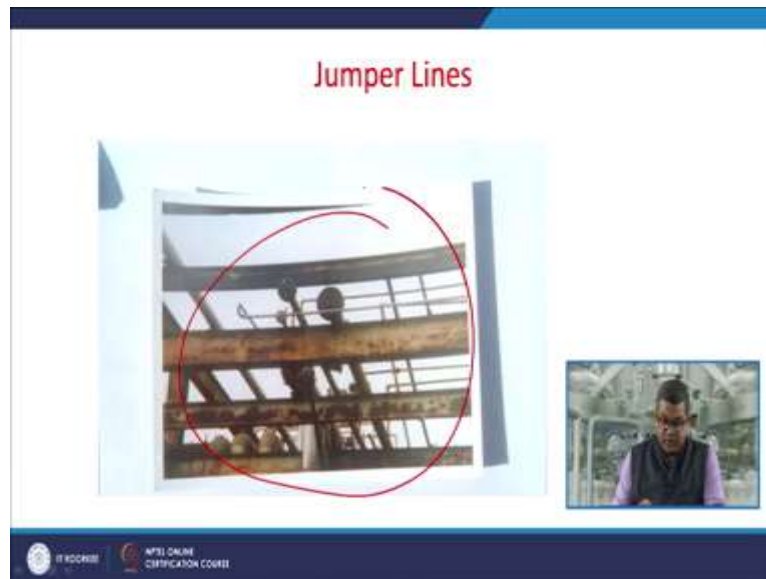
Now, it was suggested that water might have entered into the MIC storage tanks 610. Now this was the storage tank battery. Now they have anticipated that there were two causes, one cause was that the water was deliberately added to this point of time for another cause that to water was added there and leak through the relieve system back to the storage tank. So if this possibility persists then again there was a lack of training because the primary it is required that blind or a blank should be inserted to prevent the entry of water to the storage arena.

So on this particular hypothesis, the water evidently there leaked through the wall into the relief vent valve header and passed to the jumper line into the process vent header and then into the tank number 610.

Now these are the jumper lines, now this is the actual figure of the jumper line.

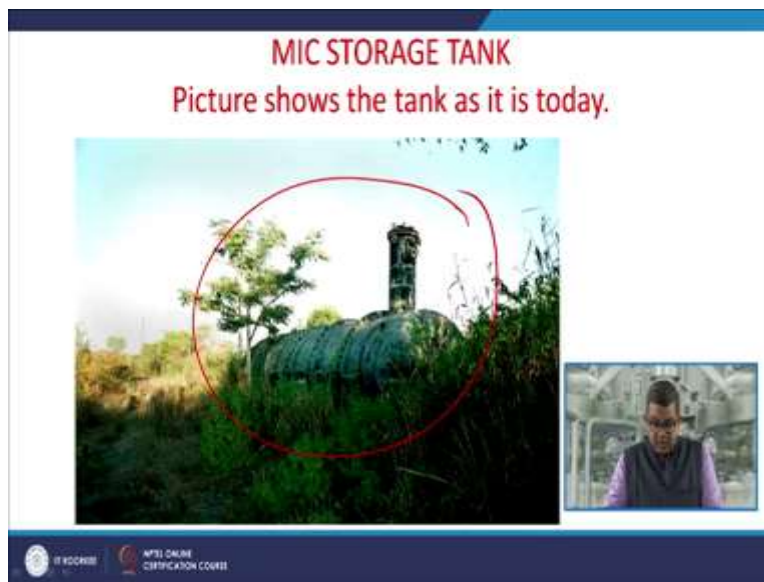
Now this is picture of the tank as on today, now it is just unearthed and so that it can be inspected clearly.

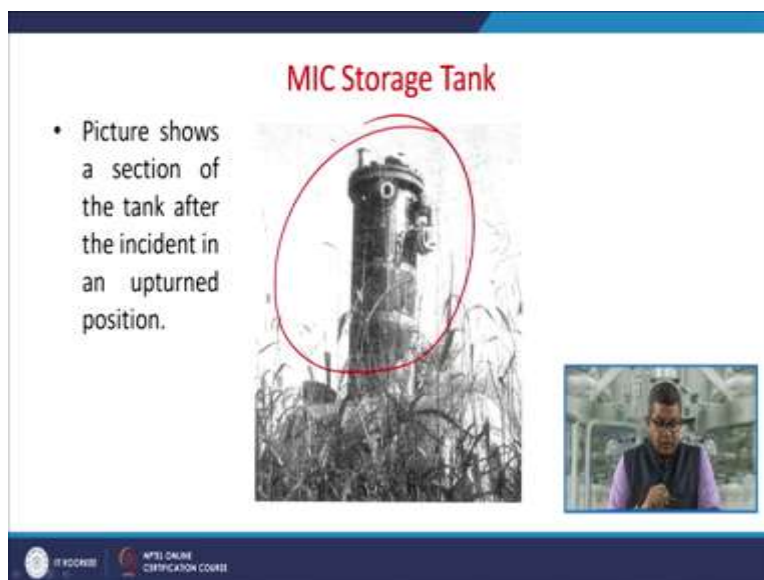
Now this is the picture of a section of the tank after the incident upturned position.

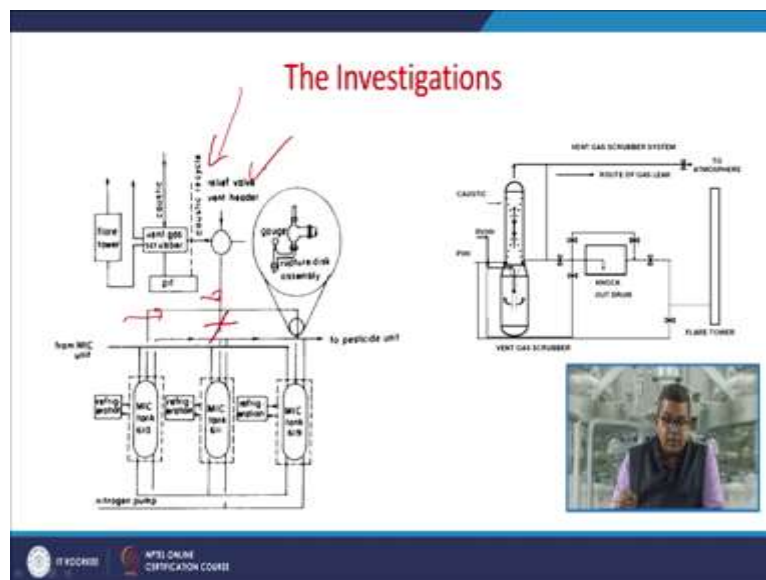
So there the report refers the fact that it was reported that at around 9:30 pm on 2nd December an operator was clearing the possible choke in relief involvement header lines downstream of the phosgene stripping still filter by water flushing without inserting a blind that was the root cause why this accident into place.

So this was the thing like this was the vent gas scrubber cost with the caustic and this was the relief valve head the vent header. So he was trying to clear the any kind of possible choke and in these lines, but he forget he probably he forget to insert a blind within this system.

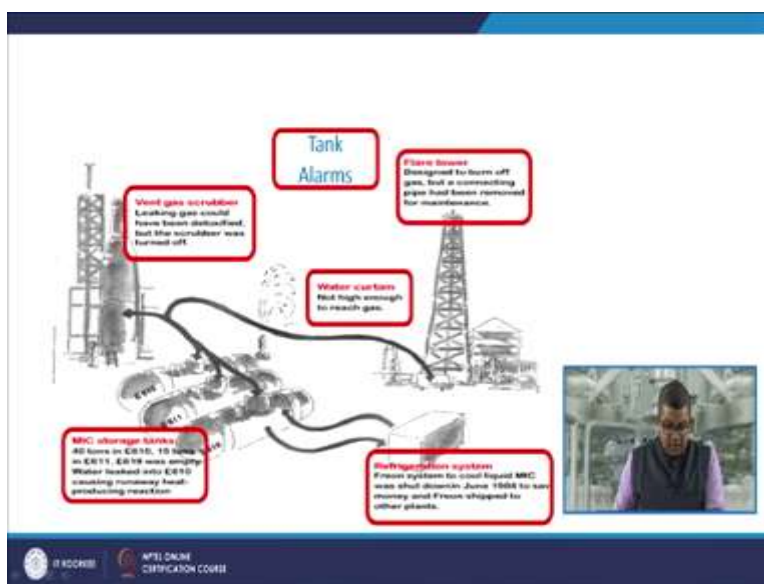
Now this is a more clear picture of the tank facility, these were the storage tanks 40 tons of in 610, 15 tons in 611 and they were in 619 was empty and water leaked into the tank number 610 causing the runaway heat-producing reaction. Now this reaction was catalyzed by the iron and the nickel particles inside the present inside the corroded 610 tank. Now this particular storage battery was supported by the refrigeration system and a free on refrigeration system was used. This is the flaring tower and this was the vent gas scrubber.

So you can see the different pipelines like this one, the refrigeration system they are all interconnected and the water curtain was given not tight enough to reach the gas and this one is the vent gas scrubber, it is duly connected with the flaring tower for the destructive decontamination of various of gases being collected from various parts of the plant. So in this particular module we have discussed about the Bhopal gas tragedy, the introductory part of the Bhopal gas tragedy then we had a discussion about the process and we discussed about the release aspect of methyl isocyanate and we have started the discussion about the various investigatory aspect of this particular gas release.
