**Safety in Construction**  
**Prof. Uma Maheswari**  
**Department of Civil Engineering**  
**Indian Institute of Technology-Delhi**

**Lecture-07**  
**A Case Study on Construction Safety**

I will be sharing a construction safety case study with you which will highlight the importance of following the correct construction sequence and strict supervision at site

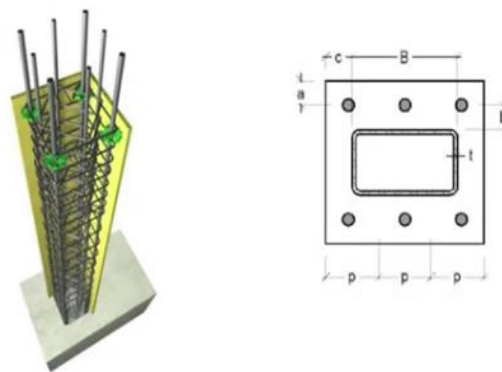
**(Refer Slide Time: 03:10)**

In our case the contractor did not purchase the j-hooks or anger boards which was supposed to be embedded in column or he forgot to do it before casting the tip of the column. When it was time to lift the truss using crane it was too late and the fabricator found a quick solution by welding the base plate with the reinforcement of the column after inserting it through the holes provided in the base plate.

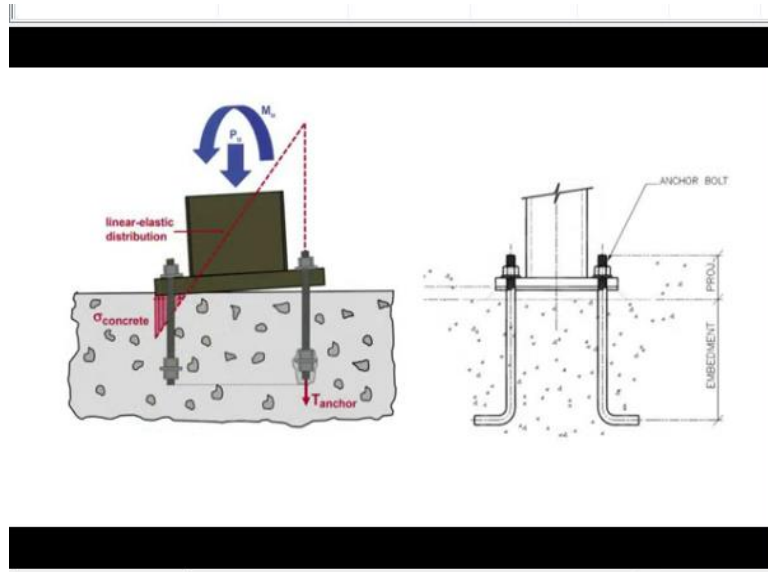
**(Refer Slide Time: 03:39)**

During high wind the truss sway and exert axial forces as well as movement on the base plates. The very purpose of anchor bolt is to resist these forces by bond in concrete and prevent any uprooting of base plate. The weld on reinforcement neither provided enough bond strength nor any axial force resisting capability. Srinagar is an area where the wind velocity is considerable and in an open area the effect was even severe.
