**Maintenance and Repair of Concrete Structures**  
**Mr. Dhruvesh Shah**  
**Vector Corrosion Technologies - Vadodara**  
**Prof. Radhakrishna G. Pillai**  
**Department of Civil Engineering**  
**Indian Institute of Technology – Madras**

**Lecture – 32**

**Case Studies on Structural Repairs Right Methodologies and Systematic Approach**

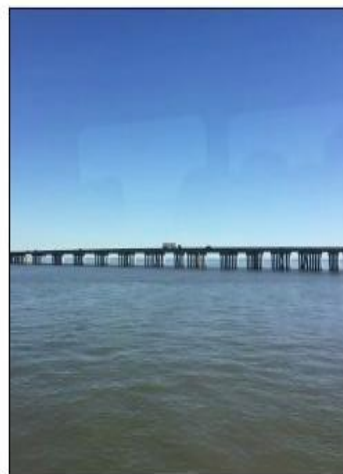
- 100 years old bridge structure affected by Katrina Hurricane.
- Cracks, spalling on beams of bridge, corrosion on piles, aging, and hurricane.

You can see this bridge; it is few kilometers long, it is located in Louisiana state of United States of America in New Orleans. This bridge is 103 years old and the problem occurred when there was a hurricane named Katrina a few years back. Because of aging, because of corrosion and hurricane when they checked the bridge, they found there were a lot of cracks, spalling in the beam of bridge, there were corrosion in the piles.

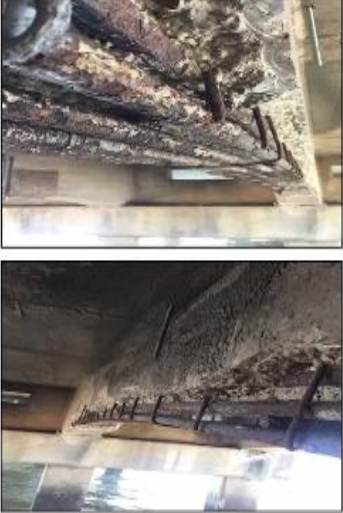
- Cracks and spalling observed in beams.
- Severe corrosion of the holding rebars.
- Corrosion in the pile rebars.

This was the condition of the beam. You can see cracks and spalling. The holding bars, these are the bars which are holding the main reinforcement. You cannot see the holding bars, they had fully corroded here. There was corrosion in the pile rebar.

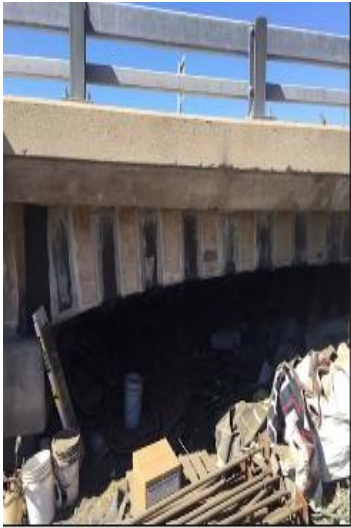
One interesting thing is that, no stirrups or shear reinforcement were found in the beams. Amazing that the beams without shear reinforcement, stirrups, are standing for 103 years, withstanding hurricane. But latest code does not permit this. So structural analysis has been carried out and shear reinforcement were provided using carbon fiber wrapping in U-shape as per equivalent amount of steel reinforcement required for shear. That amount of carbon has been installed in the form of wrap on 3 sides. Structural analysis has been carried out based on prevailing codes and design calculation for CFRP has been carried out based on ACI 440.2R 2017.

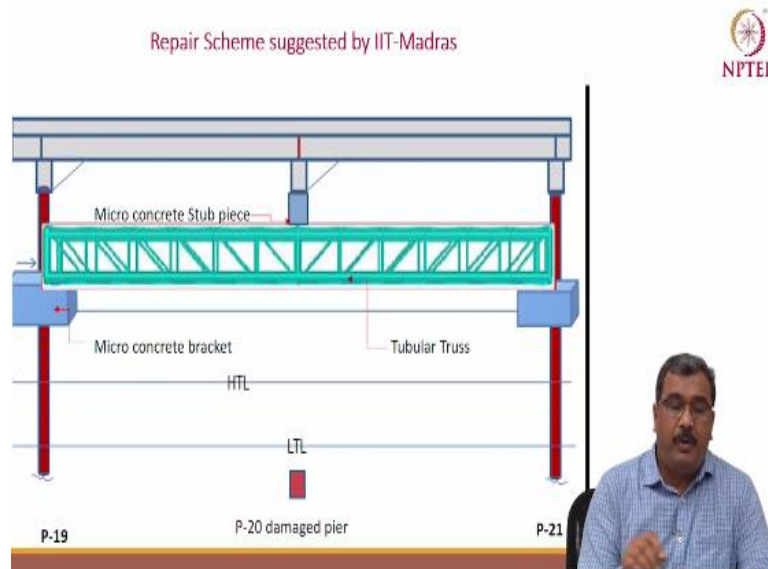
- One of the Pile (No. 20) was broken by Hit of Ship.

This case study is for a missing pile (missing pier) of a bridge. This bridge is connecting an intake of a power plant which is well inside the sea to the way-ahead power plant which supplies water. Now one of the piles, you can see the pile number 20, was broken or damaged as it was hit by a ship. So this span is not safe, this is pile P-19, this is P-21 and Pier-20 is missing.

I will explain in detail. With the help of IIT Madras, a scheme has been derived, wherein a new truss has to be fabricated, a new bracket has to be constructed, the truss is to be placed on these 2 brackets. Another stub piece of micro-concrete to be installed with base plate and then this whole truss has to be loaded jacked such a way that the load being transferred to these 2 pile. Also analysis has been done that these 2 piles are capable of taking the 50% load from the missing pile.

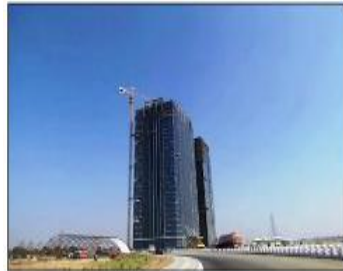
- New Server Load on 8<sup>th</sup> floor.
- Moment deficiency at lower 3 floors.

And it was found that 4th, 5th and 6th floor columns, few of the columns of these 3 floors were not adequate and they were found to be deficient for moments. Axially, for compression and for shear, they were safe. As I told, the 8th floor was not constructed. So based on new requirement, the slab and beam of that floor, design has been altered and there was no requirement of strengthening for that floor.

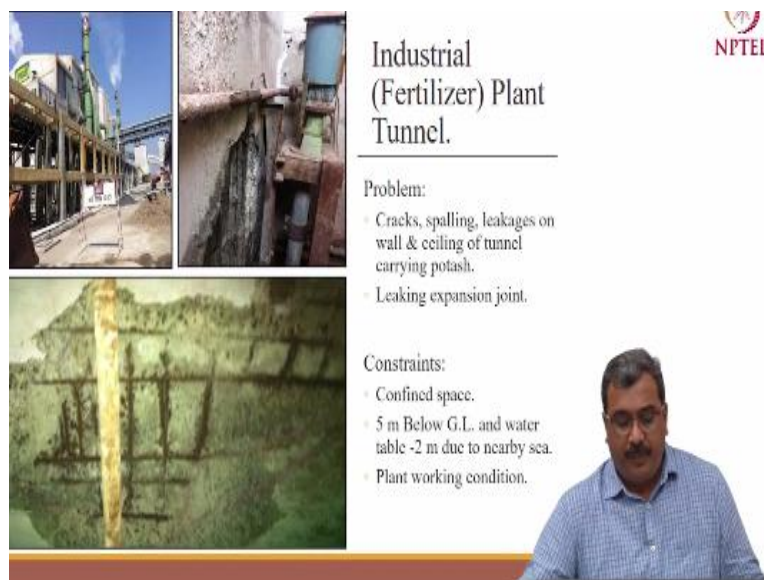
- Cracks, spalling, leakages on wall & ceiling of tunnel carrying potash.
- Leaking expansion joint.

The tunnel wall thickness is 1 meter at the bottom and 600 mm at the top. There was lot of leakage, cracks and spalling which was found during routine inspections. They had carried out a large number of various types of repair, but the root cause was not determined

and not eliminated. So we carry out proper survey, we carry out NDT, the strength was okay, contamination in the concrete was there, leakage was found severe, expansion joints were failed, and the constraint was working condition, confined space, lot of smell because of potash. You cannot work, you cannot stay there for a long period. It is nearby sea, so during high tide there will be more leakage, continuous leakage and plant is in working condition. You cannot stop, conveyor belts are moving.
