**Fracture, Fatigue and Failure of Materials**  
**Professor Indrani Sen**  
**Department of Metallurgical and Materials Engineering**  
**Indian Institute of Technology, Kharagpur**  
**Lecture 55**  
**Failure Analysis-Case Study-ALK**

Hello everyone, we are at the 55th lecture of this course fracture fatigue and failure of materials. And today also we will be discussing about a very real-life incident a case study on capsizing of Alexander L. Kielland. So, let us see what we have in store for this lecture.

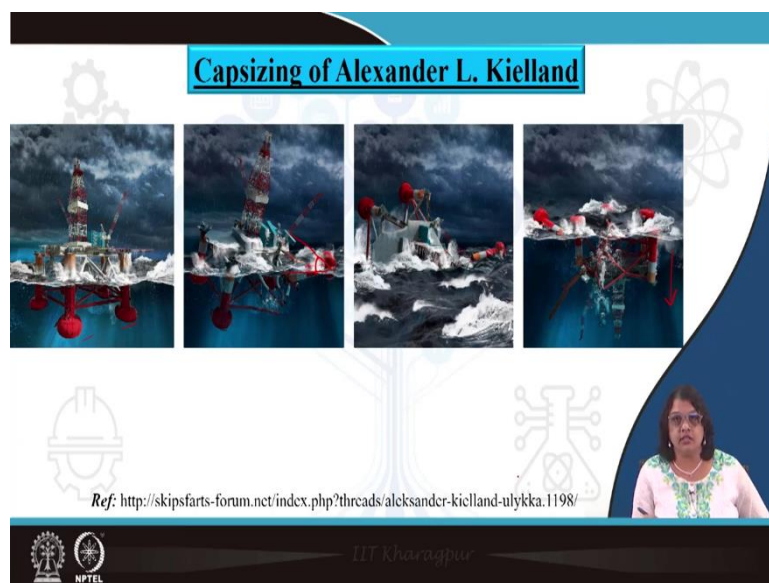
So, you can see through the schematics and you can understand how it looked like. So, this is the original way by which Alexander L. Kielland was standing you can see the columns also underwater. And then there was some heeling as you can see the water level as well as the angular degree by which it has been inclined and the ceiling continued and this is initially partly submerged and finally, it has been completely capsized.

So, you can see that it has turned upside down completely. So, that was and please do note that this has a weight of more than 10,000 tones. So, capsizing such a huge structure was quite unseen of at least up to that period.

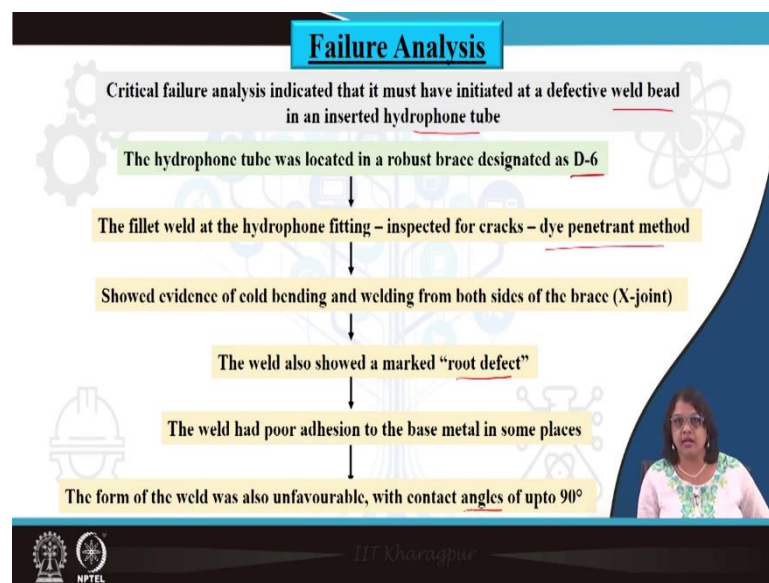
So, the critical failure analysis indicated that it must have initiated at a defective well bead in an inserted hydrophone tube. So, the entire structure has been very thoroughly scrutinized after the incident to find out that what exactly could be the reason and they have located a defective weld bead in the hydrophone tube. So, remember, we were talking about the hydrophones and the how the hydrophone is being placed by welding.

So, that has a huge impact here. The hydrophone tube first located in a robust brace designated as D 6, we have already seen that and the fillet weld at the hydrophone fitting was inspected for cracks after the incident using the dye penetrant method and when it has been done to this nondestructive method.

So, dye penetrant method is a nondestructive method, we cannot typically if such a structure is already broken, we cannot make specimens out of it rather the entire giant structure has to be tested to see that whether there are any kind of non-uniformities in the structure and that dye penetration showed evidence of cold bending and welding from both sides of the brace and also showed the marked root defect.

Thorough investigation has been done. The weld had poor adhesion to the base metal in some places the form of the weld was also unfavorable with contact angles of up to 90 degrees. So, the welding had some problem it has not been properly done, the contact angles were not up to the requirement, no preheating was done and that led to initiation of some defect.

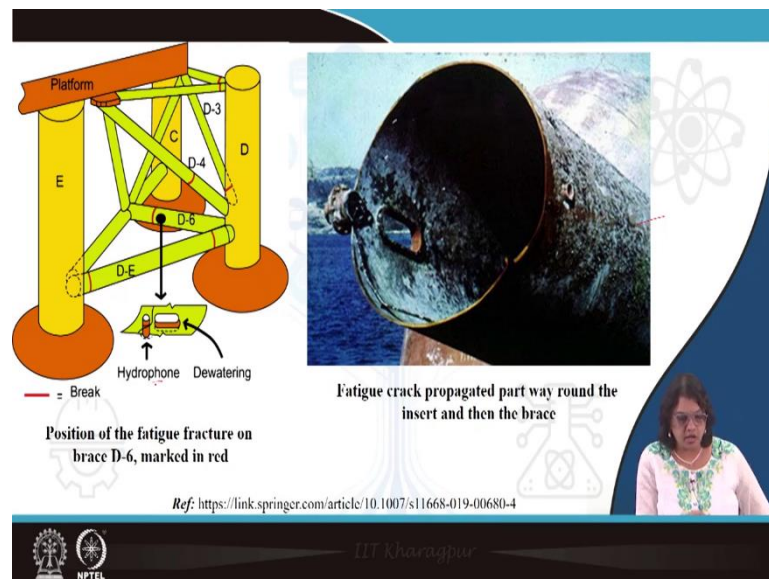
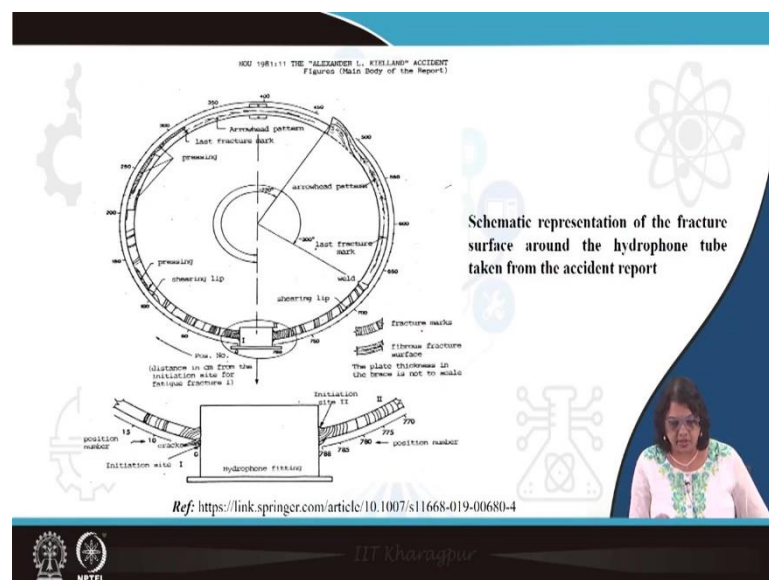
A portion in the fracture surface in the weld between the hydrophone and the brace

- contained the remains of a coat of paint
- indicates that cracks were present at the time of fabrication
- this paint was present on both the fracture surface of the inside weld and the bracing D-6

- The fillet weld joints showed shallow, flat fractures in and near the fusion zone, typical tear-off fractures, and in part, fractures in the weld itself.

So, you can see here, this were the piece that was recovered and this was actually somewhere here, where we can see the position of the hydrophone and this hole here. And based on the studies itself, we can found out that how the fracture surfaces looked like how the markings were there, and all this has been very, very carefully and critically analyzed to determine the actual reason for the failure.

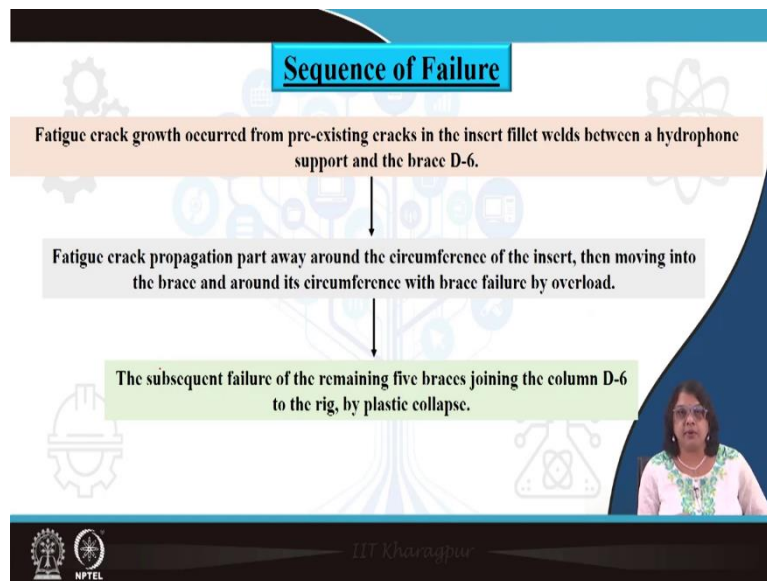
So, from this finally, we realized that the one crack that was there in the D 6 that has initiated and that led to the final fracture. So initially fatigue crack growth occurred from the pre-existing crack. So, the presence of a small defect, again, that would not be of any danger had it been not placed inside the sea where there is a corrosion atmosphere as well as there is a repeated loading based on the waves and that leads to the fatigue loading.

So, that fatigue crack propagation part way around the circumference of the insert, and then moving into the brace and around its circumference with the brace failure by overload the subsequent failure of the remaining 4 braces, joining the column D 6 to the rig also happened by plastic collapse.
