Chemical Process Safety
Professor Shishir Sinha
Department of Chemical Engineering
Indian Institute of Technology, Roorkee
Lecture-55
Bhopal Gas Tragedy - Investigation

The Investigations

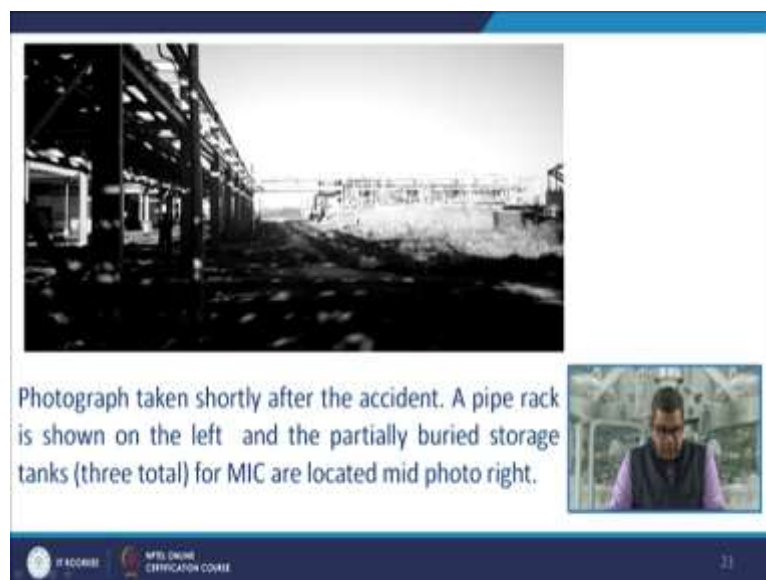
Twenty years later, the flora covers the Tank 610 which has been removed from the earthen mound

Now, you can have a look at the photographs taken shortly after the accident. This is a pipe rack is shown in this arena and the partially buried storage tank, there were 3 in total for MIC located in the mid of the photograph, if you are able to locate them. Now this is the photograph of 20 years later, the Flora covers the tank 610 which has been removed from the earthen mound and this is a photograph near the filter area. Some of the critical components are identified in this particular photograph.

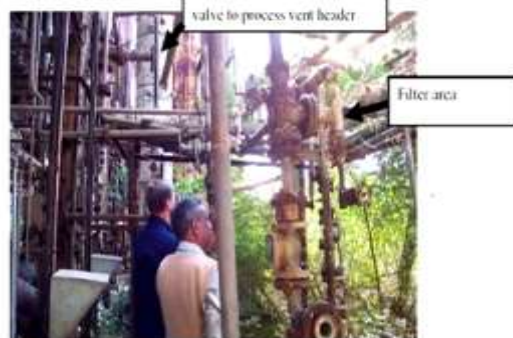
Photograph near the filter area. Some of the critical components are identified in the photograph

This is the valve to process vent meant header and this one is for the filter area. Now this is the actual photograph of the spring relief valve and this one is the ruptured disc. So, this is a photograph of tanks 611 entry piping, ruptured disc is on the centre here somewhere here. Spring relief valve is behind the Flora that has grown over the years. Now this is the

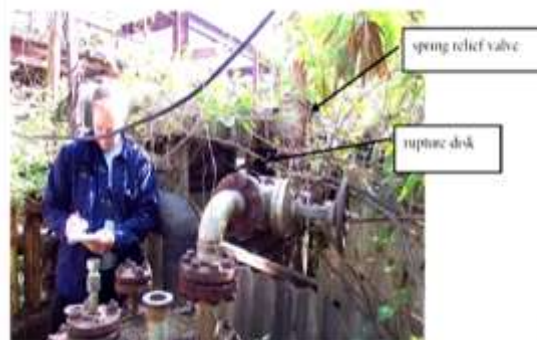
Photograph of Tank 611 entry piping. Rupture disk is in center, spring relief valve is behind flora that has grown in over the years.

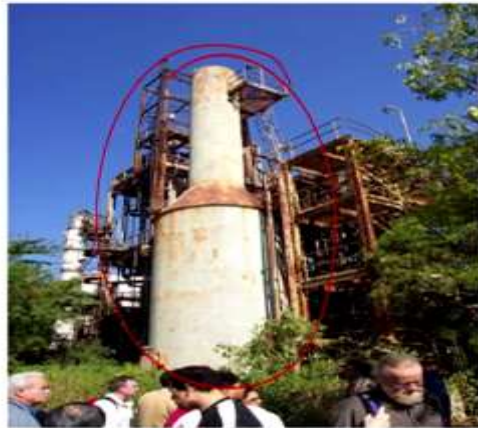
Photograph of the scrubber system.

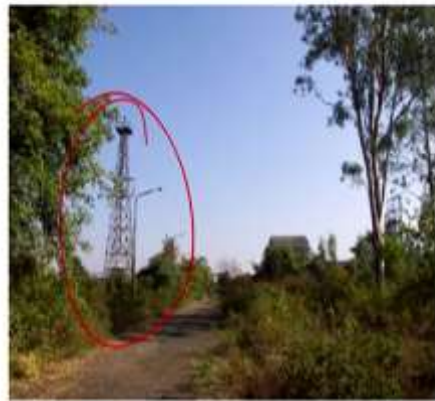
Photograph of the disabled flare tower.

- Improper design of chimneys (without consideration of weather conditions in all seasons)
- Improper design and maintenance of safety equipment.
- Not following safety regulations as that followed by UCC plants in USA.
- Decision to neglect a flare system in need of repair.

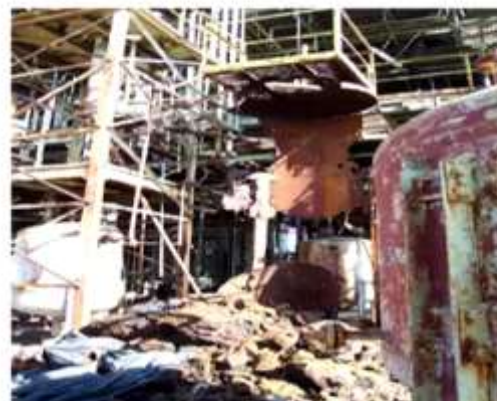
Corroded tank with unknown contents lying below.

These are the corroded tanks with unknown contents lying below. So, this is again a very crucial information for the accidental investigation. These are some of the photographs of jumper lines, et cetera you can see. Now, this is a remote photograph of gas vent scrubber and this is the gas vent scrubber stack. Then the people analyses about the possible reasons of this accident.
