**Geotechnical Earthquake Engineering**  
**Prof. Deepankar Choudhury**  
**Department of Civil Engineering**  
**Indian Institute of Technology, Bombay**

**Introduction to Geotechnical Earthquake Engineering (Contd...)**

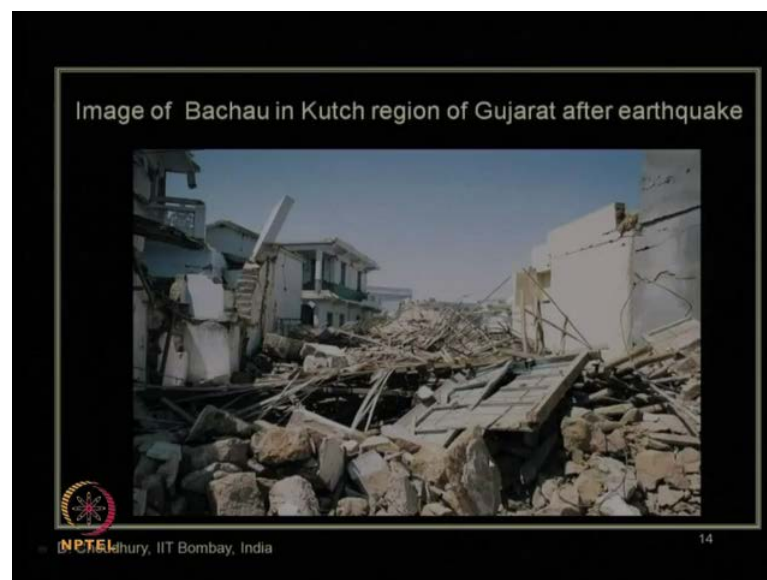
(Refer Slide Time: 09:59)

Coming to today's lecture, we can continue further on this topic and we can say this picture, which shows the total damage of the Bachau in Kutch region of Gujarat after 2001 Bhuj earthquake. And, this is the picture of the total destruction of the area, total damage of the houses and buildings, etcetera in that Bachau region of Kutch in Gujarat in India in 2001 Bhuj earthquake.

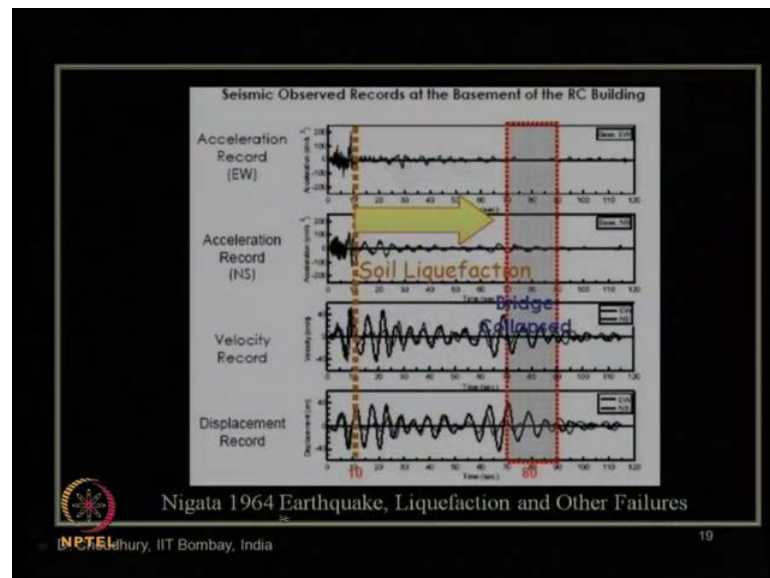
(Refer Slide Time: 19:36)

Now, let us see the various observations of Niigata earthquake. These are few more case studies we can discuss about; like the liquefaction and other failures of 1964 Niigata earthquake, these are seismic observed records at the basement of that reinforced

concrete building. You can see the accelerometer recording acceleration record in East-West.

In this slide, we are showing the Niigata 1964 earthquake, liquefaction and other failures; what are the observations of seismic stations like seismic observed records, which was recorded at the basement of that RC building. This is the acceleration record - the first picture in the East-West direction. This is the y-axis - tells us about the acceleration value in centimetre per seconds square unit; and, x-axis is the time in second. This second picture shows the acceleration record in North-South direction. Again, acceleration verses time. This third picture shows the velocity record - velocity in centimetre per second unit verses time. And, the fourth or last record - it shows the displacement record; that is, displacement in centimetre verses time in second.

You can see over here the maximum value of the acceleration, which has occurred in East-West direction as well as in North-South direction, which can be seen through this velocity record also is typically close to about 10 seconds; whereas, if you see, when the soil liquefaction got started, it got started beyond this 10 seconds; that is, once it reach this maximum value, after that, the soil liquefaction started; whereas, they monitored from the case history that the bridge started collapsing during this about 80 seconds or so between 70 to 90 seconds. That is the time when the bridge started collapsing after the soil liquefaction has occurred. So, there is a few second time lag between the soil liquefaction starts and the collapse occurred of the superstructure, which is quite obvious, because this is the time taken by the soil to fully liquefy. And, once it fully liquefies, then the bridge started collapsing. And, you can see over here the displacement record, which is nothing but integration of this acceleration record twice. And, that gives us the maximum displacement occurring at this location, which finally causes the damage of the structures constructed on that site on this liquefied soil.

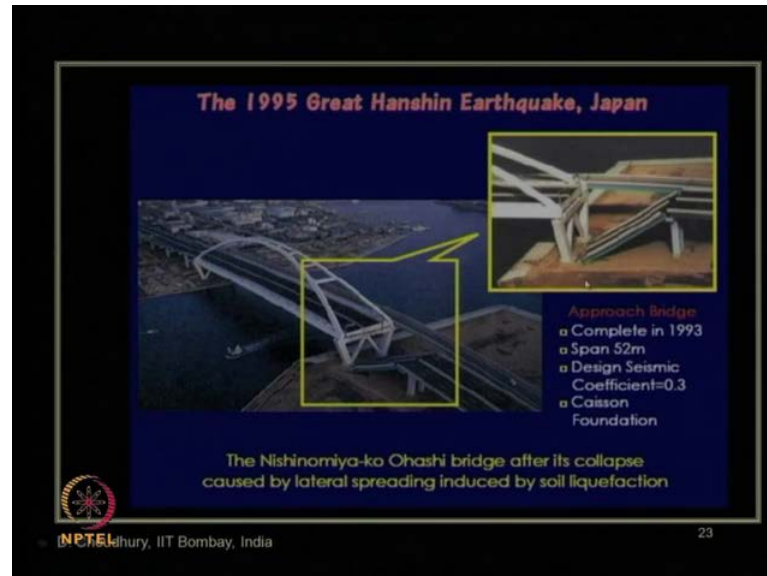
(Refer Slide Time: 28:45)

This is another picture, which shows the damage of a bridge. This is the approach bridge, which was completed in the year 1993. And, span of the bridge was 52 meters. You can see over here – this is the span of the bridge. And, the design seismic coefficient, which was used for the design of this bridge, was 0.3 G as per their design code of Japan at that time. And, Caisson foundation was used for this bridge. But, after this Kobe earthquake of Japan in 1995, what happened, this portion of the soil got liquefied; and finally, this apartment or this support sank into the soil; and finally, everything got collapsed like this. So, this is the Nishinomiya-ko Ohashi bridge after its collapse caused by lateral spreading. As I was mentioning, once the soil gets liquefied, it starts flowing in the... As it flows in the gradient wise for the case of water for higher to lower gradient, the same thing occurs. So, lateral spreading induced soil liquefaction caused the damage of the structure constructed on this site.

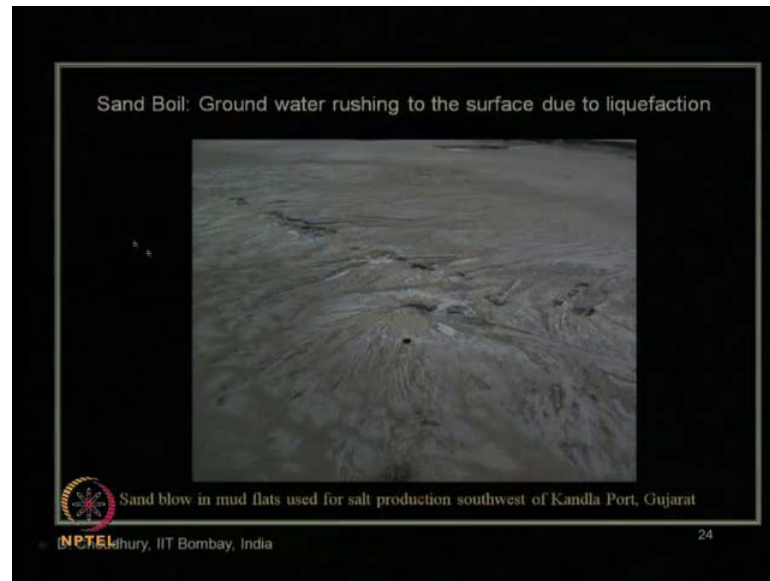
(Refer Slide Time: 30:12)

Next, let us see a picture on the ground surface, where the soil liquefaction has occurred. This slide shows a picture of the sand boiling, what we call in another term – sand boiling or soil boiling or the soil liquefaction. This is the ground water – the underground water, which is close to the ground surface, are rushing out or coming out to the surface after the liquefaction takes place at the site. This is the picture, which occurred at the Kandla Port in Gujarat soon after the Bhuj earthquake in 2001 in India. So, that sand blow in mud flats used for salt production South-West of Kandla Port Gujarat. So, this is the soil boiling or sand boiling due to the liquefaction on the ground surface.

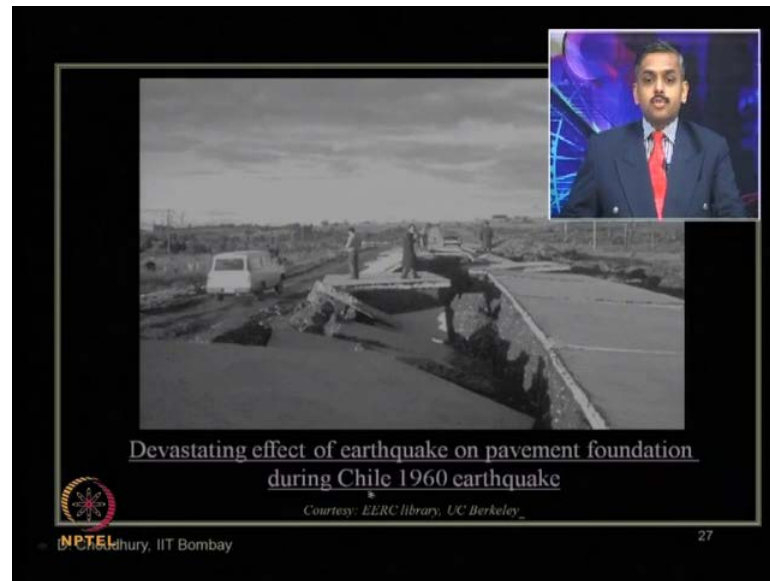
(Refer Slide Time: 32:00)

We can see some more earthquake damages. This is the devastating effect of earthquake damage on the pavement foundation. This was the initial pavement foundation. After the earthquake, the entire thing here got collapsed. This is the picture after the 1960 Chile earthquake. So far, in the history, we know that the 1960 Chile earthquake is the highest recorded earthquake so far in the world.

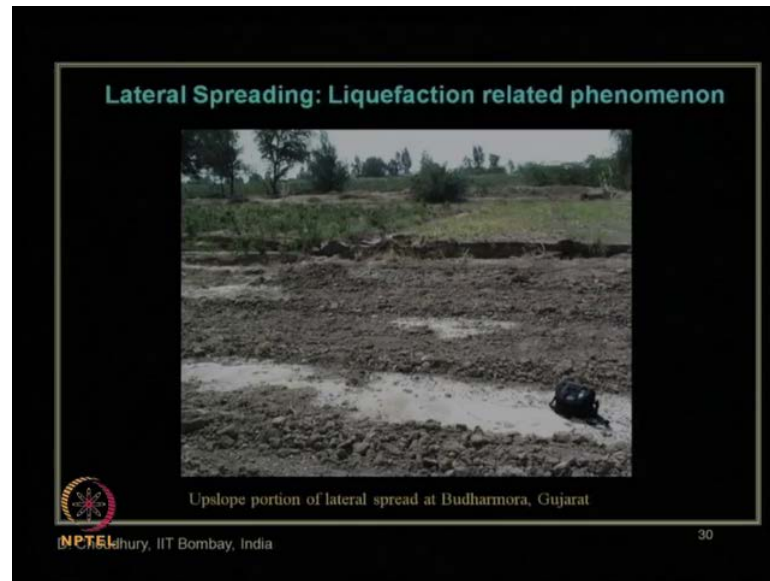
(Refer Slide Time: 33:28)

This picture shows the effect of liquefaction or liquefaction-related phenomenon as I have mentioned, which is known as lateral spreading. Lateral spreading is nothing but after the soil gets liquefied, it starts flowing; as it becomes a fluidic state, it starts flowing from higher slope to a lower slope. This is the picture after the soil flow from higher slope to lower slope or higher gradient to lower gradient after the liquefaction occurred at that portion. So, upslope portion of the lateral spread at Gujarat after that 2001 Bhuj earthquake in India – this is the picture.

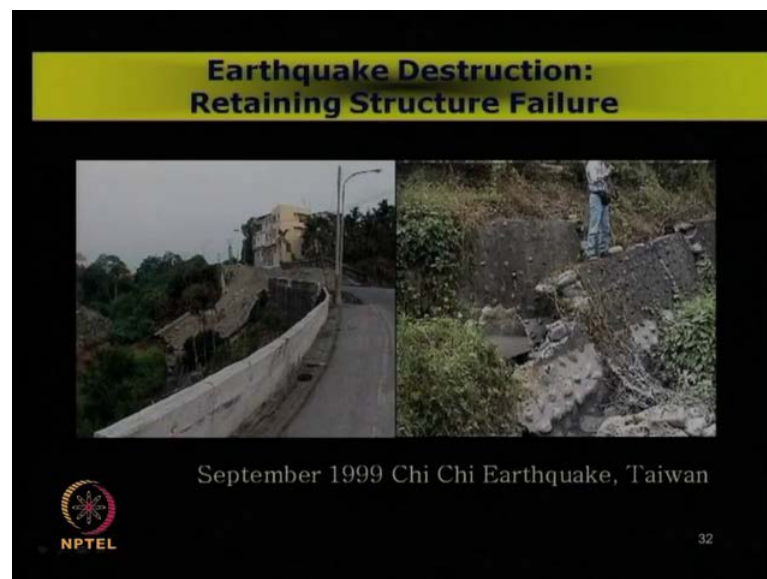
(Refer Slide Time: 34:46)

Coming to other form of earthquake destruction like retaining structure failure or retaining wall failure, this is the initial retaining wall. You can see one portion of it got collapsed over here after the 1999 Chi Chi earthquake in Taiwan. This is the close view of that collapse of that retaining structure or retaining wall after that earthquake.

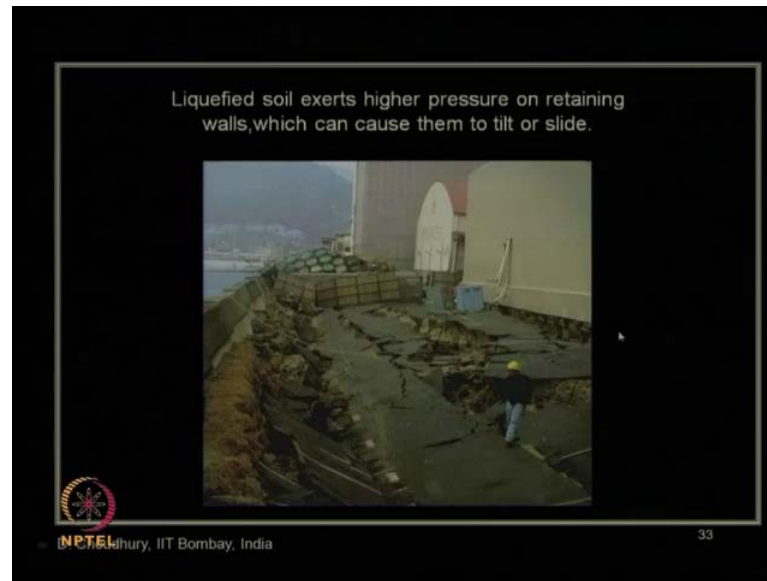
(Refer Slide Time: 35:11)

Then, liquefied soil – they start exerting higher pressure on the retaining wall. Why? Because when we design a retaining wall, it is supposed to withstand the earth. And, as we know, in the active state of earth pressure, earth pressure coefficients are typically less than 1; whereas, if the soil starts becoming or behaving like a liquefied material, it is nothing but a fluidic material. So, for that, the pressure coefficient or lateral coefficient will be 1, which is much more than the active earth pressure coefficient, which is considered for the design of any retaining wall under active state of earth pressure. So, automatically, the liquefied soil starts exerting much higher pressure on the retaining wall; and, which can cause finally, the retaining wall to tilt or slide if it is not designed properly to withstand that amount of lateral thrust coming from the fluidic soil or the liquefied soil. So, this is the picture of a retaining wall failure after the soil liquefaction.

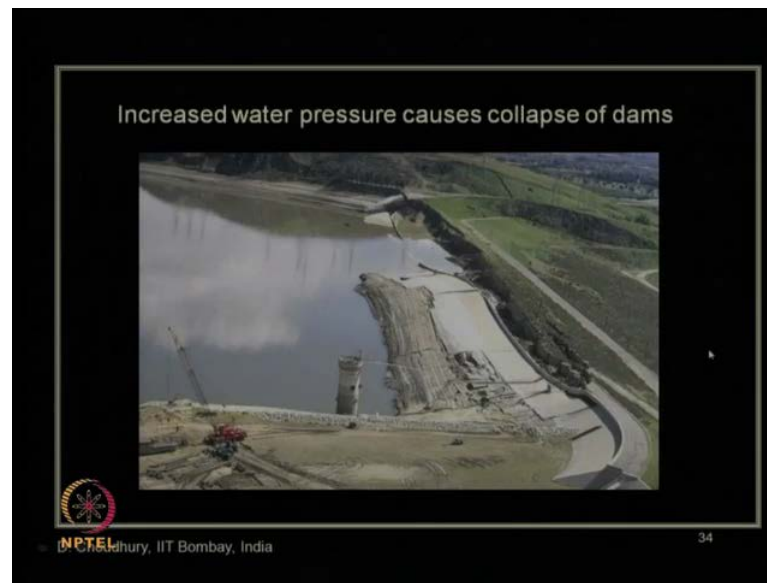
(Refer Slide Time: 36:20)

Another picture shows here the increased water pressure, which causes collapse of the dam. You can see over here at this portion, the dam has been totally collapsed. This is due to the increase water pressure during the earthquake condition.

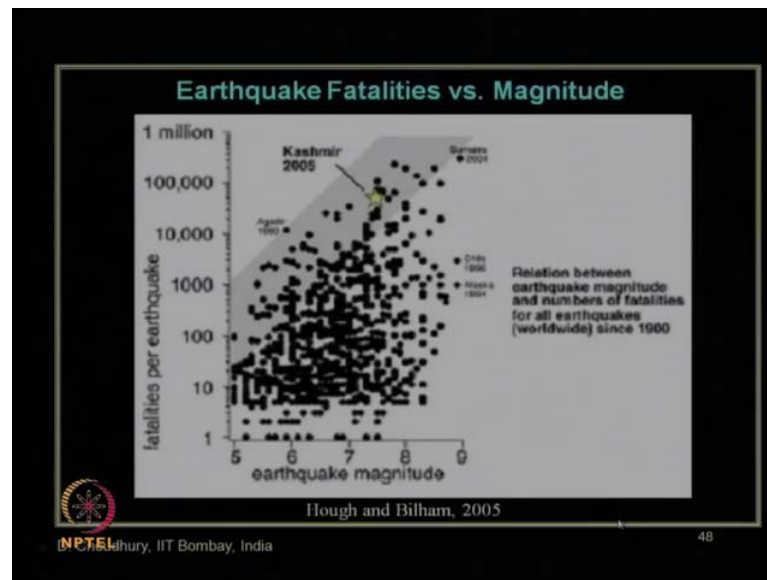
(Refer Slide Time: 57:26)

This is the typical picture given by Hough and Bilham in 2005. The relationship between number of fatalities versus earthquake magnitude, you can see the points; obviously, as we know, earthquake magnitude increases, if it is a highly populated area, number of damages or fatalities will increase; but it is not always so. Sometimes, you can see with a large magnitude, number of fatalities is less; that means, probably, either the construction was pretty good, design was pretty good, which could take care of that high magnitude of earthquake; or in that locality, there was less number of people, who were staying at that location. With this, we have come to the end of module 1 of this geotechnical earthquake engineering video course. We will continue further in the next lecture.
