Natural Hazards
Prof. Javed N Malik
Department of Earth Sciences
Indian Institute of Technology, Kanpur

Lecture – 15
Case study on 2015 Gorkha Earthquake

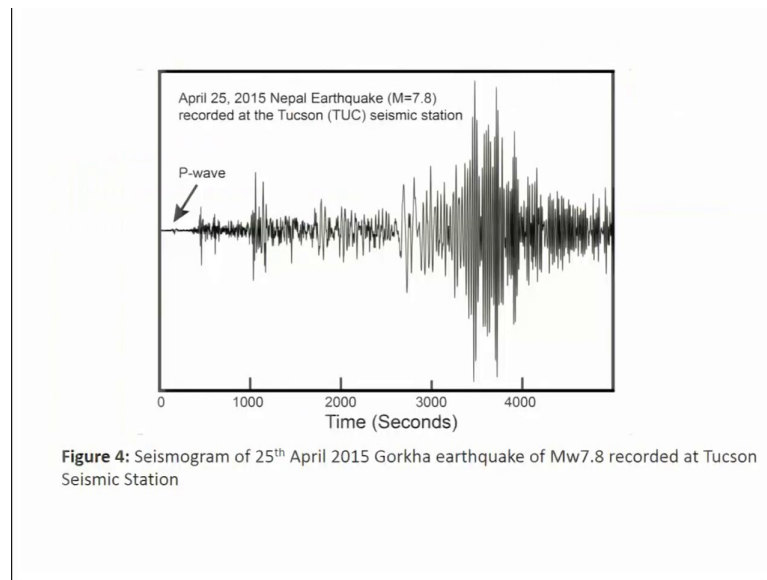
So, this is an Seismogram of 2015 Gorkha earthquake and so this was the event ah, which took place and record it at the Seismic station in Tucson.

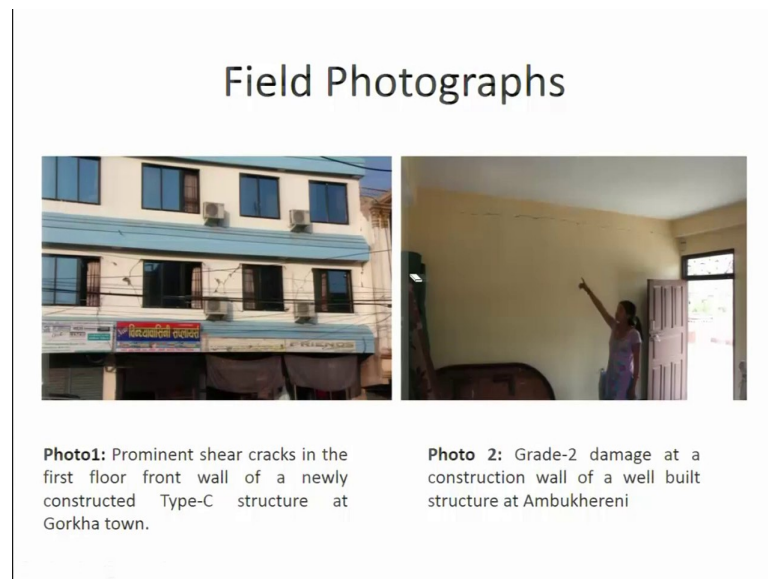
(Refer Slide Time: 14:19)

So, we slowly moved and from the Indo Gangetic plain even we, we tried to interview the people in India and in the border areas, where we were talking that what was the experience they had during the earthquake or before the main shock started, that is particularly the **Seismic** shaking started. So, we were talking to people and trying to understand that what was their experience. Some people told that there was like lightning and thunder storm, thunder and all that and some people told that there was a roaring sound.

So, that was very important for us to understand and as we moved further close to the epicentral area, we found that the damage was increasing slowly and we saw more of the building collapse and all that. Otherwise, at the initial stages when we started moving ah, from the Indo Gangetic plain and enter into the Nepal, we found some cracks which have been very visible and these structures, but no collapse was been seen.

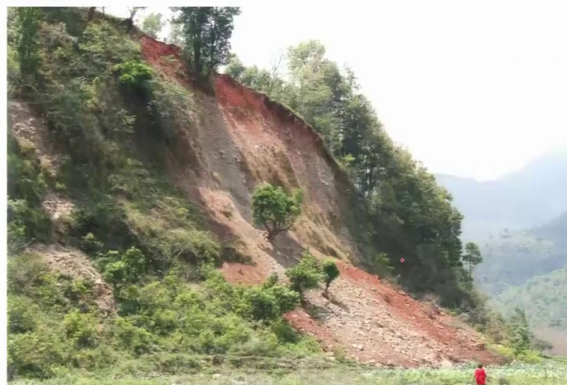
Photo 5: A coseismic landslide triggered in terrace material at Naya Sandhu village.

Of course other than geological processes, we were able to observe was common and most of the areas experience landslide, because of the strong ground shaking or Seismic shaking. Then this was at Kathmandu main and it in the main city.

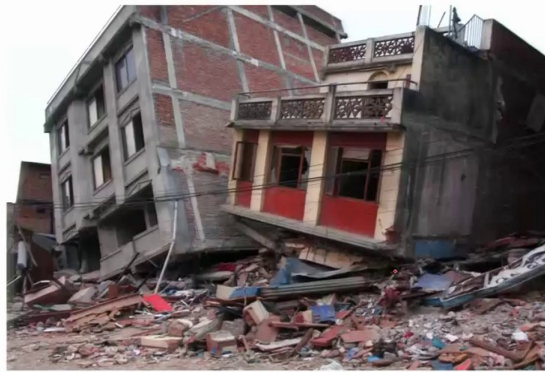
Photo 6: Collapse of RCC framed structures due to failure of load bearing base columns of the stilts in Kathmandu Valley. Central region, Bagmati, Kathmandu, Chhauni, Nepal (27°42'45.0"N; 85°16'58.5"E).

Now, failure of those houses, the civil engineers and the software engineers can tell more about this, but this was the you the damage, because of the poor construction again.

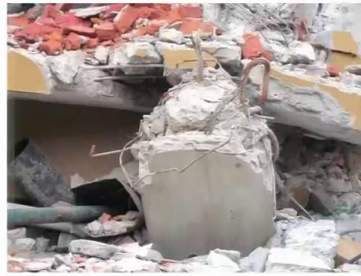
Photo 9: Failure of load bearing base column from beam junction, Thankot. Central region, Bagmati, Thankot, Tribhuvan Highway, Nepal (27°41'25.7"N; 85°13'20.7"E)

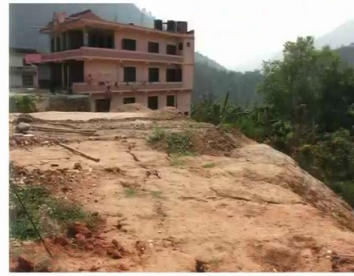
Photo 10: Development of fissures on the slump along the roadside at Malekhu Bazar.

The newly constructed structures experienced a huge damage and in some places what we found was the construction is taken place. Now, this construction of this house has been constructed over a artificial film and what you see here are the cracks, which had been developed in extensional crack. So, tired the, at some point of time, this whole mass which is been filled mass on the, on when the area close to the slope will slide down. So, this is not an good place to be selected for any construction.

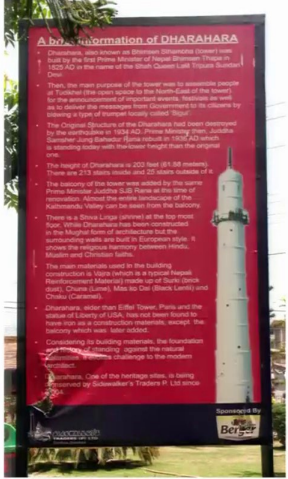
(Refer Slide Time: 17:57)

The information board for the Dharahara Tower in Kathmandu provides a detailed history of the monument. It mentions that the tower was built by the first Prime Minister of Nepal, Bhimsen Thapa, in 1824 AD. The board also notes that the tower was severely damaged by the 1833 earthquake and the 1934 Bihar-Nepal earthquake. It states that the tower was completely destroyed and only two storeys remained standing. The board also mentions that the tower was reconstructed by the then Prime Minister of Nepal, Juddha Shumsher, in 1934. The board is titled 'A brief information of DHARAHARA' and includes a small illustration of the tower.

- Dharahara Tower**

The Dharahara Tower in the Kathmandu was the tallest monument in Nepal and the second such tower built by Bhimsen Thapa. Of the two, the 11-storey high first tower was built in 1824. The 9-storey, 61.88 m high second tower (Dharahara), also known as Bhimsen Tower was built eight years later in 1832. The construction material was baked brick tiles set in a lime mortar. During the earthquake of 26 August 1833 earthquake, both towers survived, though the first one was quite severely damaged. However, under the influence of the 1934 Bihar-Nepal earthquake, the first tower was completely destroyed and in the second one only two storeys remained standing. The then Prime Minister of Nepal Juddha Shumsher, subsequently carried out renovation work to completely restore the 9-storey Dharahara Tower. The 25th April 2015 Gorkha earthquake once again demolished it with only its basal part remaining standing.

Now, this tower experience the massive damage or way I can say, total damage of that. Now, this is important point that during the earthquake of 26 August 1833 both towers survived. So, the first one was quite severely damaged; however, under the influence of 1934 Bihar, Nepal earthquake, this was an the earthquake above magnitude 8, the first tower was completely destroyed and in the second one only two storey remains standing.

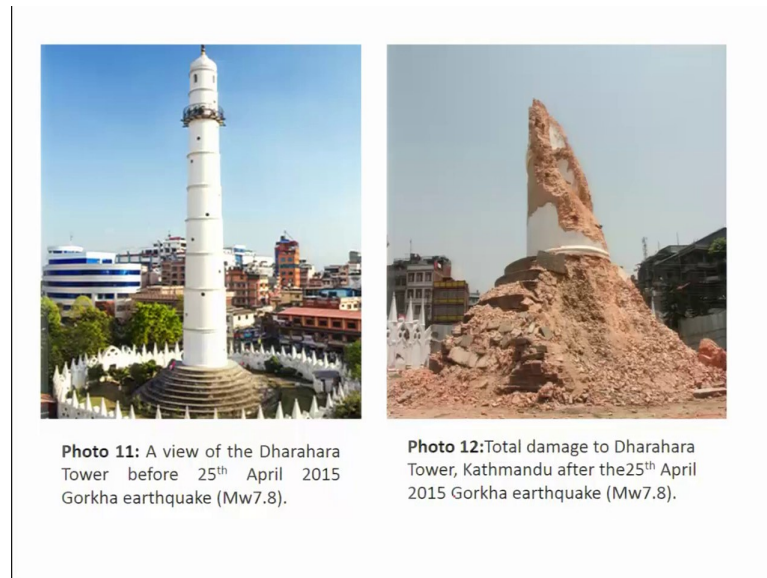
So, this is, the before Dharahara tower before the earthquake and this one is after the earthquake. So, it was completely destroyed that definitely, the construction was not up to the mark to withstand even the earthquake of 7.8 within very different acceleration.

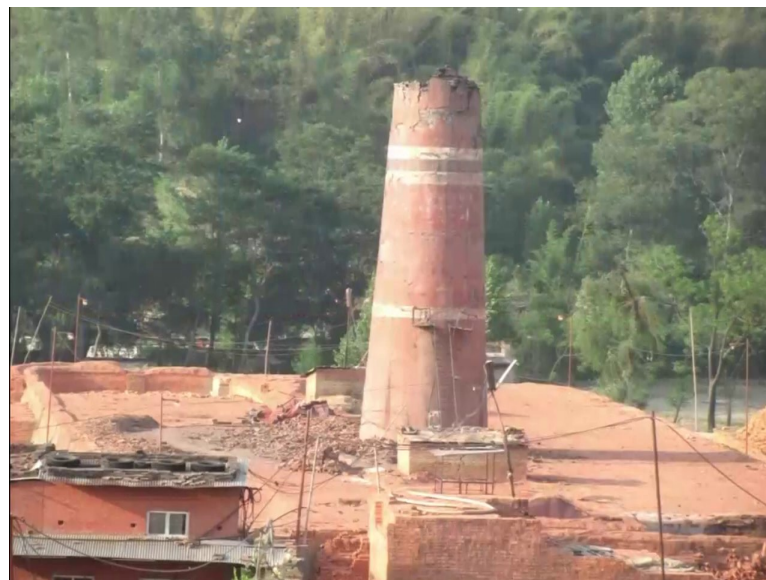
Now, what we observed was most of similar structures like what we see Dharahara, a this is an chimney ah, which most of the chimneys in this area got damaged and this was very much similar phenomena, which we observed or this area of Dharahara experienced in

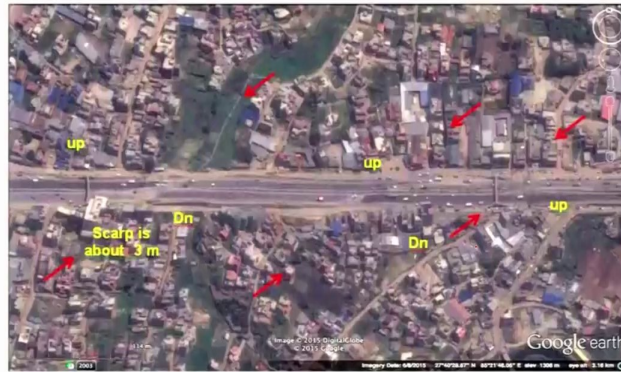
Fig. 7: Google image showing the surface deformation caused by 25 April 2015 Gorkha earthquake (Mw7.8). It resulted into formation of en-echelon fractures developed striking in N60°-70°E. Fractures/extensional cracks are associated with warping of the surface, which has caused relative uplift and subsidence in the deformational zone extending for about 400 m.

Now, there are two views again debate is there that this area or which is the area, it is the main highway and close to Katmandu. So, we found surface deformation which was resulted, because of 2015 Gorkha earthquake. What we was saw was that the area was subjected to the en-echelon and fracturing and the strike force, this actually. This was what we found and the en-echelon fracturing that some places resulted into the land uplift and subsidence, uplift subsidence and uplift like that. So, we did little bit detail survey and this area extended for almost like 400 meters.

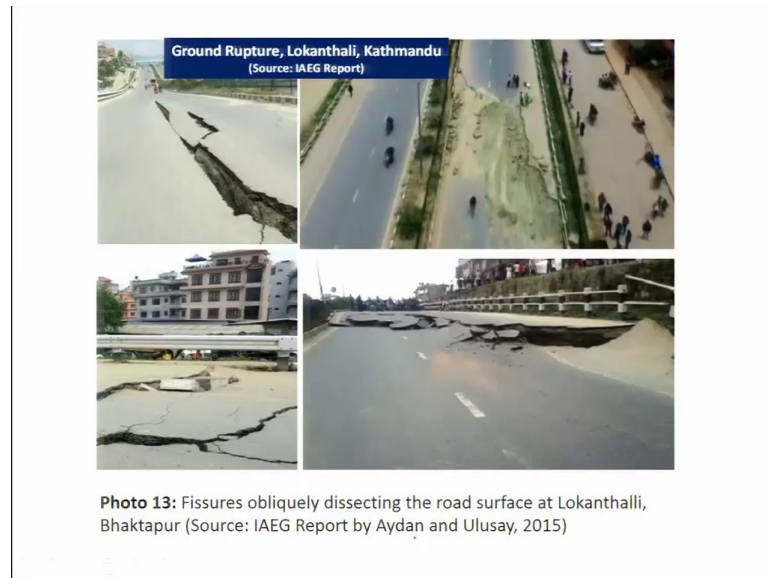
(Refer Slide Time: 22:10)

So, this were the pictures which were been also available on the net, which shows the damage pattern, where the roads and the bridges were buckled up huge deep cracks were been formed, but our idea was that let us go and try to study, if possible to see subsurface, what exactly has happened.

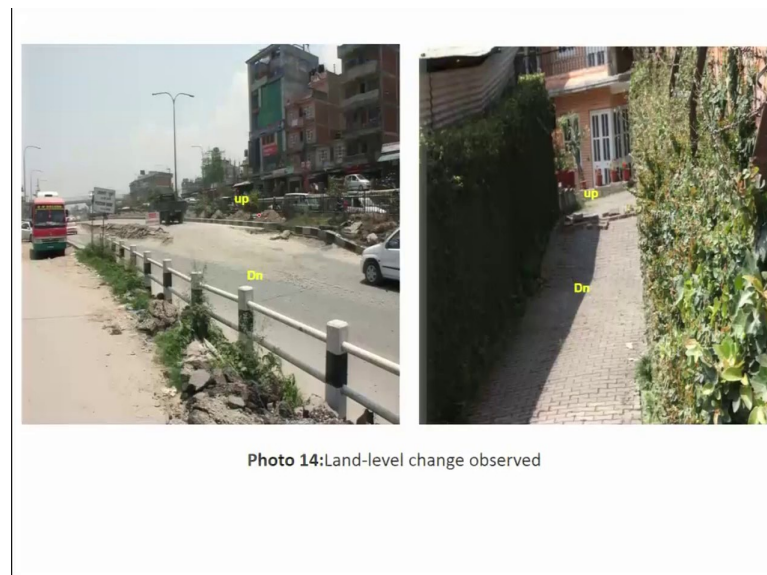
And of course, we were not able to go much deeper, but with the help of ground penetrating radar, we tried to see at some location that what is the ah, the features which we see in such pattern of deformation in subsurface.

So, this portion closely clearly shows a very well develops scarp here. The side is up, the side is down and close to the in the and the on the same line in the veranda, if we see this portion is up and you can see this portion is coming down here.

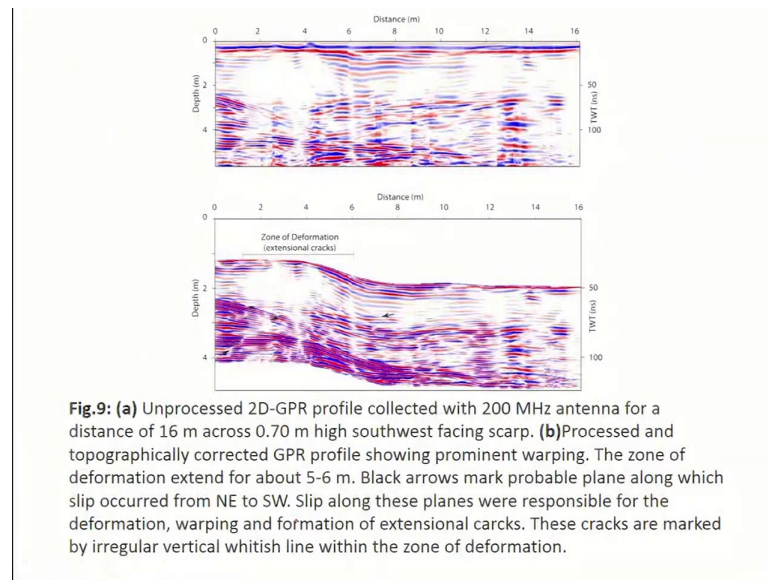
So, we did G P R of course, as I told that we were not able to go deeper, but what we found was that; so this is an unprocessed profile, without topographic correction. The topographic correction is this one, we applied to it and what we found was there are the cracks, this was the zone of deformation the extension cracks are developed on the warping side. So, if you warp anything then the crust will show you some openings or the cracks will form the extensional cracks will be seen on the on the crust part. So, this is very common ah.

So, this extension cracks were observed here, but at the deeper portion what we saw that there is another similar deformation ah, which has occurred probably not due to this earthquake, but of the past event and this warping was experienced in the past also. So, this area must have experienced such type of deformation in the and the earthquakes during the historic time.

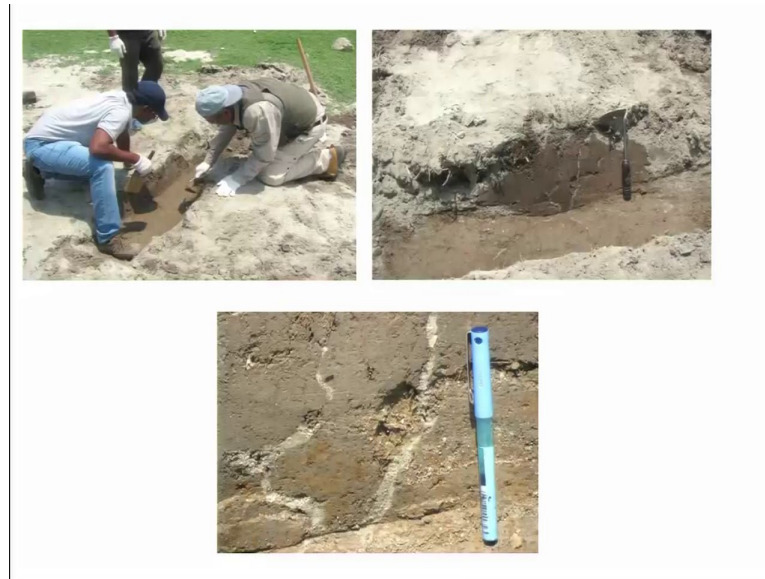
Very commonly found secondary features or the secondary effect and most of the areas where the water table was very shallow, we found the formation of the sand dikes and sand blows.

So, this is ah typical of liquefaction sand dikes, which are coming up and this sand has been the liquefied sandwiches, which has broken this layers and coming right up to the surface, because of change in pore water pressure.

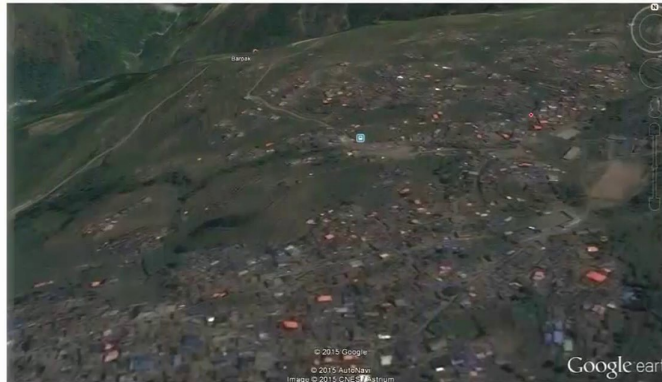
Fig.10: Post earthquake Google image of Barpak village located within the epicentral tract

So, post earthquake google image of Barpak that was the village, which was in the epicentral area of Gorkha earthquake, maximum damage was been experienced. Now, because of the connectivity of the roads, we could not reach at this place, but the local people, the survivors, they told us that this Barpak village experience ah, the huge damage and that was mainly, because of the poor construction and the construction was done using this stone and mud masonry.
