Natural Hazards
Prof. Javed N Malik
Department of Earth Sciences
Indian Institute of Technology, Kanpur

Lecture – 08
Introduction to Natural Hazards (Flood & Tsunami)

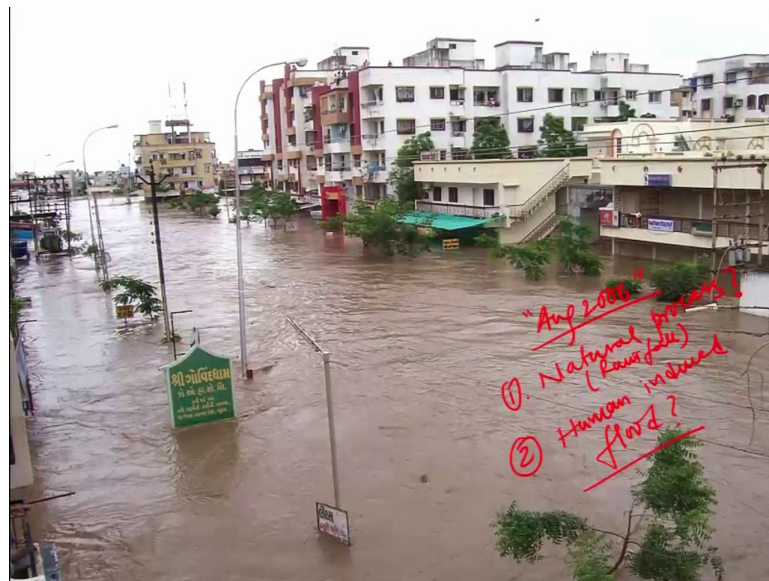
(Refer Slide Time: 00:18)

So, this is a bit this picture is from Gujarat and the city this Surat city which was affected by the flood and that was in August 2006. Now, the question which lies here important one is whether this was because of natural process.

Now, there is a very interesting story behind this. Now, what happened was that there was a heavy rain in the upstream of Tapti river and the Surat city is located on the bank of Tapti river, not very far from the coast. So, you have the Arabian sea not very far from Surat. So, there was a heavy rain in the of the upper reaches of Tapti river.

Now, the fact that there was a dam almost like 50 to 60 kilometers if I am not wrong in the upstream of Surat are known as Ukai dam. Now, the look the officers or the technical staff knew that there is a heavy rain in the upstream and water is going to come down to their reservoir. They allowed the reservoir to fill up because this is a human tendency and mostly in India where we are having lot of scarcity of drinking water and all that and even the water for irrigation we think that whatever the amount of water has been stored will be helpful for the people or the society for the next spell of or the coming spell of the year. So, with this in mind we usually try to store water and we believe that if we are storing water that is going to help in or overcome the shortage of the water in the major cities as well as in the surrounding areas. So, they allowed the water to accumulate in the reservoir, but finally they realized that they need to release it otherwise the dam will get

damaged and there will be more devastation which was not they were not ready to accept it. So, they started releasing the water.

Now, in this region the Gulf of Khambhat, the tidal range is quite high more than if I am not wrong around 5 meter or. So, high tidal range is very dangerous for the local flooding or the flooding because of the. So, the water was released at the time of high tide. If you are loving the water to be released from the upstream towards the ocean during the high tide, you have a very less chance to flow out the water in ocean and this resulted into the flooding the local flooding in Surat. So, now the question is not should we call this as a natural process hazard related to the natural process or it was human induced. I would say this was a human induced disaster which took place in this region.

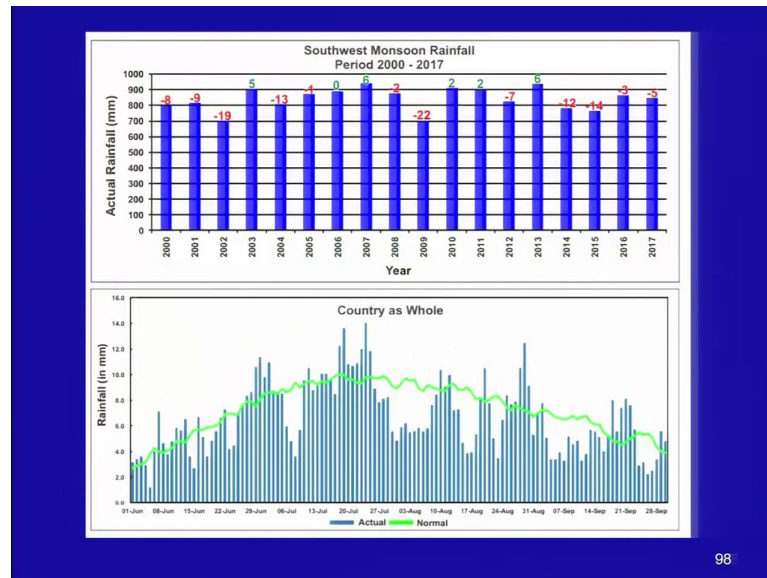
(Refer Slide Time: 06:44)

Again mostly we are concerned with the southwest monsoon rainfall over the years and this the this shows the annual actual rainfall in millimetre and what was the fluctuation which was experienced over the time between the period 2000 and 2017 and this figure shows again the rainfall from June until September and this was for 2017 where we see that this was the normal rainfall. Some places we see deficit here, but in some locations, we seed. So, spikes coming up with suggest that it was above normal. So, during this month we experience some excess rainfalls and probably that will be one of the reasons that we experienced the floods also in some part of parts of India.

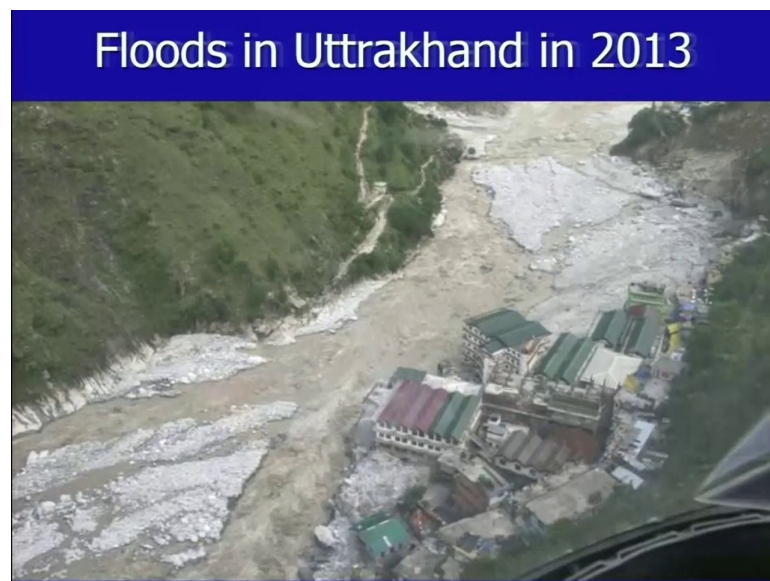
(Refer Slide Time: 15:53)

Again flood in 2013 in Uttarkashi. Now, if you see this picture probably we can spend some time on this and then, understand that because of in appropriate practice of land use, we our self are putting like us to risk more and more risk and as I told that river will not stop saying that fine you people are staying here and leaving and occupying my area. So, I will flow some for somewhere else and not come across crossing your region, but it can flow anywhere and it has tendency to reoccupying its own floodplains in own paleo channels and all that.

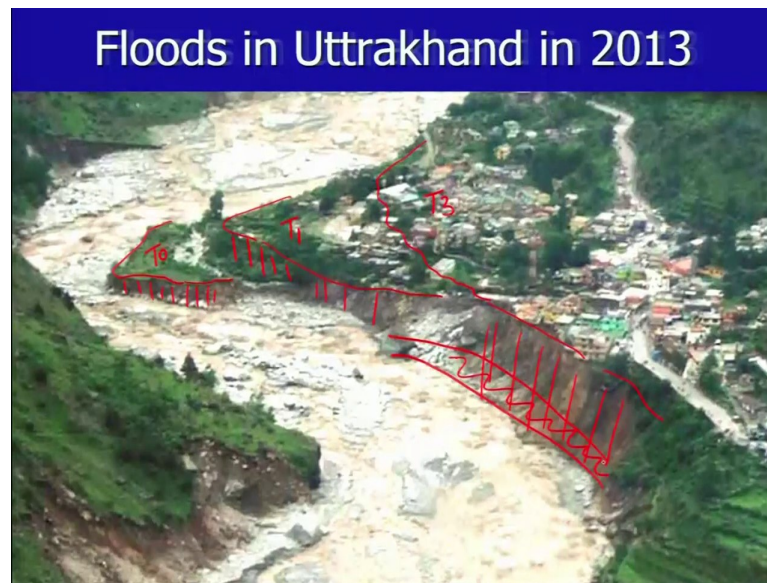
(Refer Slide Time: 16:52)

And the erosion of the banks were one of the major cause of collapsing of the houses which we are sitting close to the river banks now rode this house houses you see here the lower portion is been slided down. So, this is one of the process which we can put it in landslip or the landslide, but this was caused because of the erosion of the banks at the base. So, you erode the bank at the base and this portion hanging in the air will collapse and some places what you see are the terraces. So, terraces we will learn when we are talking about the in the floods and all that, but this is one of the important land form which will be always associated with the river system. So, these are the terraces and these are all I will just catch it here.

So, if you if you put the boundary here, this is the boundary one, there is another boundary over here which goes and then you have 3rd boundary which is coming here and these are all the river cliffs or the banks and these are one and this is another one. So, if you ask to how to classify it, it is just the elevation. The higher terrace may come somewhere over here.

So, this will be your youngest T0 terrace. This is T1 and this is your T3. T3 is the highest and the older one and this is younger one. So, in any case we are occupying these terraces and in this case in particular the water did not reach right up to this, but because of the erosion which took place underneath close to the time because the water was very

turbulent. So, this court eroded and because of the erosion and the experience the collapse.

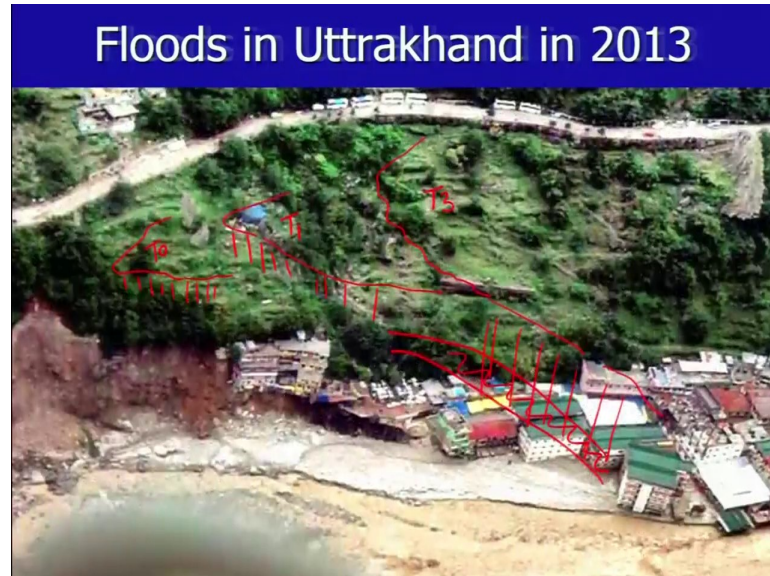
(Refer Slide Time: 18:58)

And there is another picture from that area again. You can easily make out what I was talking about. This is hanging, this is the hanging part and of course, this whole housing are sitting in your its whole plain which has been occupied and now got getting affected because of the and heavy flood in this region and this house is hanging in air. The lower part portion of this is been eroded by water action

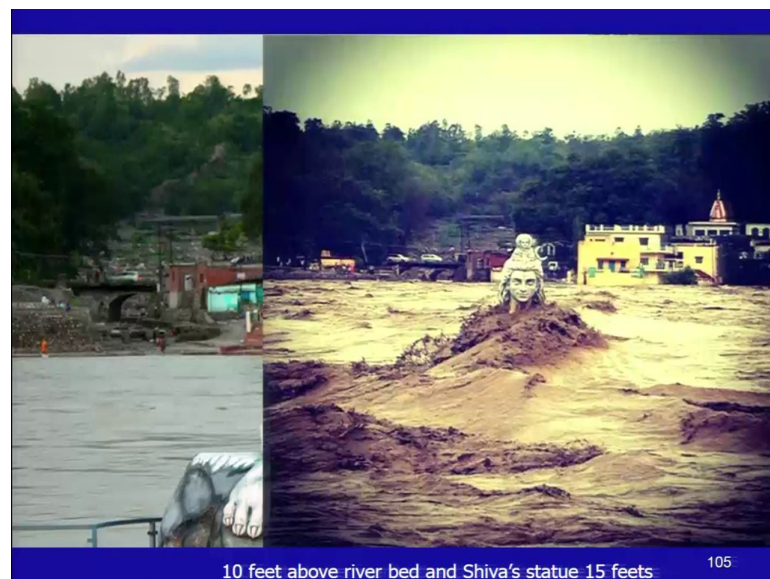
(Refer Slide Time: 19:46)

Now, this is the statue of Shiv which is 10 feet above the river bed. This is from Rishikesh and 10 feet above the riverbed and the statue is around 15 feet, 10 from the bed and 15, almost 25 feet above the river bed. So, what happened at the time of the flood, the peak flood the water reach right up to its neck. So, his neck was pain and finally which I what I learned was that the statue was been driven away in waters ok, but in the previous slide if you see remember this house I will just put it back. So, over here this is the house which has been shown in the next one and the temple is over here this one. So, you can make out that whole this area is been occupied by water and it is going right up to this green part over somewhere over here. So, the water flow depth were very high and which was experienced in the Utrakhand flood.

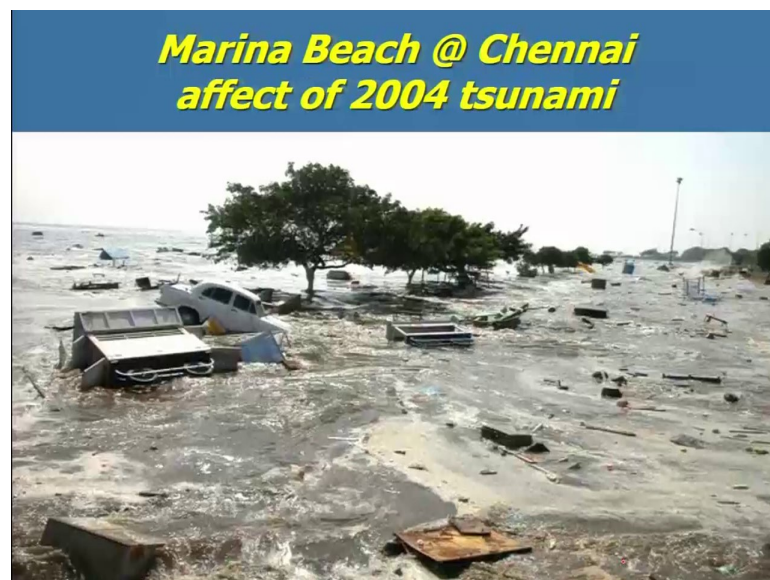
(Refer Slide Time: 24:12)

Now, Tsunami is very well known in other countries like mostly in Japan and the world. It was being coined in Japan as a great offshore wave or harbour wave, but this was shocking for us in 2004 given of Sumatra Andaman Tsunami. This picture is from Mariana beach at Chennai which shows the devastation and then local flooding which

was caused by 2004 Tsunami. I am not going to get into the detail right now, but I have couple of pictures which we collected and took from Andaman after immediately after the event in 2005 January. So, anyways this was quite shocking. Lot of people who got killed not only in Andaman, but along the in the East and West coast line of Indian Mainland and also it affected the neighbouring countries like Thailand and other regions at joining in ocean it was one of the devastating event. The magnitude of the earthquake which triggered the Tsunami was 9.2 and 9.3.

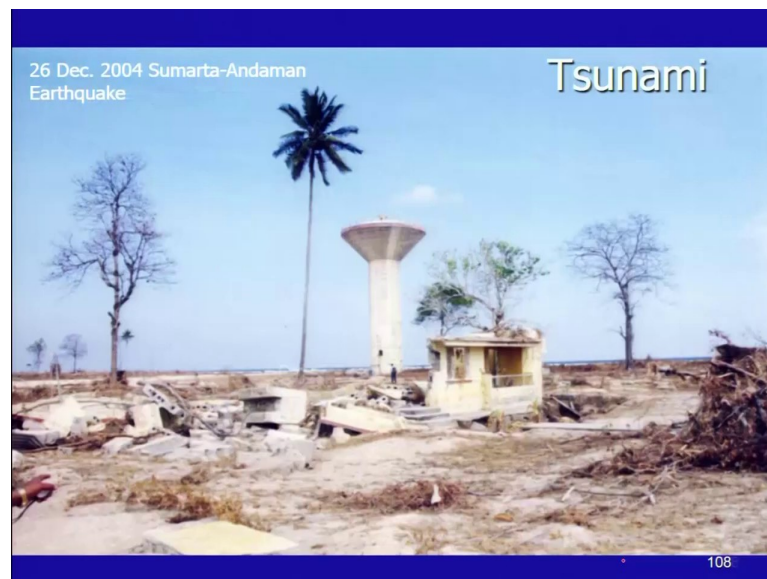
(Refer Slide Time: 25:39)

Now, this picture was taken at Carnicobar and the what you see here is only the water tank which standing and rest of the whole occupation which was the housing society or the houses or the colony of occupied by the Indian army and Air Force at Malacca bay was completely wiped off. The reason for this was that because it has in circular structure the energy got dissipated and nothing happened to this even this structure even though it was quite tall, but other areas they in or the houses which were being constructed were completely destroyed. I will talk in detail when I am talking about in particular about this event the lectures which I will be giving later on.

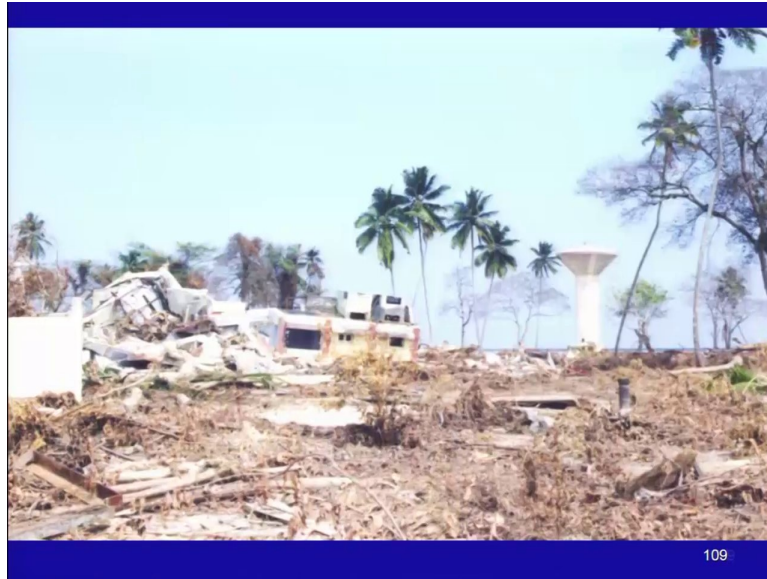
(Refer Slide Time: 26:36)

But here there are a couple of pictures which you see that it has it had a twofold effect. One was because of strong ground shaking and the area in this area this region got subsided or because during in the major earthquake subduction zone earthquake some areas will get uplifted and some areas will get subsided and this area of Carnicobar was subsided almost by 1.5 to 2 meters.

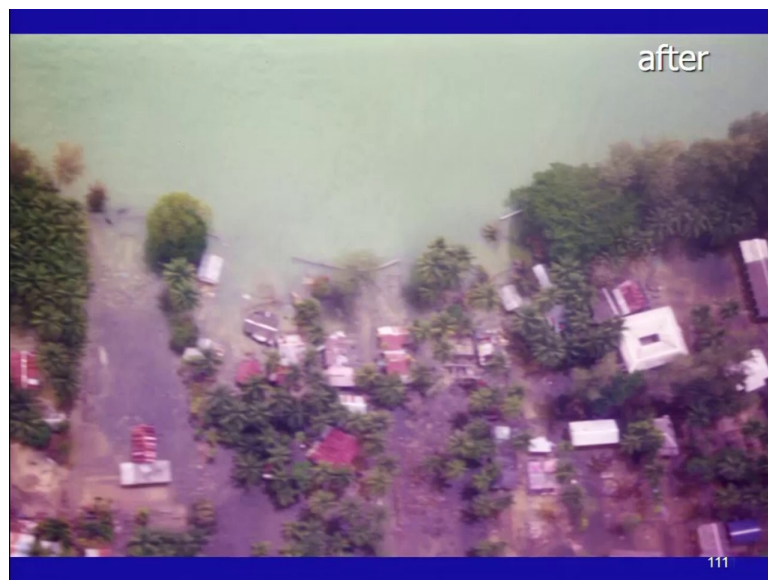
(Refer Slide Time: 28:30)

This was at great Nicobar at the southernmost tip of India in Andaman islands where most of the houses now sits and water they say this point subsided almost by 3 meters.

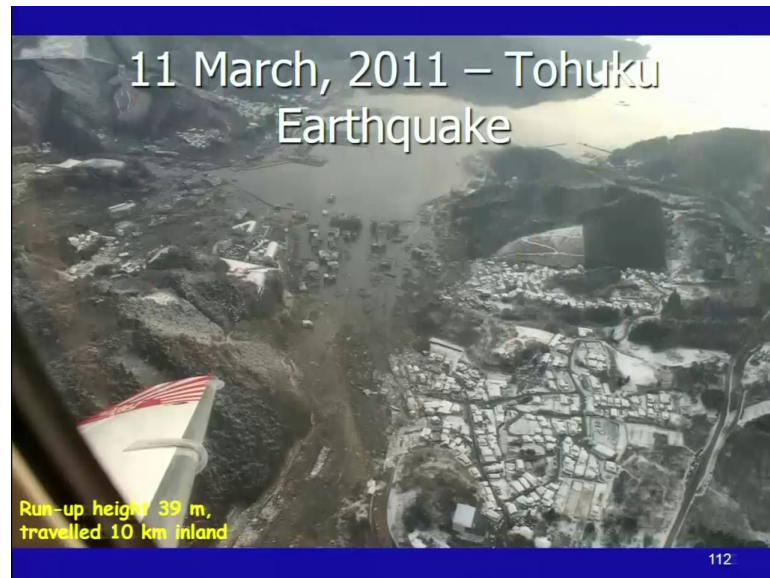
(Refer Slide Time: 28:48)

Another example from Tohoku earthquake in two thousand eleven it was again and devastating even nine point one magnitude.

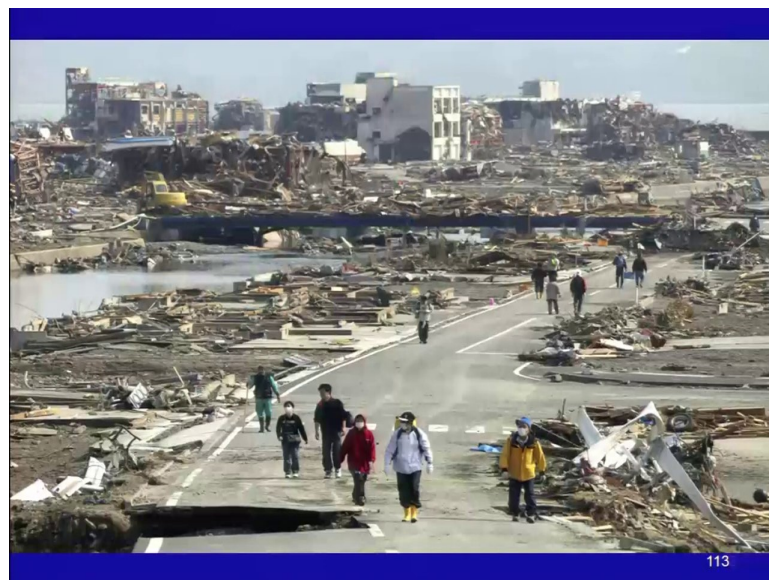
(Refer Slide Time: 29:03)

This was the situation in some locations at the Japan a lot of houses were been completely wiped off and the energy conditions of the waves were too high.

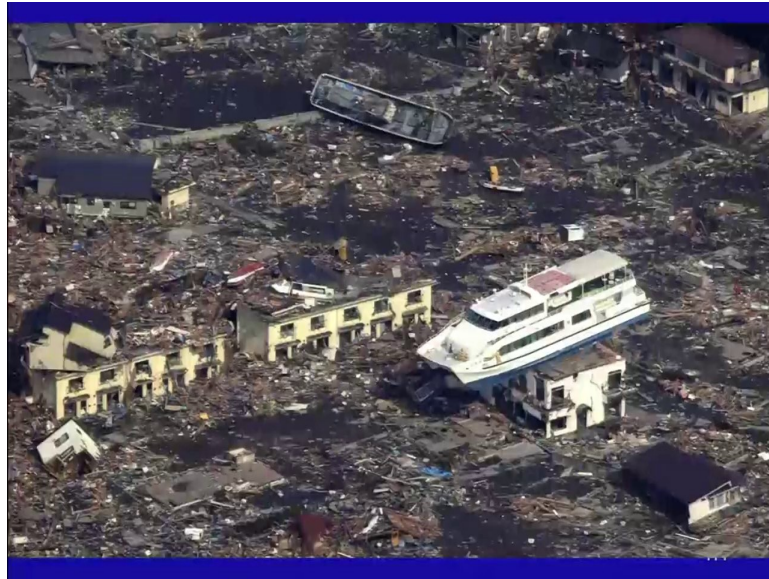
(Refer Slide Time: 29:17)

That it moved already the vessels are right on the top of the houses this picture you can see which has been which is close to the coast, but yes it was quite devastating compared to your 2004 also in some locations.
