Maintenance and Repair of Concrete Structures
Prabha Mohandoss
Prof. Radhakrishna G. Pillai
Department of Civil Engineering
Indian Institute of Technology - Madras

Lecture – 31
Structural Repair of Prestressed Concrete Systems

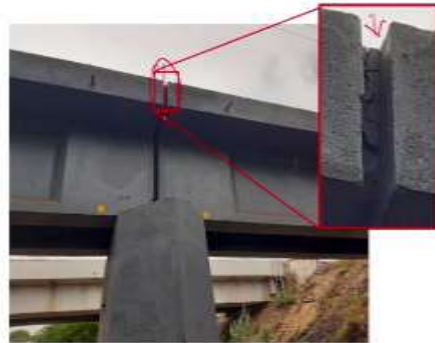
End anchorages are covered with poor mortar

These are some real-life examples where we can see such scenarios. So here in this case in anchorages between the expansion joints are covered with the poor mortar. So you can see the region here, the mortar quality which is used to fill the joint was not good and you can see the cracks over it, so that will lead to the path for moisture to get in and to reach the strand surface.

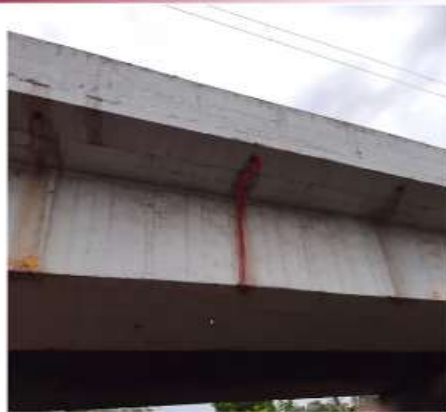
Vertical drains without projection

And here is another example, where the vertical drains which was supposed to drain out the water surface is not placed properly and hence the water flowed over the concrete surface and leading to damage or deterioration on the region.

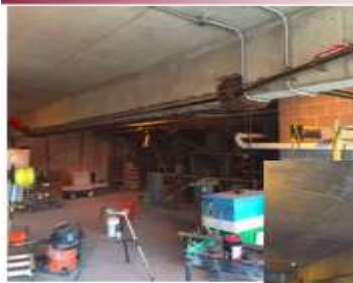
Strengthening of 48 years old parking garage using external post-tensioning - 1

So let us get into the case 1 that is external post-tensioning. Here is the case of strengthening of 48 years old parking garage using external post-tensioning. So I am not going to get into details of this method as this was elaborately covered in the previous lectures. So here is the case so I will just get into briefly explain the scenario here. The girder of the parking garage was deteriorated due to aging and loading conditions.

So external prestressing strands were placed outside and it was stressed at both ends to enhance the capacity of the; flexural capacity of the member. Once it is stress, once the stressing applications all done this region was covered using concrete, so that the externally placed tendons can be protected.

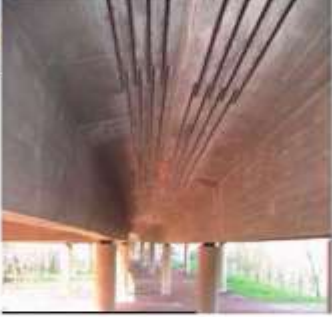
Flexural strengthening using CFRP strips - 2

So the most common and preferred method is that flexure strengthening using CFRP that is carbon fiber reinforced polymer strips. Because the carbon fiber reinforced polymer strips has high stiffness and strength to enhance the flexural capacity or the required performance of the member. This CFRP strips are highly orthotropic in nature so the stiffness and strength is in higher magnitude in one direction than the other.

This due to its high strength and stiffness it becomes a good alternative for prestressing purpose. However, the CFRP strips has certain challenges for gripping and prestressing. So we have commercially available components for the effective prestressing CFRP system.

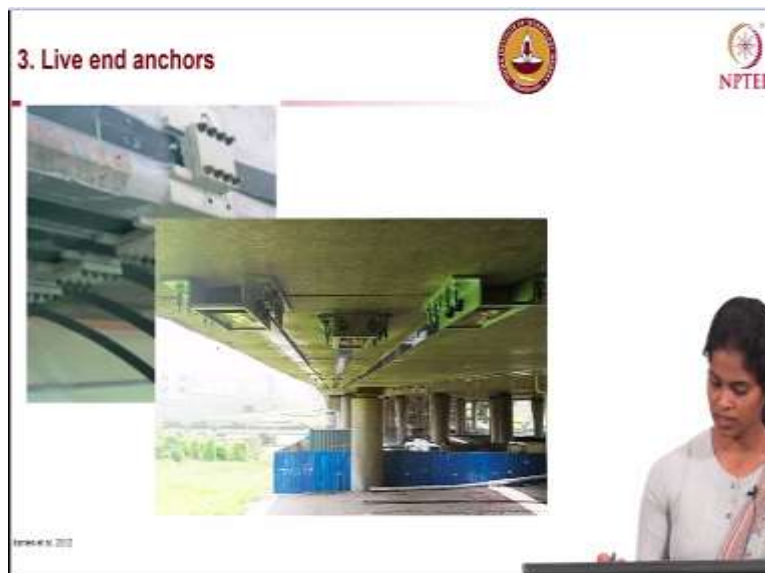
And this image shows the live end anchors once the strips are placed and anchored at the live end. And here shows the clear image of how it was done for a bridge deck. So where you can see a steel frame and the CFRP strips are placed inside and clamped it for stressing.

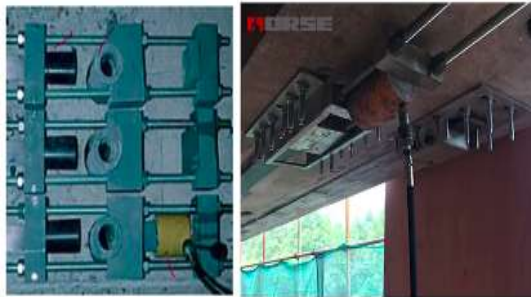
4. Stress head system

And these are the stress head system, which helps us to apply the required prestress and basically for gripping and stressing. So you can see the wedges and anchorages for gripping and locking the stress and here is the hydraulic jack, which will help us to apply the required prestressing force. So this image right here shows the assemblage of this stress head system at the live end for stressing application. So these are the components that help us to prestress the CFRP system for enhancing the structural performance of the member. Next case that we are going to see is for near surface mount CFRP system.

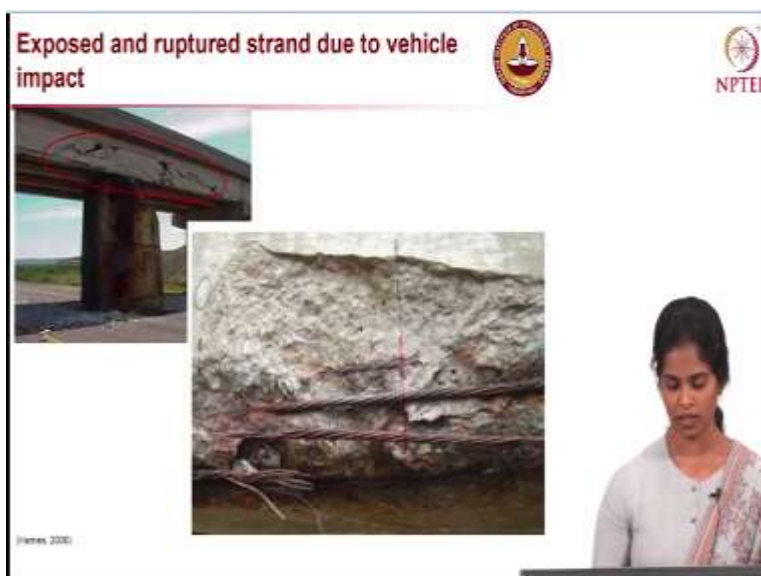
Let us consider a case where the bridge member experiencing sudden impact failure. So when member expect experience such sudden impact failure it is obvious that this concrete is going to

get fall off so here you can see the intensity of the damage and the concrete spot. So once the concrete has fall the stands will get exposed and in some case depending on the load if it is huge then the strand in that region get rupture. So let us see how that is going to affect the performance.

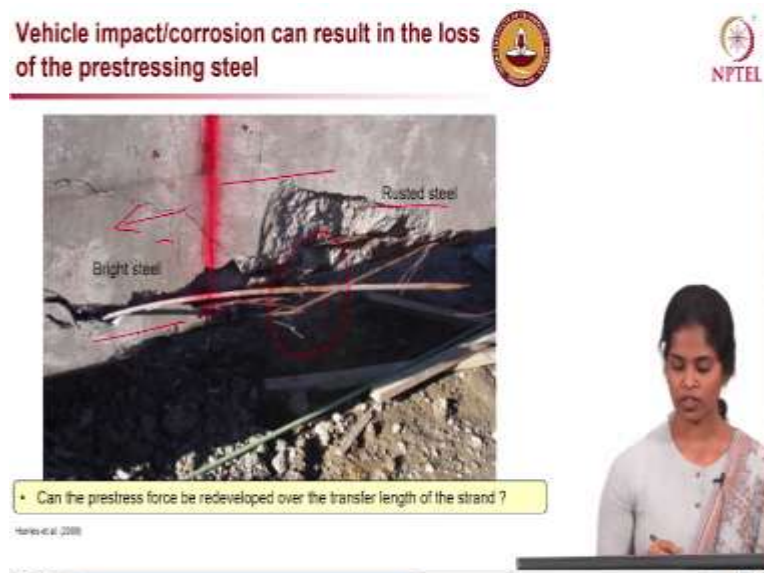
When we have such vehicle impact or corrosion damage so the member could significantly lose its prestressing level. Here you can see the red mark, the right to the red mark where you can see the ruptured strands and rusted steel. The left to the red mark you can see the bright steel. So when the member has such strand failure or reduction in capacity it does not represent the scenario of the whole length of the girder; it is very localized.

In that case, we need to account the other region, where the strands are in good condition and embedded in a good concrete. So this leads to a question; so in general in pretension concrete systems stress will be transferred from strand to the concrete. If the strand is ruptured or damaged in this region the stress transfer mechanism will be failed but here in this region this strands are in good condition and embedded in concrete.

If that is the case then can the prestress force be redeveloped over the transfer length of the strand, if so then we need to account the prestressing level available in this region to determine the capacity of the member. So for any strengthening methods first we have to evaluate the

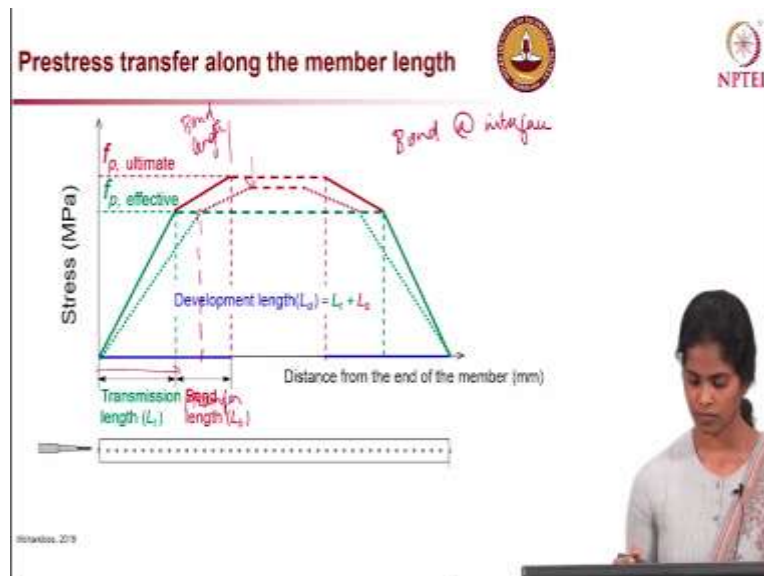
So before getting into that let me explain about the transfer mechanism along the length of the member. As I said earlier in pretensioned concrete systems, we have stress transfer from strand to the concrete. So when the stress is getting transferred it get transferred from the end of the members and it gradually increases to along the length and reaches the effective prestress. The length required to reach the effective prestress is called transmission or transfer length.

And further under service the effective prestress will be developed to reach the ultimate stress and the length required to reach the ultimate stress is called development length. Basically, the length of this region alone is called Bond length, and together the length of transmission or transfer length and the bond length is called development length which is the length required to is the ultimate stress from zero.

So this transfer mechanism is significantly depends on the bond at interface. Hence this will be affected if the interface is getting damaged or disturbed due to the external loading or due to aggressive environments in case of corrosion. So for example you are assuming that the member is experiencing corrosion or near the damage this bond interface gets affected. So in such cases

to transfer the effective prestress we may need a longer or the member will need a longer transmission length.

So in that case the transmission length will get moved from this region to that region. If it is the corrosion damage then the prestress level will also get reduced due to loss of strands. This is the simple hypothesis for this transfer mechanism, what happens if it is affected by corrosion or any bond damages at the interface.

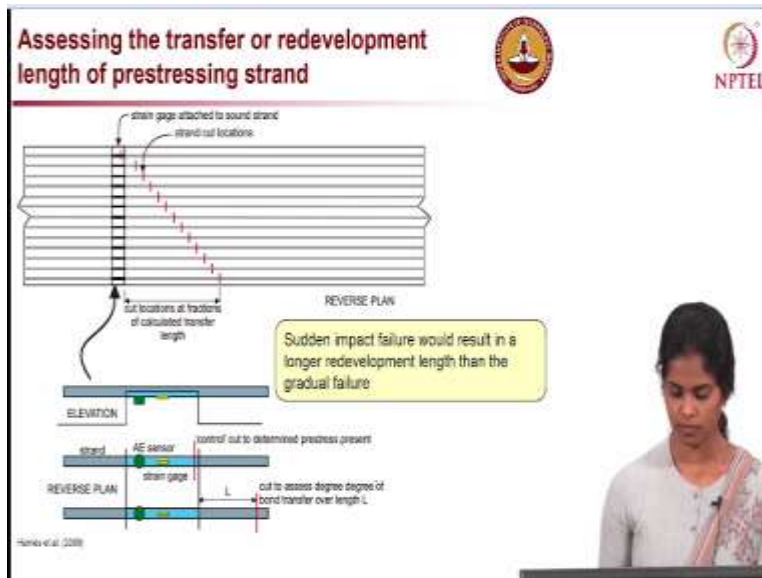
Now let us see assessing the transfer or redevelopment length of prestressing strands on the existing system. People have proved that we can measure the transmission length or the prestress can be redeveloped along the length of the member in the undamaged portion of the damaged structure. So here to determine the transmission length what we have to do is we need to select the cut location at fractions of distance and then we can place the strain gage to the good quality or the undamaged strand and measure the stress or strain acting on it.

Here in this case acoustic emission sensors were placed to determine the strength. So by measuring or by monitoring the stress on acting on the surface so based on this we can easily determine the transmission and based on the concept transmission length is the length required to attain the effective prestress, effective prestress can be obtained by the sensors that we placed on the existing surface.

So from the observed results we have seen that the transmission length of the existing member is large if it is due to the sudden impact load comparing to the gradual failure. That means sudden impact failure could result in longer transmission length or redevelopment length comparing to the gradual failure.

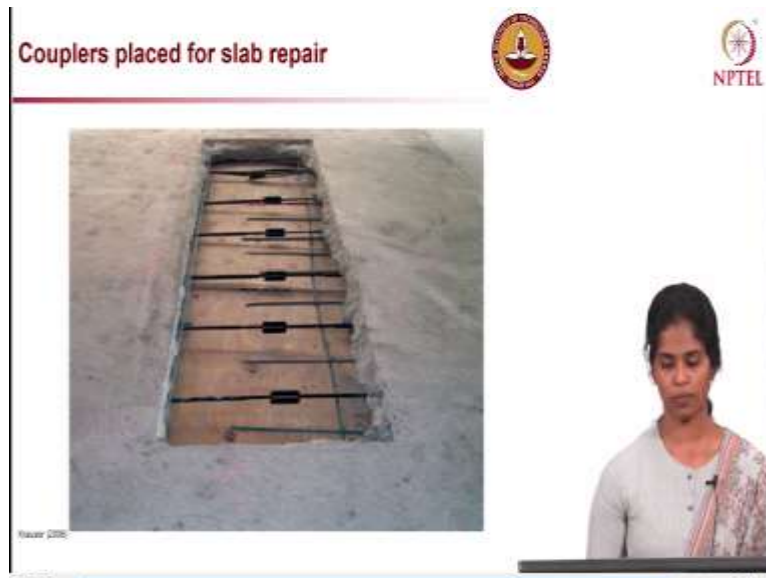
This image here shows couplers placed to join the old or the existing tendons with the new tendons. This work is for a slab work, where the tendons are spliced using couplers and stressed to meet its required performance.

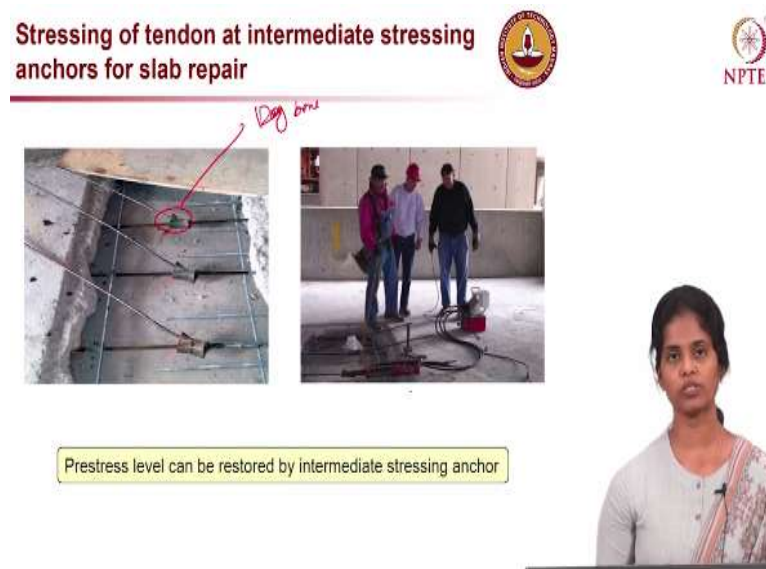
Now another method for stressing the strands is that the intermediate stressing using intermediate stressing anchors for slab repair. This is being followed or used when we cannot access the end anchorages but still we need to stress the strands at the intermediate. So here in this region so we have excavated the concrete over it; the size of excavation depends on the stressing equipment that we use or the type of anchorages that we use.

Here is the case you can see Dog bone system has been; arrangement has been placed to provide stressing tile for intermediate stressing anchors while detentioning the strands for repairing the length of the strands will get shortened but for this intermediate stressing anchors we need to have a stressing tail to provide stressing. Since the existing tendons will not have sufficient length new tendons has to be spliced to increase the length such that, will provide tail for intermediate stressing anchors.

So here is an arrangements how the whole tendon was embedded in a concrete and the dog bone system was placed to enhance the length of the tendons for intermediate stressing anchors. So once this is done; right image shows how the strands were stressed at the intermediate using hydraulic jack. So by doing so we can restore the prestress level in the member.
