Biomechanics of Joints and Orthopaedic Implants
Professor Sanjay Gupta
Department of Mechanical Engineering
Indian Institute of Technology, Kharagpur
Lecture 29
Implant Classification and Failure Mechanism

On Implant Classification and Failure Mechanisms.

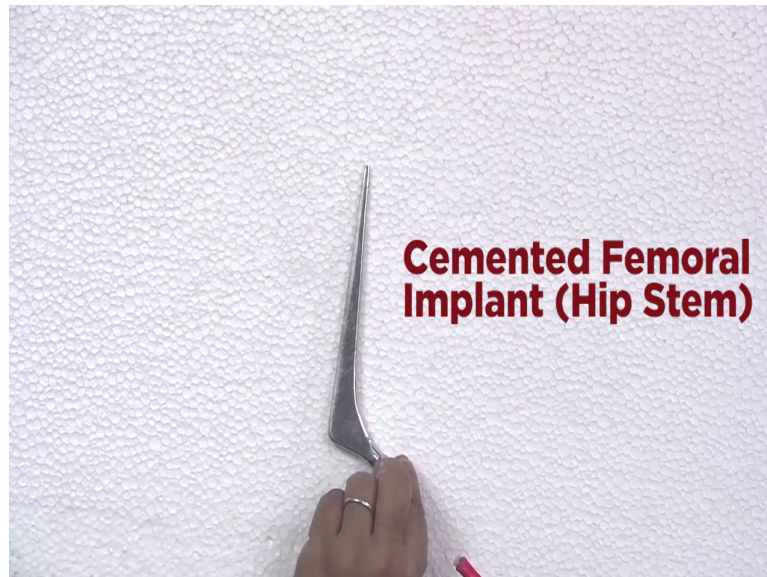
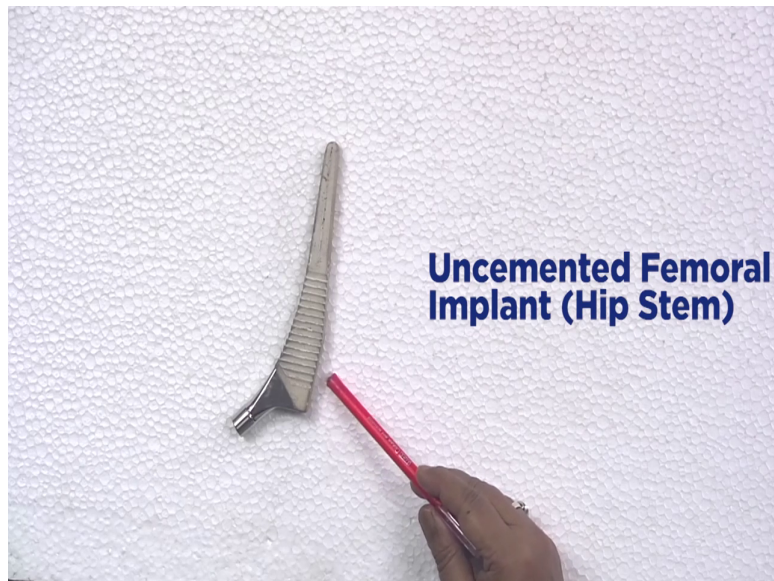
Let me present to you a hip implant. This is a cemented hip implant or femoral implant which is used for hip replacement. I am rotating the implant so that you can see the femoral hip stem that is used for cemented hip replacement. Please note that this cemented femoral implant has a very polished surface on all sides. It has a very polished surface on all sides.

Let me present to you an uncemented hip stem with a rough texture and a porous coating on the proximal part of the hip stem compared to the polished surface that we had for the cemented hips stem shown earlier. Let me turn it around to see the prosthesis fully. This stem has a rough texture, a coated texture that helps biological fixation with bone.

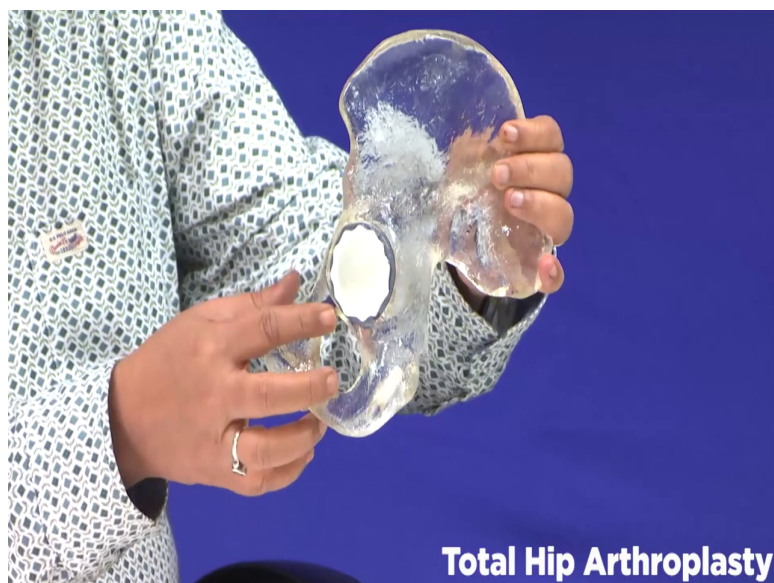
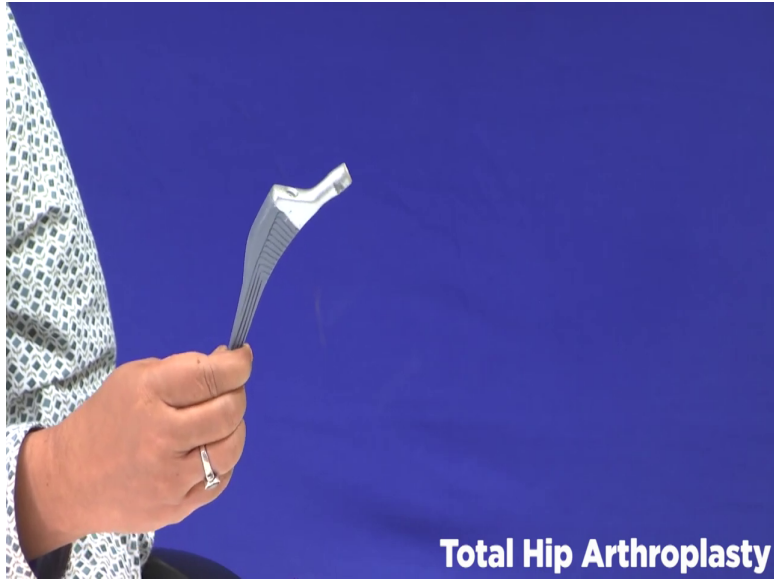
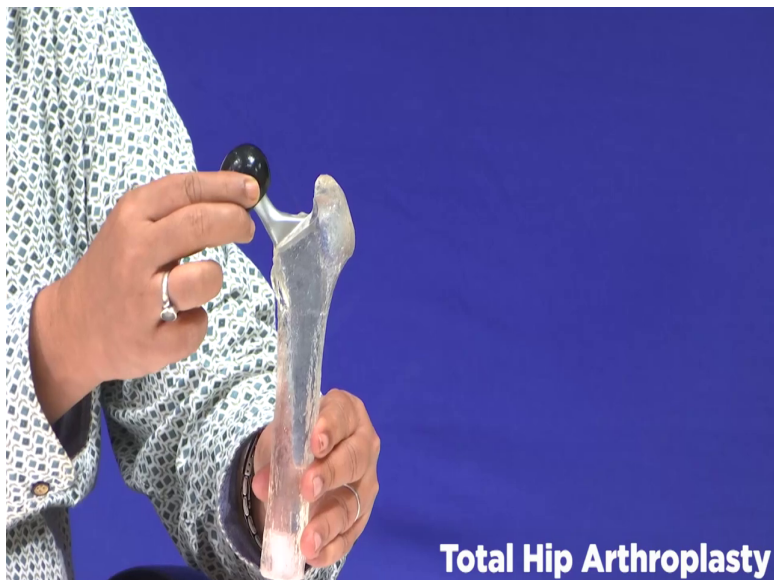
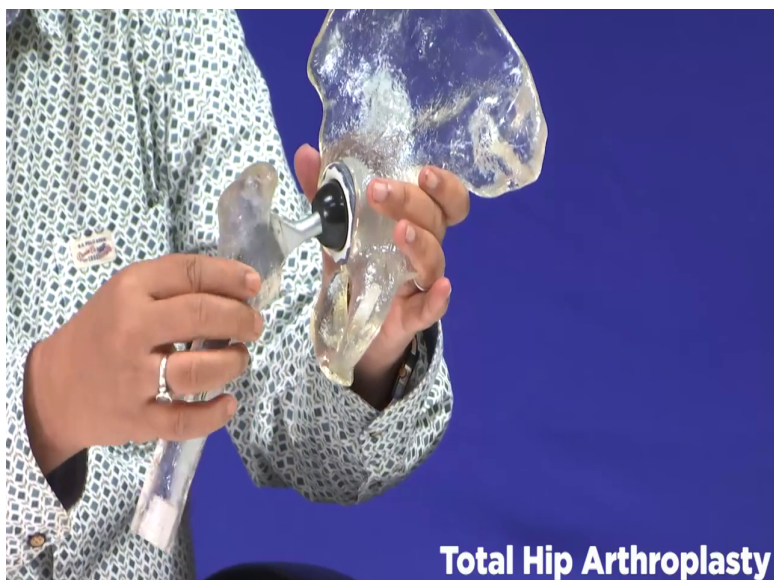
Total Hip Arthroplasty

Let me present to you a reconstructed femur with a hip implant, as you can see clearly. So, now, I will this is the femur head, the artificial femur head, and I will take off in parts and here you can see the rimmed canal within the femur into which the prosthesis is placed. Now, please have a look at the prosthesis. This is an uncemented hip stem with texture on the surface to facilitate bone ingrowth. It has a porous coating on the surface of the implant that is supposed to promote bone ingrowth. Now, I will assemble these modular parts and insert them in place within the resected femur.

Now, I present to you a pelvic bone with the acetabular component implanted within it. You can see in different views the reconstructed pelvic bone with the hemispherical acetabular component implanted within it. So, the femoral component and the acetabular component articulate with each other and thereby produces and thereby, the hip joint is reconstructed to offer a normal range of motions.

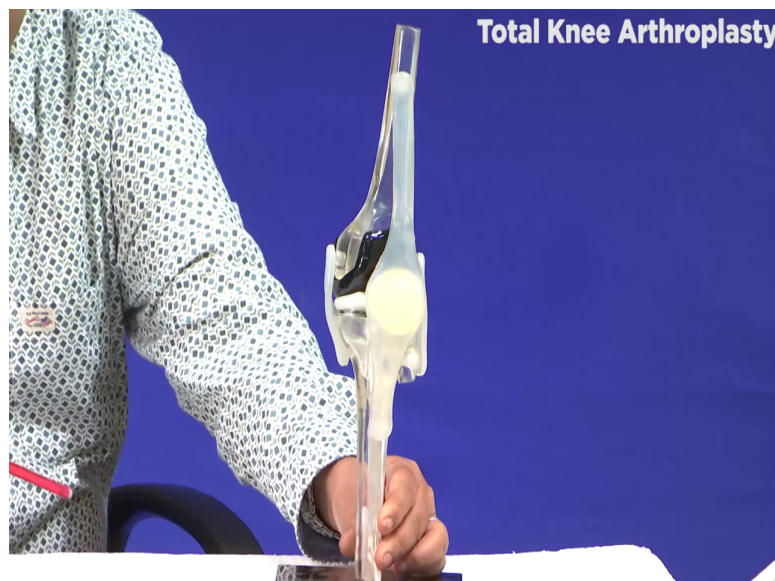
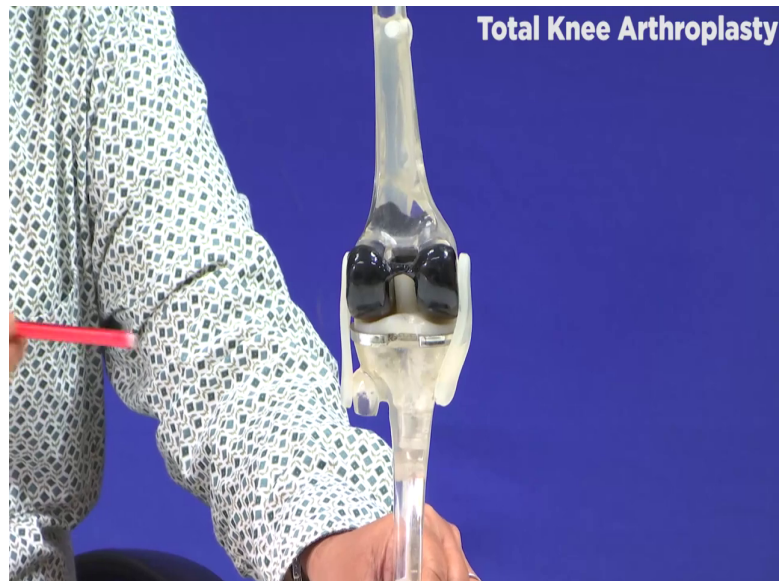
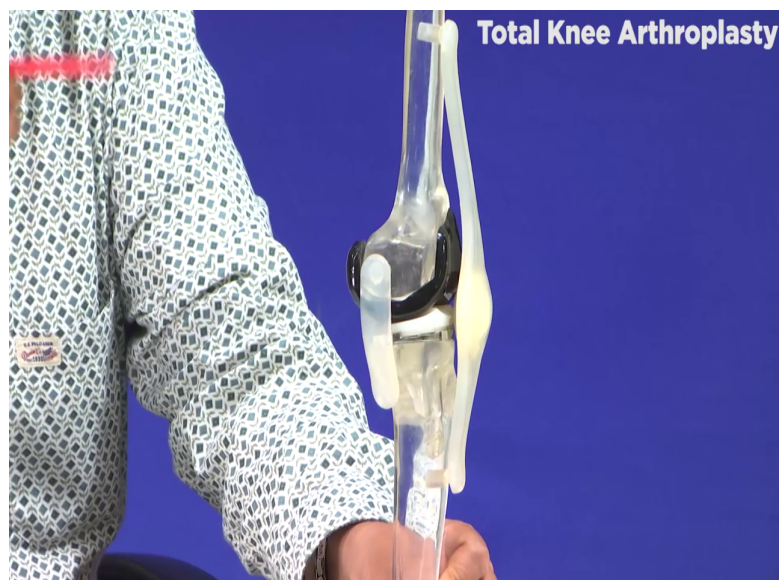
Let me present to you a model of the total knee replacement. So, if you are looking from the front, you can see the patella. Now I will be rotating the replaced knee, and you can see the femoral component, the black one on the top and the tibial component inserted within the tibia.

Now, I am moving towards the posterior view, where you can clearly see the tibial and femoral components. In the posterior view, you can clearly see the black femoral and tibial components inserted below within the tibia in total knee replacement. On the sides, the collateral ligament is holding the bone, as can be seen in the model.
