Failure Analysis & Prevention
Dr. Dheerendra Kumar Dwivedi
Department of Mechanical and Industrial Engineering
Indian Institute of Technology, Roorkee

Lecture - 01

Introduction: Need and Scope of Failure Analysis and Prevention

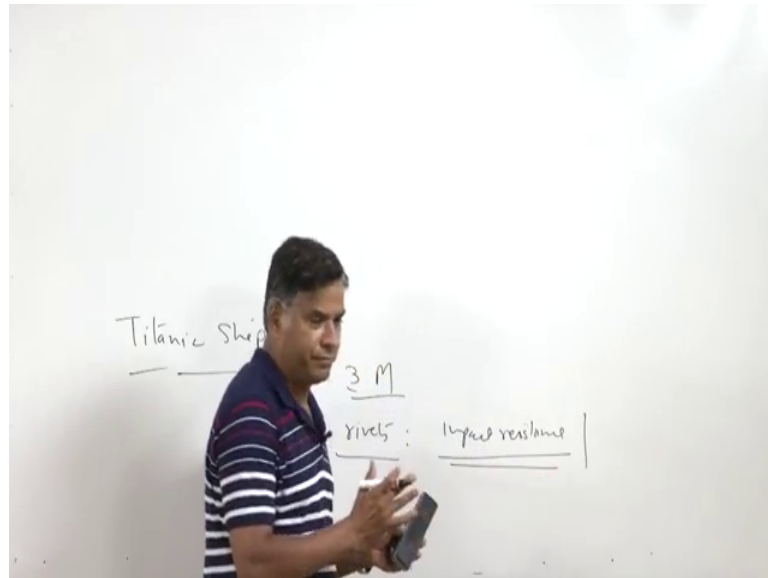
This was one in this titanic shik ship failure. This failure occurred as you can see in a 1912.

This af failure of the ship a lead to the a loss of the life of more than 1500 people and this failure primarily occurred due to the failure of the rivets this had more than 300 million

rivets to join the different plates of the ship and in this ship these rivets which were there, it was found that their impact resistance was very poor.

And when the ship hit the iceberg; that impact led to the fracture of the rivets and that fracture led to the separation of the different plates and that finally, led to the sinking of the ship. So, if you see the details of this Titanic was a British passenger ship that sank after the collision with an iceberg and this happened in April 1912 and led to the loss of more than 1500 lives of more than 1500 people and as we can see the several rivets of the 300 million; 3 million rivets that held Titanic together were recently recovered.

And tested was the cause which was found for the failure of the ship was the poor impact resistance of the rivets are due to the low quality iron which was used and another problem which was observed in design of the Titanic ship was that there were sixteen watertight compartments which were separated from each other, but all of them were connected near the ceiling and this enabled the water to spill from one compartment to the another and finally, led to the sinking of the boat.

So, this was the big engineering failure or engineering disaster which primarily happened due to the poor impact resistance of the rivets as well as poor design of the ship where in there was sixteen different compartments all were interconnected at the ceiling. So, when the water filling started, then this led to the failing of the water from one compartment to another in sequence and finally, the sinking of the ship had happened which led to the loss of a life of more than 1500 people.

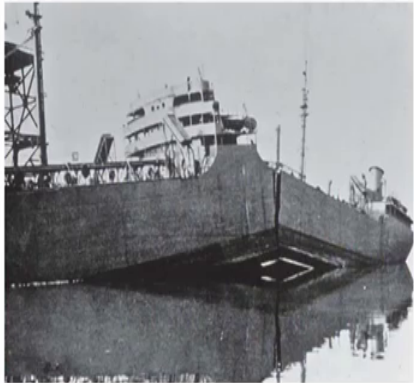
Titanic Ship, 1912

- RMS Titanic was a British passenger ship that sank after hitting an iceberg on her maiden voyage from Southampton (UK) to New York City, in April 1912. The tragedy claimed the lives of over 1,500 people.
- Several rivets of the 3 million rivets that held the Titanic together were recently recovered and tested, and found to be made of low quality iron, which on impact caused them to fall apart.
- Another engineering fault was that the 16 watertight compartments that kept the boat afloat, were not individually sealed, but rather connected near the ceiling. This enabled the water to spill from one compartment to another and sink the boat.

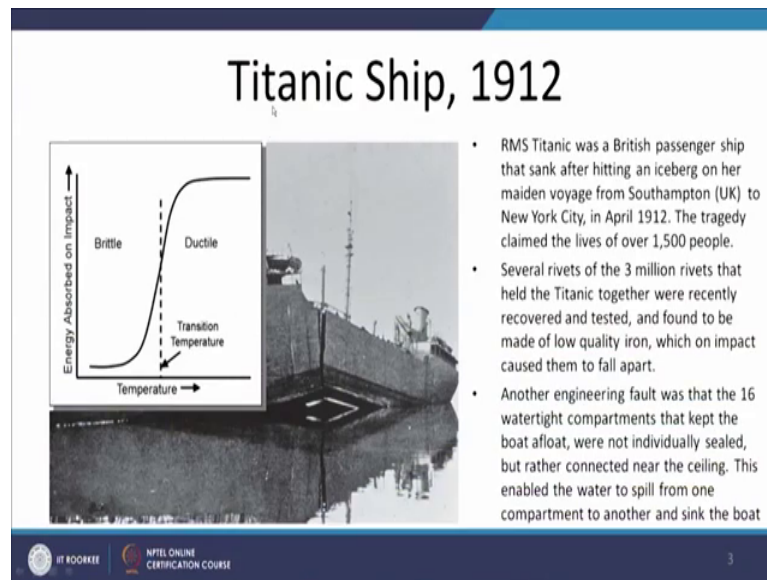
Titanic Ship, 1912

The slide contains a graph on the left showing 'Energy Absorbed on Impact' on the y-axis and 'Temperature' on the x-axis. The curve starts at a low energy level at low temperatures, rises sharply at a point labeled 'Transition Temperature', and then levels off at a higher energy level at higher temperatures. The region to the left of the transition is labeled 'Brittle' and the region to the right is labeled 'Ductile'. To the right of the graph is a black and white photograph of the RMS Titanic at sea. To the right of the photograph is a list of bullet points.

Then there is another case, this is what has been explained with the help of this diagram where in like a the iron under the low temperature conditions loses its the toughness and this particular temperature at which loss of toughness is observed is called ductile to brittle transition temperature and here, we can see the toughness as we know we measure in terms of the energy absorbed and energy absorbed reduces with the reduction in temperature for most of the steel this temperature is about minus 20 to minus 30 degree centigrade almost of the mild steel in structural steels.

While for alloy steels especially by adding nickel and other elements are this can be reduced further. So, that there is no significant loss or loss of the toughness. So, basically the when the material is subjected to the high temperature conditions like room temperature and above it has a fairly good ductility and it becomes brittle when it is exposed to the low temperature conditions.

So, basically the iron rivets which were used them had a low toughness under the low temperature conditions especially when it hit the iceberg and that lead to the fracture of the rivets and which led to separation of the ship also another big disaster engineering disaster was the Saint Francis dam.

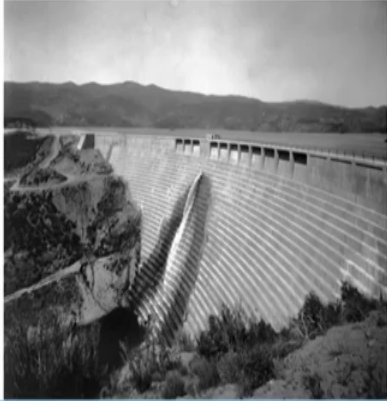
St. Francis Dam flooding (1928)

- The St. Francis Dam was a concrete dam built between the years 1924 and 1926, to create a water reservoir for Los Angeles.
- The dam was located in a canyon around 40 miles (64 km) from the city.
- On March 12, 1928, just hours after being inspected by the Chief Engineer William Mulholland, the dam failed, sending a massive water wave 120 ft tall, and killing as many as 600 people in one of the worst American civil engineering disasters

This dam was constructed in 1926 to supply the water to the Los Angeles city and this was very close to the Los Angeles about 60 miles from 40 miles from the Los Angeles into it. There is a famous Canva Canyon hills where it was constructed and this figure shows the dam constructed on the canon canyon hills which was about 40 miles from the Los Angeles it is about 20-15 kilometer from the Las Vegas and on March 12, 1928.

Just after few hours of the inspection by the relevant engineers the dam failed and that resulted in very high water waves and killing as many as 1600 people this has been one of the worst disasters in the American Civil Engineering disasters history. So, this is the kind of the residual and the left out structures were there the structure which was like this before the failure of the dam and after that all this is structure was damaged.

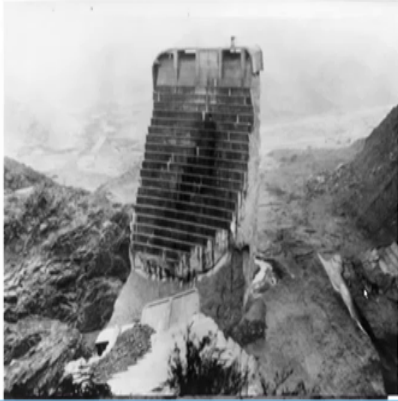
St. Francis Dam flooding (1928)

- The St. Francis Dam was a concrete dam built between the years 1924 and 1926, to create a water reservoir for Los Angeles.
- The dam was located in a canyon around 40 miles (64 km) from the city.
- On March 12, 1928, just hours after being inspected by the Chief Engineer William Mulholland, the dam failed, sending a massive water wave 120 ft tall, and killing as many as 600 people in one of the worst American civil engineering disasters

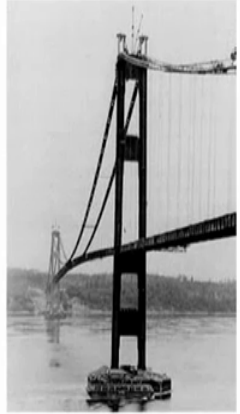
Tacoma Narrows Bridge collapse (1940)

- The first Tacoma Narrows Bridge was a suspension bridge in Washington state that opened in 1940 and collapsed at the same year. At the time of its construction, the bridge was the world's third longest suspension bridge, by main span length.
- The bridge was known to move vertically in windy conditions, and in November 7, 1940, under 40 mph (64 km/h) winds it collapsed. The collapse was caught on video and made an impact on science and engineering, especially bridge designing till today.
- The cause of failure was aeroelastic flutter – a dynamic instability of an elastic structure.

And then there is another accident which happened again in USA around 1940. This is called Tacoma narrow bridge collapse, all this was the third world's third longest suspension bridge in terms of the span length and that bridge used to flutter under the influence of the air. So, under the conditions on the of the wind velocity of 40 mile per hour this was fluttering to such an extent that it collapsed and this collapse was caught in

the camera also and the main cause of the failure was the aero elastic flutter that is a dynamic instability of an elastic structure.

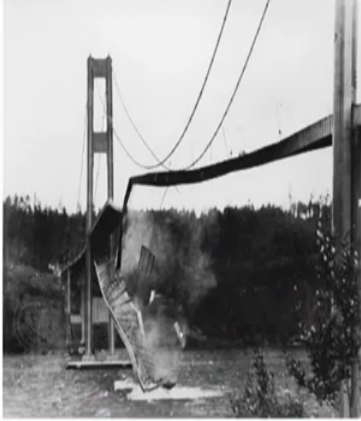
Tacoma Narrows Bridge collapse (1940)

- The first Tacoma Narrows Bridge was a suspension bridge in Washington state that opened in 1940 and collapsed at the same year. At the time of its construction, the bridge was the world's third longest suspension bridge, by main span length.
- The bridge was known to move vertically in windy conditions, and in November 7, 1940, under 40 mph (64 km/h) winds it collapsed. The collapse was caught on video and made an impact on science and engineering, especially bridge designing till today.
- The cause of failure was aeroelastic flutter – a dynamic instability of an elastic structure.

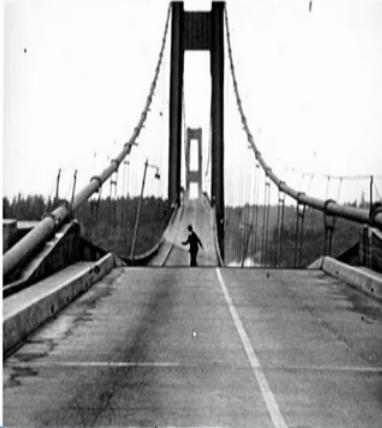
Tacoma Narrows Bridge collapse (1940)

The first Tacoma Narrows Bridge was a suspension bridge in Washington state that opened in 1940 and collapsed at the same year. At the time of its construction, the bridge was the world's third longest suspension bridge, by main span length.

The bridge was known to move vertically in windy conditions, and in November 7, 1940, under 40 mph (64 km/h) winds it collapsed. The collapse was caught on video and made an impact on science and engineering, especially bridge designing till today.

The cause of failure was aeroelastic flutter – a dynamic instability of an elastic structure.

So, these are the flutter we can easily see under the influence of the air or the wind, it was fluttering up and down and this under the extreme conditions led to the collapse of the bridge.

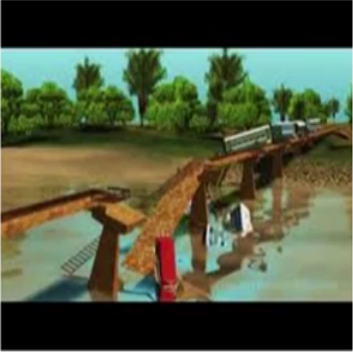
Kadalundi Train Disaster

- There was a structural failure. The railway bridge was around 140 years old and it definitely needed repair.
- What happened was one of the pier had settled down causing internal stresses to grow in rails.
- As soon as a train came near it, the track snapped and the train derailed which eventually landed into river.
- So lesson one, never ever use a structure of high importance without testing it. Always, keep an eye on it and test it.

Then there are three more disasters which took place here in India, one is a Kadalundi train disaster here when the train was passing over the river bridge on the river had a number of piers.

So, one of the piers had settled down causing the internal stresses in the rails. So, when the train was passing the track snapped the track railway track snapped and the train was derailed which eventually landed into the river and. So, in this case basically the testing was not carried out and then the pier one of the piers at settled which caused a lot of stress internal stresses to the track especially when the train was passing through the air that train was got derailed.

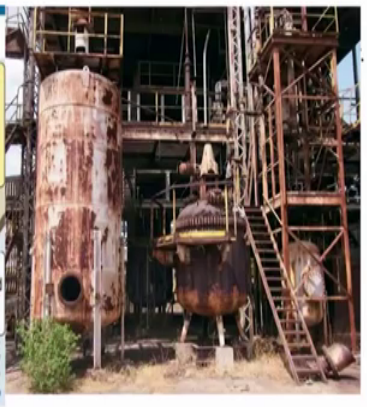
December 3, 1984
A cloud of methyl isocyanate gas leaks from the Union Carbide pesticide plant

Area affected by gas leak

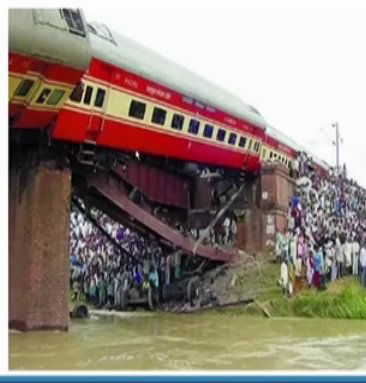
- Blamed to poor design and construction as well as low maintenance.
- It is said that the plate girder deteriorated over time and was losing its **strength in fatigue due to vibrations** from trains.
- Nobody paid attention to it. Also the **bridge was rusty** to a great extent.
- When the train was passing by, the plate girder gave up leading to this fatal crash.
- Lesson two, make sure your design is checked against fatigue and steel is coated with anti-corrosion paints.

Then there is one example of the Rafiganj rail bridge here also it was the failure was blamed to the poor design and construction and the low maintenance conditions and it is said that the plate girder deteriorated over a period of time.

rusted which are internal to reduce the strength. So, when the train was passing the plate of the girder gave up leading to the fatal crash and because of this it was learnt because of this after this accident it was learned that make sure that you are design is checked against the fatigue and steel is coated for the corrosion.

So, for the Rafiganj roll rail bridge accident two causes were identified mainly one was the corrosion of the steel plate girders and another one was the fatigue. So, due to the vibrations the fatigue the crack or nucleated and fatigue reduce the strength and means load carrying capacity and which eventually under the loading conditions led to the catastrophic failure.

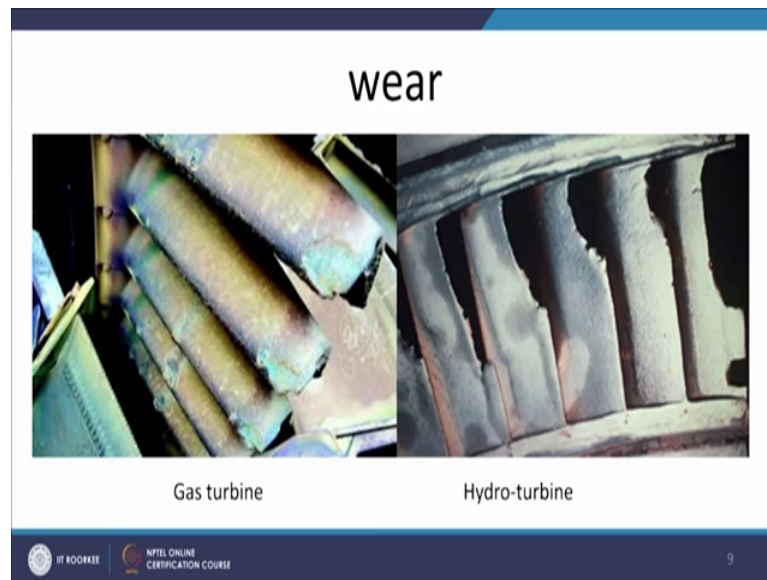
So, this wear can be there in different forms in the case of gas turbines like the high temperature in case of a gas turbine they will be working under the high temperature conditions and if the hard particles are striking to the surface of the turbine blades, then they will be causing the erosion similarly in hydro turbines if the silt is coming along with the water then it will be causing the loss of the material from the turbine blades and the erosion of the material from the surface and that will lead into the loss of the material as well as loss of shape of the turbine blades and the guidelines.

So, this kind of ah; so, this is an example of the loss of the failure of the components due to the wear in the earlier case we have seen the failure of the component like the gear due to the fracture and here in one of the case what we have seen the failure of the tubes due to the creep and the failure of the shaft due to the plastic deformation where change in size and shape takes place due to the excessive loading beyond the yield strength limit this is the case of the elastic deformation if the crack the shafts are subjected to the greater if the elastic strength of the material is poor and the current shafts are not properly designed using suitable material of the required rigidity, then it will be leading to the alligator elastic deformation.

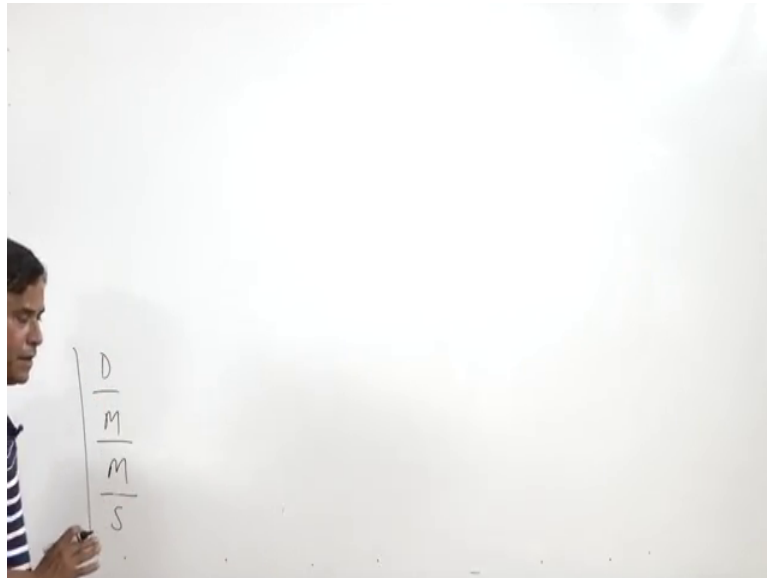
One is the design second is the material third is the service sorry third is the manufacturing and forth is the service conditions for which these are exposed, I will talk in detail about these fundamental causes at the factors which can lead to the failure of the mechanical components.
