**Failure Analysis & Prevention**  
**Dr. Dheerendra Kumar Dwivedi**  
**Department of Mechanical and Industrial Engineering**  
**Indian Institute of Technology, Roorkee**

**Lecture - 11**  
**Fundamental Sources of Failures: Poor Assembly, Service Conditions and Maintenance**

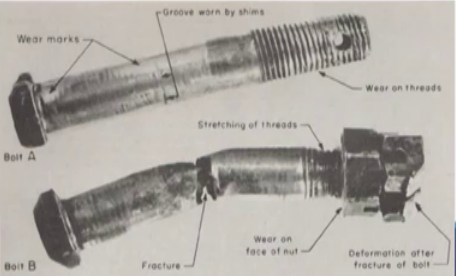
## Breakdown of air compressor engine

- **Case:** A 4 cylinder engine broke down with fracture of piston, end of connecting rod.
- **Disassembly and examination:** occurred due to failure of two connecting rod bolts used for joining of piston with connecting rod.
- One bolt had no nut showed wear marks

The photograph shows two connecting rod bolts, Bolt A and Bolt B, with various failure modes labeled. Bolt A shows wear marks, a groove worn by shims, and wear on threads. Bolt B shows stretching of threads, a fracture, wear on the face of the nut, and deformation after fracture of the bolt.

The breakdown of the air compressor engine which was full which was made from the four cylinder engine this engine actually broke down with the fracture of the piston on the connecting rod and side and the disassembly when the system was opened it was found system was opened for examination it was found that that the failure occurred of the two connecting rod bolts used for the joining of the piston and connecting rods.

So, the basically the failure occurred in the nut and bolt which were used for joining the connecting rod with the piston and 1 bolt had 1 bolt did not show any mark of the wear like here we can see these were the 2 nut bolts which were used for assembling the piston to the connecting rod and when the system was opened for examination it was found that one of the bolt had the wear marks on the on it surface while another was fractured. So, it was observed that the 2 2 nuts were present in one of the bolt while another bolt was free from an inert this is what also it can be seen

So, since the bolt a did not had any nut so it was free during the operation and that is why there was a lot of relative movement between the between this bolt and the connect and the piston which caused lot of wear marks on the surface of the bolt. While in other case since this was free so it was not taking much of the load while another was which was having the 2 nuts the which was having the 2 nuts say this was the only one which was carrying the load and since it was this was sharing the load say this was taking the load of the system completely.

And another one not sharing the load that is why it fractured under the it fractured this what we can see and this also lead to the stretching of the thread and some of the crushing of the threads on onto the bolt and the this and also can be seen that it was damaged.

So, here it was found that this actually nut was inadvertently tightened in the same one another and other one was the bolt was left another bolt was left without nut and that is why it was free to move. So, this is the kind of error which occur in which occurs inadvertently not knowingly.

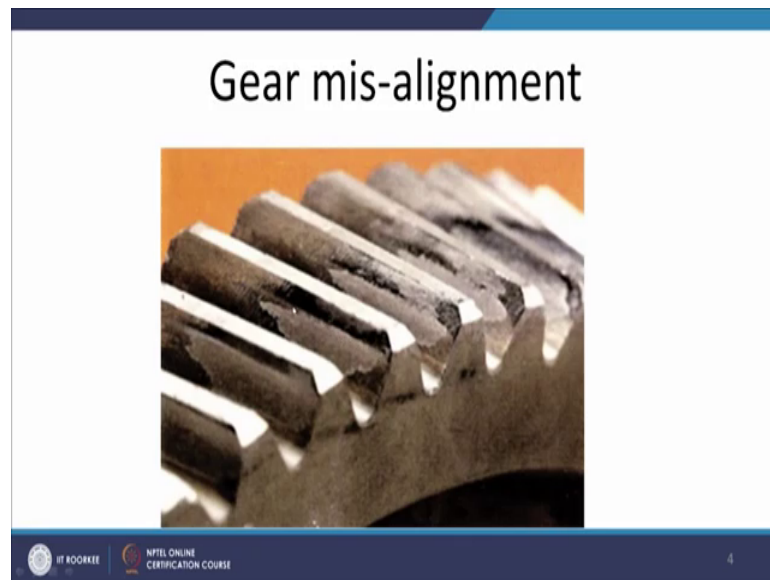
And in this particular case what we can see here mis-alignment will be leading to the increased contact in one side and another and the noncontact in another side of the gear.

So, the gear is having like two sides this is one and this is another side, this is the width of the gear. So, mis-alignment will be leading to the increased stresses and the increased load in one side of the gear which will be causing the higher rate of the wear in one side as compared to the another.

This also can be seen from the temperature rise it is expected the temperature rise in the two sides of the gear is not temperature difference in the two sides of the gear are not much and if it exists that is also used as an indicator, indicator of the possibility of the misalignment.

So, mis-alignment will be leading to the non uniform distribution of the stresses along the width of the gear and which will be causing the increased wear rate in one side as compared another side and that in turn will be leading to the increased wear rate in one side. So, similarly lot of there can be lot of examples for where failure occurs due to the misalignments in case of the shaft couplings.

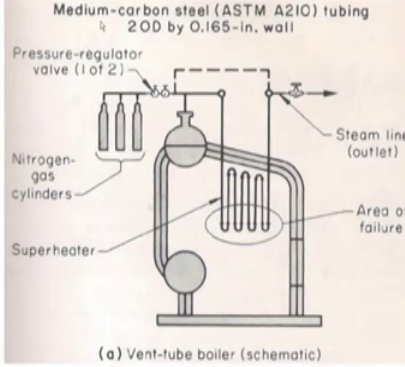
## Failure of boiler tubes

- During hydrostatic testing of 15 year old boiler showed leakage in super-heater tubes at 400 °C and 700 psi.
- Tubes of 50 mm size and 4.12 mm thickness had been in service for nine year at 650 psi at 400 °C

The diagram is a schematic of a vent-tube boiler. It shows a vertical cylindrical boiler body with a bundle of tubes (the superheater) extending from the top. A steam line outlet is shown on the right side. On the left, there are nitrogen gas cylinders connected to a pressure-regulator valve. The tubes are labeled as 'Medium-carbon steel (ASTM A210) tubing' with a diameter of 2.00 inches and a wall thickness of 0.165 inches. A specific section of the superheater tubes is circled and labeled 'Area of failure'. The caption below the diagram is '(a) Vent-tube boiler (schematic)'. At the bottom left of the slide, there are logos for 'IIT ROORKEE' and 'NPTL ONLINE CERTIFICATION COURSE'.

So, actually the boiler for the details if you go the boiler tube failure the failure of the boiler tube here. So, these are the super heater tubes and these started leaking during the trial run, and the trial run was conducted after the maintenance during the hydrostatic testing of 15 year old boiler showed the leakage in the super heater tubes and the tubes were operating at 400 degree centigrade and 700 psi.

So, the tubes of the 50 mm diameter and 4.12 mm thickness had been in service for past 9 years at this was so expected life was this one 15 years, but during the service after the during the service of the 9 years it had worked successfully at 650 psi and 400 degree centigrade. So, after the maintenance it was in trial run at 400 degree centigrade and 700 psi.

So, what it was made of medium carbon steel was used for making the super heater tubes which was having the wall thickness of 0.165 inch that was about like say 4.12 mm and 5 mm or 50 mm size the of the tube diameter. And this was the arrangement and for regular maintenance of the system and will shut down used to be taken and during that the maintenance was carried out.

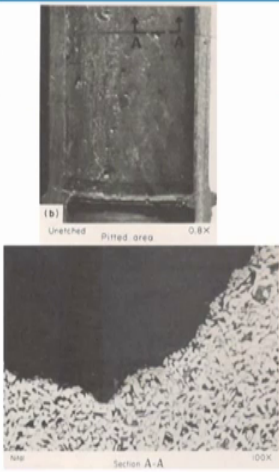
### Investigation

- **Visual:** black adherent magnetic scale with localised presence of powdery, loose, none-magnetic black scale showed pits on removal
- **Analysis of deposit:** XRD showed  $\text{Fe}_3\text{O}_4$  (black iron oxides),  $\text{Fe}_2\text{O}_3$  (red dust), FeO without chlorides
- **Metallography:** Normal medium carbo steel structure, no segregation and heterogeneity

So, they wanted to investigate what lead to the failure of the premature failure of the super heater tubes. So, the tubes over cut and it was found through the visual inspection that black at adherent magnetic scale with the localised presence of powdery loose. So, both type of the black and both types of the oxides were found black adherent magnetic scale with the localised presence of the powdery loose and non-magnetic black scale.

So, the powders of both magnetic and non-magnetic type one was adherent and another was loose this was found on the internal surface of the tube. Analysis of these oxides by XRD showed that  $\text{Fe}_3\text{O}_4$  black iron oxide powder and  $\text{Fe}_2\text{O}_3$  the red dust like the powdery form and in the iron oxide without chloride.

So, this was important to important for the inference that there was no effect of the chlorides which is normally added in water for the softening purpose and the metallography of the super heated tubes also showed that carbon steel carbon steel is the carbon steel has the normal structure of the ferrite and pearlite and there is no segregation and heterogeneity.
