Coastal Engineering
Prof. V. Sundar
Department of Ocean Engineering
Indian Institute of Technology, Madras

Module - 3
Coastal Erosion Protection Measures
Lecture - 10
Coastal Erosion Protection Measures – X

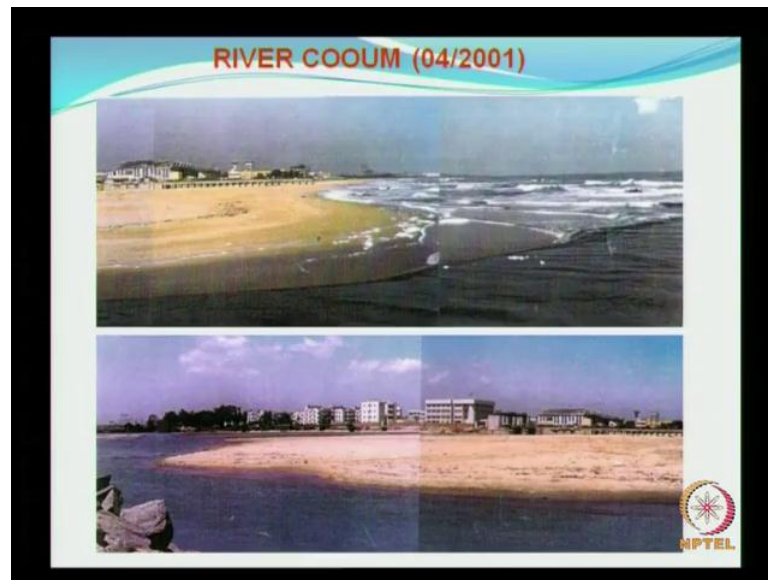
So, look at the some of the pictures where in your formation of the sand bar in process, there is a small portion of the, there is a small portion of the mouth which is open actually the width of the river is so much. This is a closer view so you see the sand bar.

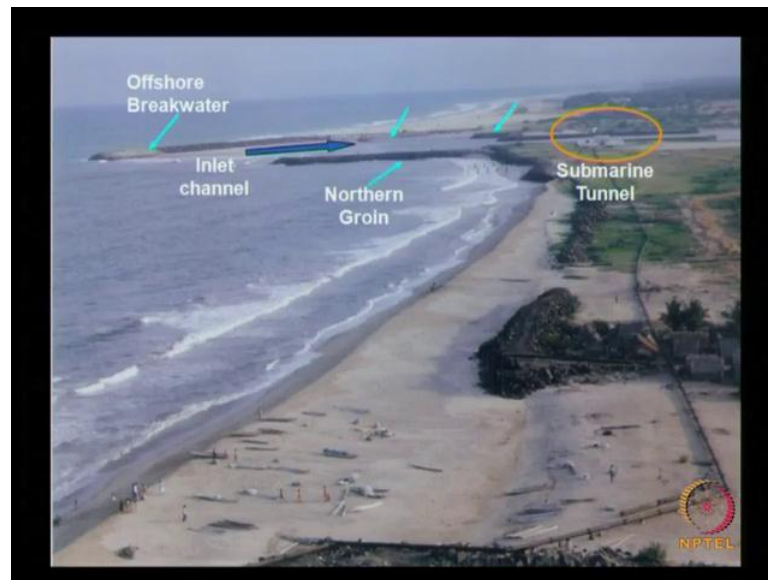
So, there were pipe lines laid. I will explain about this process in the original project around mid-seventies itself. The original project encompassed a artificial beach nourishment, but it was only in papers, in the report, it was never implemented. When we took the report and looked at all the possibilities, then we decided that the project can be revived and when we investigated we saw that there is a submerged tunnel here constructed already and it was in its place below the sea bed below the river bed. So, only thing what we need do is have pumps to dredge the quantity of sand, lay some pipelines across and then pump this sand, this is what we did in 2001.

So, you look at the process, this is the pipeline you see here and this is the submerged tunnel. You cannot see it is below the, so you just this is the offshore break water, that is the southern break water and this is the northern break water. So, here you can either call it as groin or (()) or whatever because it is also serving as a river groining plus it is also guiding the vessels. So, when we did that, you look at this sand bypassing after the sand bypassing has taken place before the sand bypassing this was the situation.

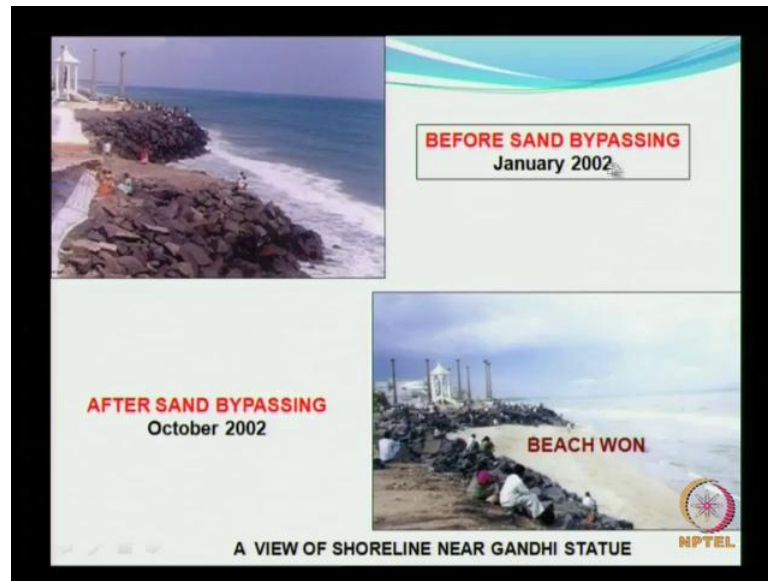
At the same location in October 2002, so the sand bypassing had taken place, that is to the extent of about 0.4 millimeter cube per year and this is what you see a different locations along the the effectiveness of artificial beach nourishment.

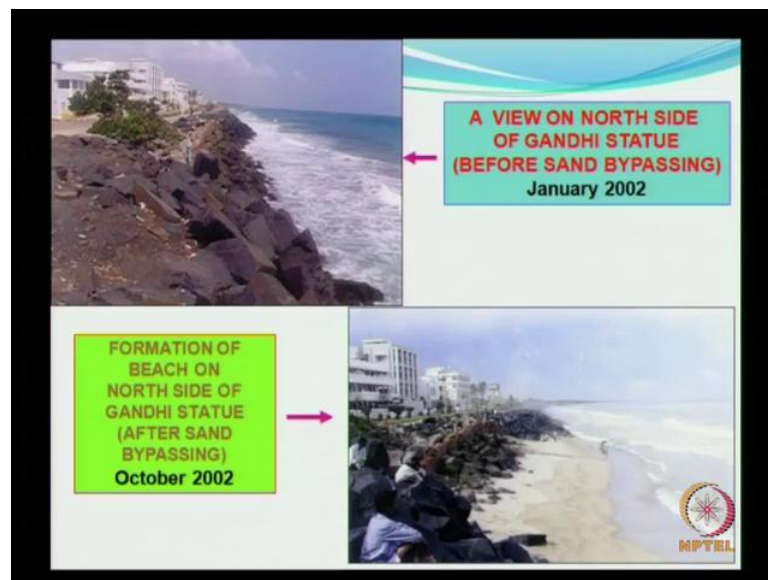
(Refer Slide Time: 34:31)

So, look at this point, this is the same location. This proved that artificial beach nourishment did work.

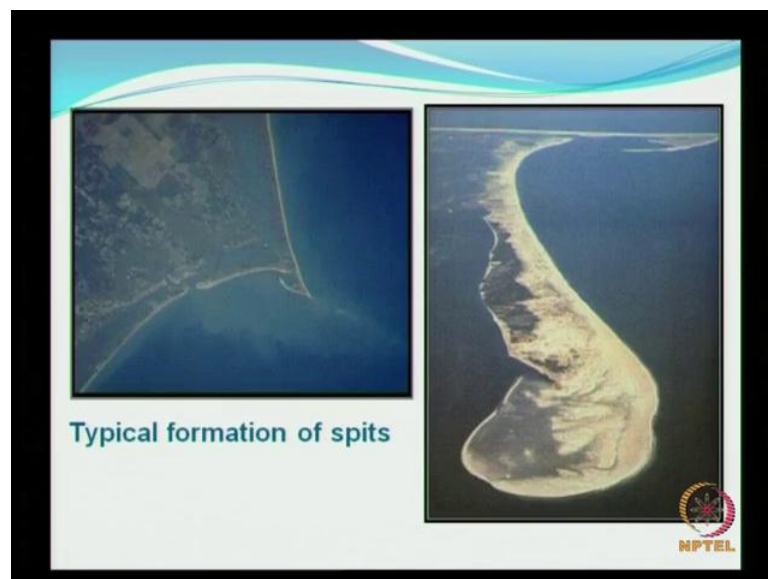
(Refer Slide Time: 41:52)

Typical formation of spits and then I will, I think probably if the, if I take the because that might take some time, I will try to finish this. Shall I continue, no problem? Well now we move on to Orissa.

In 88 and 89 this is the Kakinada bay and now it is a a port.

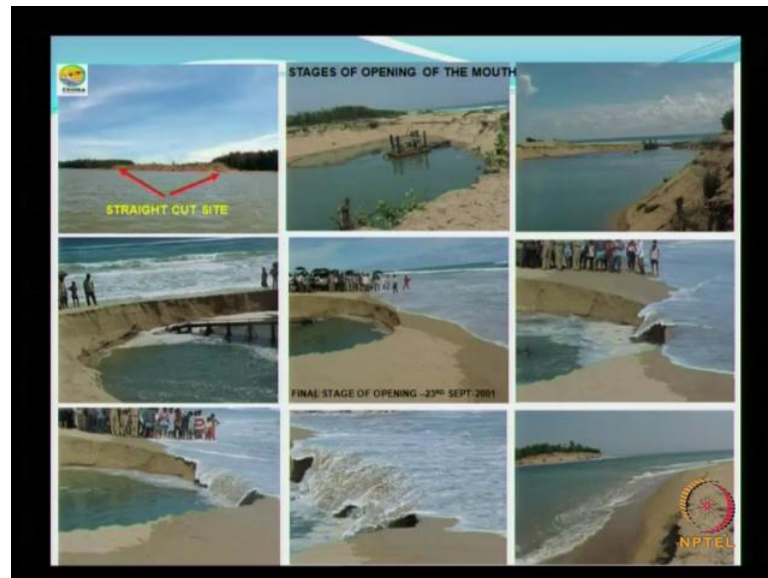
This picture shows the straight cut, all these things are this is the a spit, this is a straight cut the dimension I have given already, so the dredger is in operation. Now, it is dredging here cutting the thing and now we have achieved some kind of an exchange between this and this. Now, you see that the sea water flows into the Chilika lake and now you see that the Chilika lake is connected and look at this, look at the height of the spit, it is quite something like of small hillock.

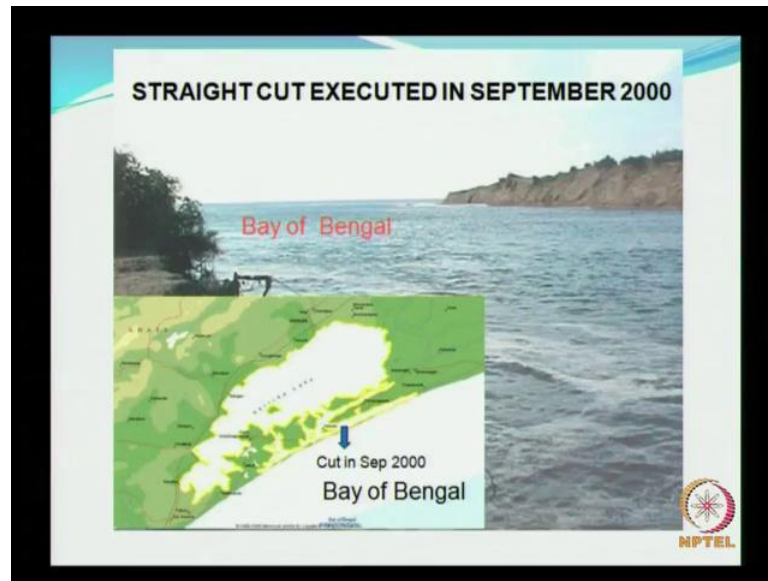
(Refer Slide Time: 47:30)

And now you see that the straight crest was established or executed in September 2010, 2000, September 2000.

So, regular monitoring was taking place inside the lake, to find out what is the salt content etcetera. The salt content improved the fish catch also improved, so for all these details I suggest I suggest you visit Chilika development authority through google and then you get all the information concerning some of these problems also.
