Architectural Conservation and Historic Preservation Prof. Sanghamitra Basu Department of Architecture and Regional Planning Indian Institute of Technology, Kharagpur

Lecture – 10 Divergent Approaches for Managing and Rehabilitating Heritage Properties Degrees of Intervention

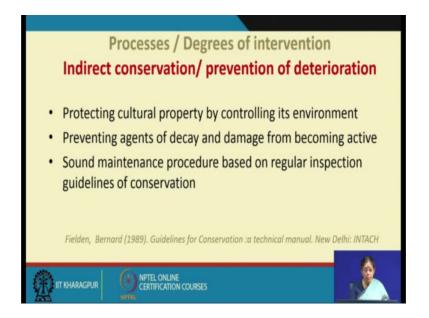
(Refer Slide Time: 02:44)

It actually says that protecting cultural property by controlling his environment. So, if you have signify or understood the significance of a place or a cultural property it can be

an artifact or can be a structure, it can be a group of structures. So, here what is being seen that it has to the culture by controlling its environment, preventing agents of decay and damage from becoming active, there may be various ways or that or structure can be affected and so, preventing the agents of decay and damage from becoming active. And finally, the sound maintenance procedure based on regular inspection and guidelines of conservation.

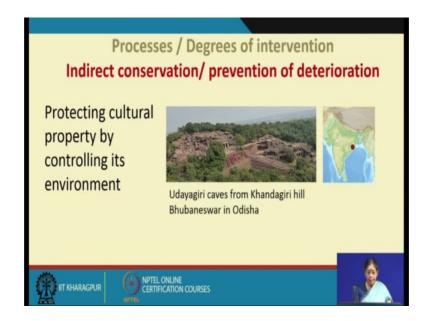
(Refer Slide Time: 03:55)

So, protecting cultural property by controlling his environment. Let us take an example of Udayagiri caves from Khandagiri hills in Bhubaneswar Odisha, its located here, and it is a very important site. What is this importance will come gradually. There are two hills on the two sides of the road and there are many rock cut caves.

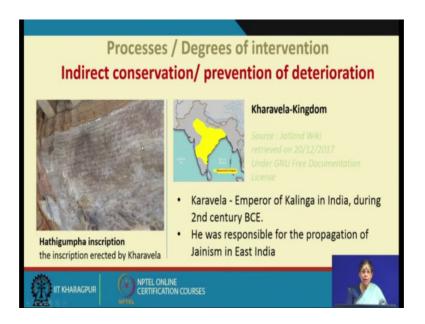
(Refer Slide Time: 04:35)

If you look at the emperor of the Kharavela, it is a huge area, because he is actually Emperor Ashoka devastated and then he sort of built up his an empire. So, now, what is the relationship of this empire Kharavela and this inscription, because this inscription the Hathigumpha inscription is the one which talks about Kharavela his reign, his twinks and everything, and it was been deciphered and this is in one of the caves, and it has been gems princes and many other historians actually try to understand and it gives a very important historical document. But now where it is located is very susceptible to damage, because it is exposed to the environmental condition, water, the sunlight, many other causes if its kept there like that it cannot be maintained.

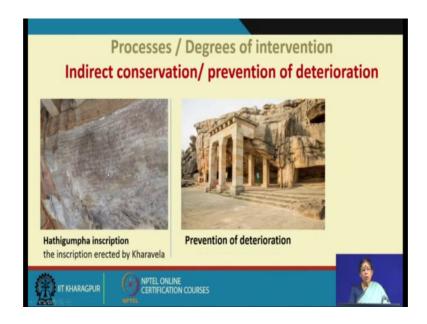
(Refer Slide Time: 05:56)

So what were the options which are available? One could have copied that and kept it like that, one could have removed the entire stone to a museum, but if you see that if we associate this inscription with the place in his best to keep the inscription in his original location. Now keeping it original location, just like that it own would not have been stayed very long. So, it was very important to protect it from the environmental condition without touching the inscription and. So, archaeological survey of India who is in charge of decides what they have done, is they have done this external sort of an extension in a very comfortable manner with the stones, similar type of sand stone and they have done it. So, that that inscription which is a very valuable historical document, its kept in its place and is no damage by the different condition.

So, in this case what we see that the inscription is being protected without touching the inscription, what are the causes and the prevention has been taken like that. this is quite a good example, oh why I see is good example, because this is one of the example I think archaeological survey has done a very sensitive manner, the extension they have matched the material, but at the same time they have not tried to copy any original, the structure is very clear that is a new addition, what some sort of a sensitive approach has been adopted, it is not always like that.

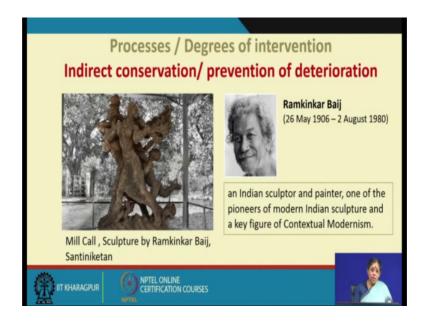
(Refer Slide Time: 07:41)

This other example also where we have talked about an inscription, these are the examples of the sculptures, it is in Santiniketan by Ramkinkar Baij. Ramkinkar Baij, it is a very interesting life, he was the son of a barber a village boy, and he came and he was noticed by the teachers there and Ravindranath Tagore adopted him and brought him to the campus of Santiniketan, he adopted means I say did not as an adoption in the normal way, but I mean he was taken care of and he studied there and he became a sculptor, renounce sculptor.

Now, as we see the Indian sculptor and painter, he is one of the pioneers of the modern Indian sculpture and a key figure of the contextual modernism. So, night Ramkinkar Baij what he did that, because he was very innovative and he was experimenting with the material. So, when he was doing apart from his painting another sculpture, when he built the series of sculpture here he experimented other than the clay and the mud and other thing he experiment with concrete. So, when he did a series of such sculptures which I keep outside, he experiment with concrete and the reinforcement was given by the (Refer Time: 08:58).

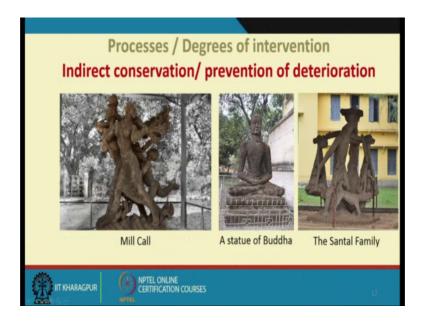
(Refer Slide Time: 09:03)

Now, the problem is that, when they are exposed to the environment and there are some cracks there, and when there is a crack, there is a seepage of the water and because of that the iron rods which are inside, which he used as a sort of support that gets corroded and it bursts and a corrosion sort of expands. So, what would have been the best way to preserve that, there were been many ways to do that; one is that to remove that within in interview whether they will not be exposed to the this such environmental condition or the damage or decay or just to leave it like that and say that let it be. Now, what Visva Bharati authority or Santiniketan did, is that they put up certain shelters or support or canopy on these structures.

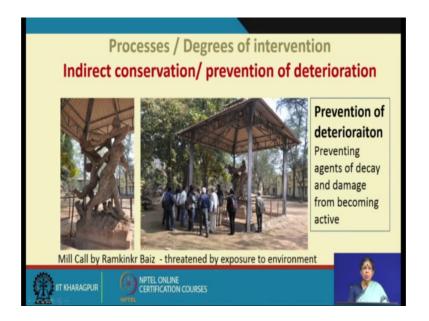
(Refer Slide Time: 10:21)

So, that they do not get eroded by rainwater and other things. There is a lot of opposition against that, because they are some say that it is not very aesthetically pleasing, it is not the original environment, but I think one has to take a decision, but in this case what we see, that it is actually without taking care of the structure itself or sculpture itself, it is trying to manage the environment which is causing damage to the sculpture of the structure itself. I will later on come to that, the other alternative also has been adopted in that case, but that will talk of later.

So, this is one of the case of a minimum intervention and which you call the in direct conservation, because it is really not touching the sculpture itself and trying to prevent the process of deterioration, and preventing the agents of decay and damage from becoming active in this case mainly the rainwater. One can question that why not taking them inside the museum. In this case we have to remember that the context is also very important the site, the surrounding, the nature keeping them in the museum could have sort of saved the structure, but it would have lost his context and the surrounding. We will talked in the next example, we will talk about another example where this contextual or this importance of the surrounding to a structure is very important and we will see that how to maintain the relationship and how do we do the prevention of deterioration.

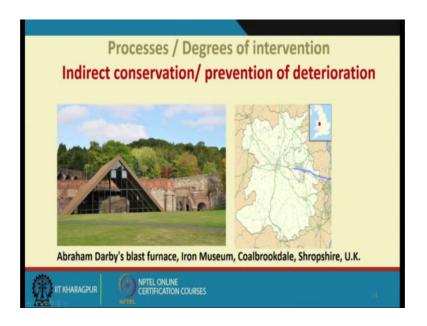
(Refer Slide Time: 12:10)

These example is a very well known example, because it is a world heritage site, it is a Abraham Darby's blast furnace in iron museum Coalbrookdale in Shropshire in UK is here. Now what is the importance of this blast furnace, you can see that it is protected the original burst furnace which is made of brick, it is protected by a very modern structure.

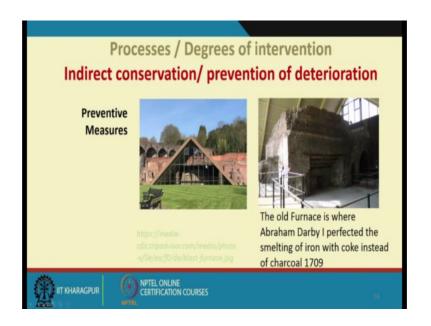
(Refer Slide Time: 14:08)

So, they have covered it, there is a very interesting thing, because this is the picture of the blast furnace where he perfected the smelting of iron with coke instead of charcoal in 1709, and when it is now protected and there is a sound and light show which goes on and people come there and can know that what had happened, what is the significance of this blast furnace, and this is the what we talk about the preventive measures. So, what we have seen in this example is that this indirect control or conservation means prevention of deterioration, it can have the various depending on the case, depending on

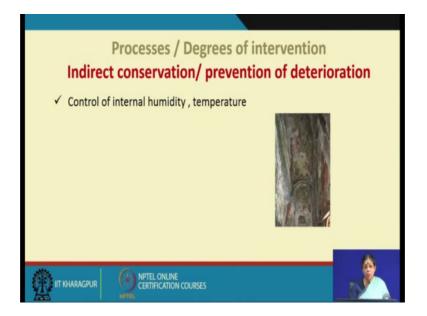
(Refer Slide Time: 14:46)

So, it can be the control of the humidity and the temperature; like in this case we see that it is the humidity and the water seepage which is really causing is one of the temple in Bengal, where the humidity and the seepage actually is creating the problem and which lead to further structural problem with measures to prevent fire, arson, theft, vandalism.

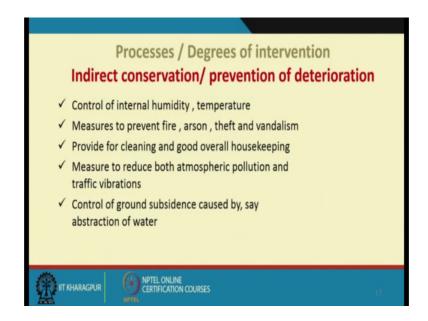
(Refer Slide Time: 17:15)

Control of water again is in various form, is very important to understand, because in many cases the control of ground subsidence caused by let us say abstraction of water, because many structures could have sort of been there were initially there was no human settlement, may be outside and because of the increase in the density and the extraction of water from the ground, with many times causes a change in the substrate water level and which may cause a problem later on.

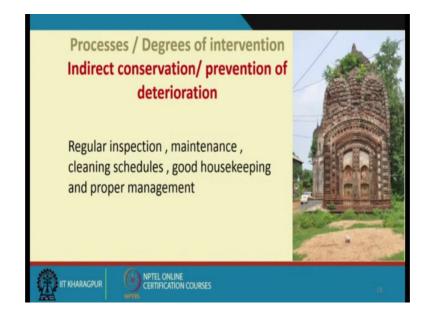
(Refer Slide Time: 17:53)

So, one has to see that how to take care of. So, this first I talks about regular inspection, the maintenance, cleaning schedules, good housekeeping and proper management. For example, this is again it is not any stress structure, it is a small temple, a household temple near Bakura in Bishnupur or Bishnupur in Bakura. Sorry and then if you can see that it is very unique, because, not because of the style there are many such temples, there it actually A Giri Govardhan temple. So, what the artist thought that they actually made the clay look like stones, and they made it look like a hillock, and it is quite unique in his sort of a conception the design and the structure.

Now, you see that there minimum things, the trees are coming up and which I mean because of this rain water and the monsoon climate. So, these trees are coming up and. So, these actually they are allowed to remain like that they will grow and cause a further damage to their. So, this regular inspection could have saved or could prevent the damage and decay of this temple. So, this is what we call a good housekeeping of the structures.

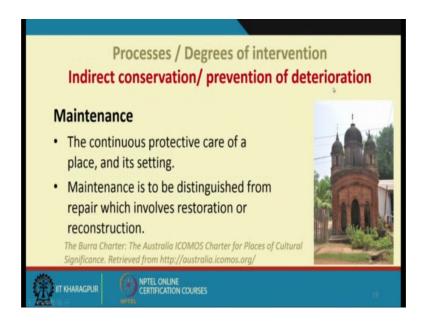
(Refer Slide Time: 19:17)

So, when he was talking about maintenance. Like again this is a very small temple, we see that there are it is not as it has not been restored or it has not been reconstructed, but it is a simple cleaning process which is very different from the earlier temple what we have seen; that is setting has been clean, the brakes have been clean, some pointing has been done, something just minimum maintenance has been done and that is why this temple is likely to survive for a longer period.

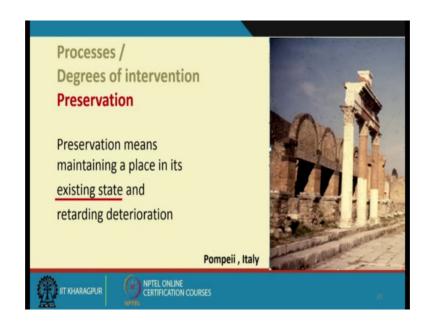
(Refer Slide Time: 20:38)

Now, let us talk about the next stage which is the preservation. Now preservation which is different from the first indirect conservation, preservation means maintaining a place in its existing state and returning the deterioration. So, its maintaining a place in its existing state, this is very important to understand and returning the deterioration. So, its actually directly deals with the cultural property. Let us take this example, this is Pompeii in Italy you know this again a world heritage site very important, because it was (Refer Time: 21:18) devastated by an earthquake and the entire city got buried under the ashes of the volcano, and this has been taken and we have can go to that city and see what it was like.

In this case what you can see that, this colonnade which was there on the side of the road and here you can see that the plasters, which are original plaster, they have been kept like that, where the plasters were not there, they have been just the big bricks have been exposed and only that portion of the colonnade which has been there they are kept, no restoration, no reconstruction nothing has been done; whatever has been remaining they have been preserved in his original existing state. So, this is a different. Now of course, the taking care of the environmental and causes of decay and damage is also has to be understood, but here we are actually directly dealing with the cultural property.

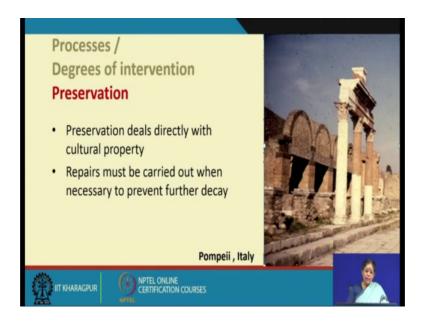
(Refer Slide Time: 22:20)

So, preservation deals directly with the cultural property and repairs must be carried out when necessary to prevent further decay. So, in this case definitely this brick which is an expose brick, and very difficult to maintain that, some sort of repair must have been done to keep it like that, but not plastering. So, it is the minimum intervention which has been done. So, that it can remain, or it continues to remain in this existing state. So, these are very important to understand.

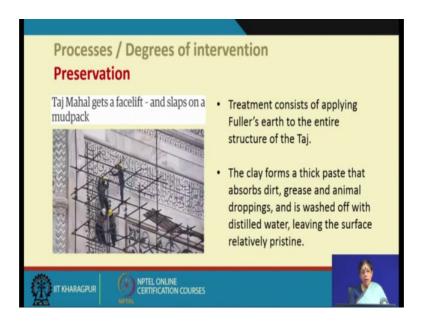
(Refer Slide Time: 24:53)

So, what is a mudpack, it is almost a fullers earth which they call it and this treatment consists of applying the fuller earth to the entire structure of the Taj and this sort of put in

different portions one by one; that is being applied and then the clay forms a thick paste and that absorbed the dirt, grease and the animal droppings and its washed off with distilled water, leaving the surface relatively pristine.

So, here we are not really changing the marble or because it is discolored, we are trying to clean it my applying something externally. So, we must understand this difference, we are now directly dealing with the cultural property, apart from trying to remove or mitigate the causes, which are causing this pollution or causing this problem. So, these are the things which are very important to understand.

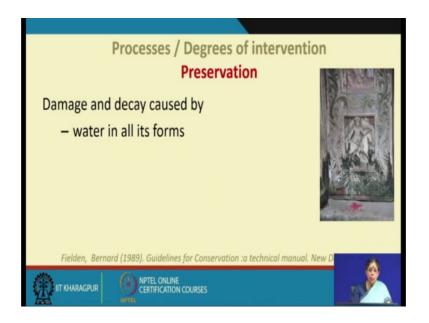
(Refer Slide Time: 26:00)

So, preservation, we have to understand it is the damage and decay caused by we have to understand water in all is form, what are the problem as we can see the, it can be the rainwater, the groundwater, the seepage many types of water problems, the snow water in various forms can cause the problem, as we can see the it is the seepage and also the ground water rising dampness is causing the problem to this structure, because of that there is a moss and fungus.

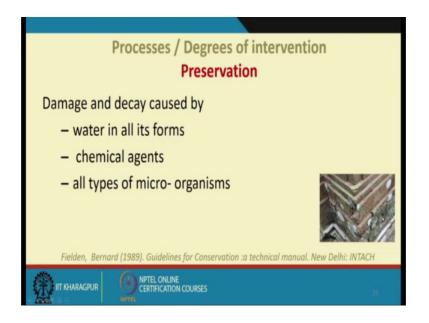
(Refer Slide Time: 26:36)

The chemical agents may cause as we have seen in the case of Taj Mahal, and all types of microorganism, and there are so many varieties of microorganism the fungus, the lichens and algae there are different types, and different types of this microorganism have a different relationship with the different material. So, one has to understand with the proper experts that what are the problem and has to take and there also that, there are the different environmental condition which enhance or which sort of deterred the growth of this microorganism. So, it is very important to understand that what are these

causes, there is a break and you can see the different types of fungus, which has grown on the break and this has to be clean.
