**Architectural Conservation and Historic Preservation**  
**Prof. Sanghamitra Basu**  
**Department of Architecture and Regional Planning**  
**Indian Institute of Technology, Kharagpur**

**Lecture – 26**  
**Documenting Heritage Properties: A Demonstration Example**

For that I have taken this beautiful structure, it is actually Radhadamodar Rashmancha which is situated near Panchkula in East Midnapore and it is not listed, it is not protected is a private property.

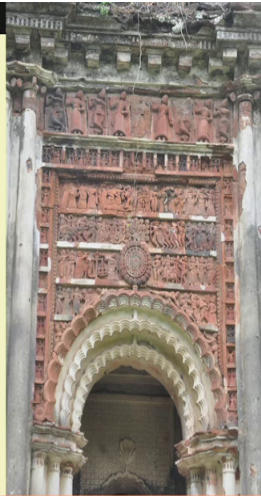
10.0 Distinctive/ Significant Features

1. High quality terracotta decorations and information plaque giving dates and name of the founder
2. Multi foil arch with high quality stucco work in lime.
3. Turrets, total seventeen in number are pidha style, an example of Orissa, Nagara architecture , not very common in Medinipur.
4. The staircase almost hidden in the plinth, is also unusual.

So, this is one of the multi foil arches the you can still see the lime plaster which is there and the, this is the day sort of a decoration and the pull ons and other thing on the terracotta and plasters are still in intact many of the places. So, we are summarising sort of distinctive features let us see what can be the distinct features of this. So, one the first and foremost which sort of comes, there is a high quality terracotta decorations and information plaque giving the dates and name of the founder that comes the first and founders day, then the multi foil arch with high quality stucco work in lime and turrets as we said initially the total seventeen in number are Pidha style or a example of Orissa influence of Nagara architecture not very common in Midnapore.

So, that is by referring the other documents and others. So, we have seen that its quite un common. So, that makes it this particular structure quite distinctive and quite unique the staircase almost hidden in the plinth is also quite unusual, I been one cannot make out where is the things it goes under the plinth is also quit unusual have been one cannot make out where is the things it goes under the plinth. So, these are some of the things
