Architectural Conservation and Historic Preservation
Prof. Sanghamitra Basu
Department of Architecture and Regional Planning
Indian Institute of Technology, Kharagpur

Investigation and Conservation of Historic Structures Case Study 2 (Part a)

1966 inspection
by Sir Bernard Fielden

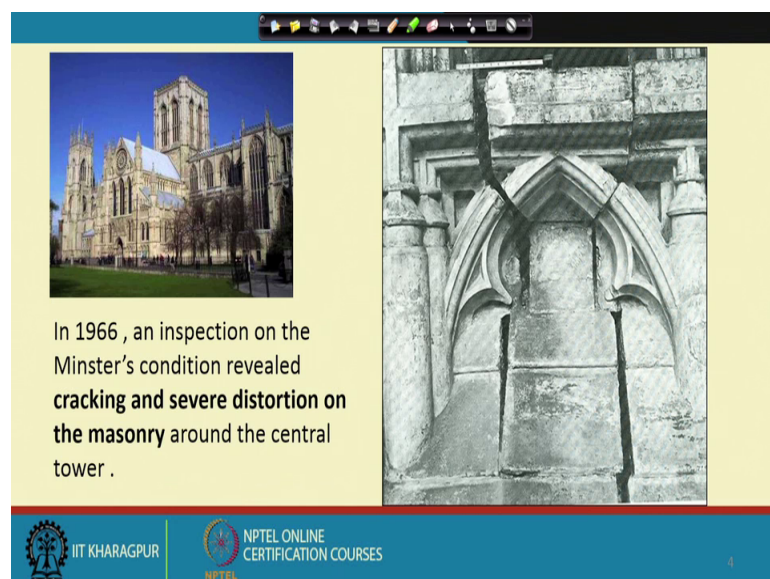
In 1966, an inspection on the Minster's condition revealed **cracking and severe distortion on the masonry** around the central tower.

So, this was the situation, it can see the cracks which happen and there were cracks all over, but suddenly, it found that the cracks probably, it was widening and I mention that when there are cracks, one has to understand whether these are life crack or a dead crack. So, in 1966, when there was a learning science and inspection team on the minster condition revealed cracking and severe distortion on the masonry around the central tower, it looked like the cracks were still continuing and there is danger.

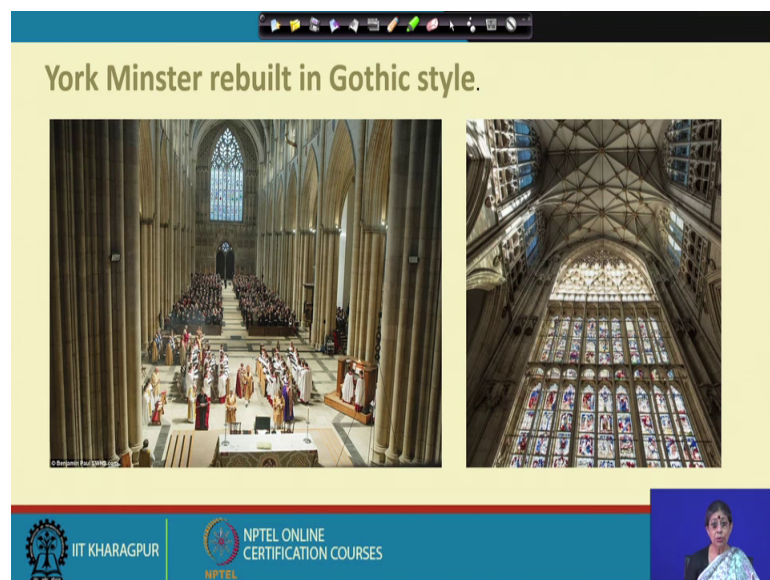
This is what it is today beautiful interior the grand scale stainless windows all over the world cross walls decoration beautiful place, it is and still being actively used for religious purpose as well as the tourist and visitors come there.

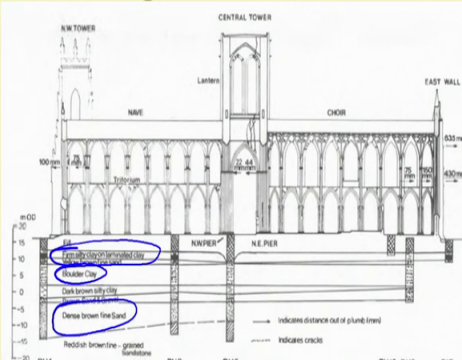
Site Investigation eleven boreholes to investigate ground strata

Piers of Central Tower had settled up to 225 mm and the western towers up to 75mm with respect to the Nave

Now, what was done is that 11 bore holes were put drilled through the soil to investigate the ground strata and you can see that this is the start did the various types of ground strata, it is found that the ground condition when this boreholes were dug and it is found drilled through that that it was not a similar condition, it was a very composite and a variable type of soils are there and it was also found that the taking the plumb line the settlement was not equal.

It was found the piers of the central tower has settled up to 225 millimetre and western towers up to 75 millimetre with respect to the name. So, what is found out that the settlement which was happening is not equal, it was different in different parts of the huge structure and if you see the different types of clay, we can clearly see that there are bolded clay there are the different types of sand were found which are there and there are silt also which are there different types of clay which are there. So, it was every composite type of soil which happened.

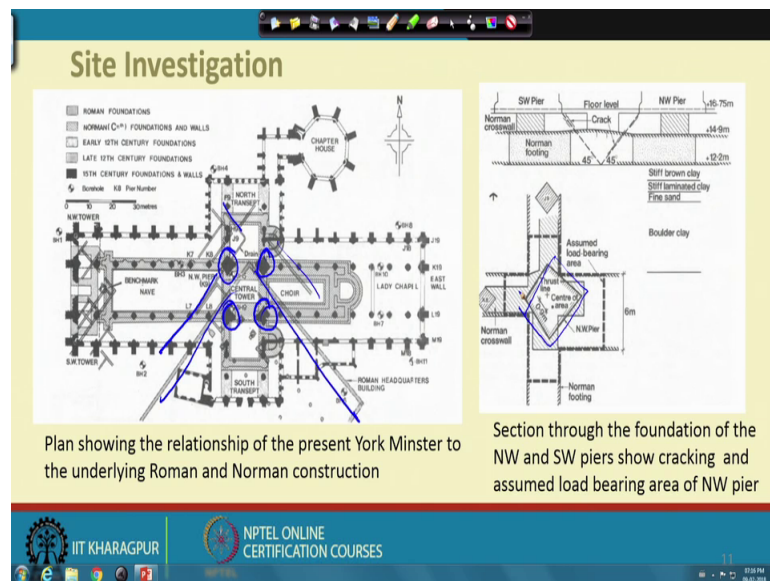
Now, let us look at the plan of the here you have seen earlier. So, it was found that there is a plan which showing the relationship of the present York Minster to the underlying Roman and Norman construction as we saw the history historical record that there were various types of structures which are there they were not so big, small, wooden and stone and they were rebuilt and there were distort and they had their own foundation and one part of that these huge structure came up and also in stages.

So, here you can see that it showed the how the present that four a the central tower which is there, how it is the supreme post on the Norman foundation and it is not actually matching. So, part of the two of the towers are on the Norman foundation and the other towers were outside the Norman foundation and also this Norman foundation the weight was built it is very different there were used to have wooden piles and this wooden pile also changes there condition because of the groundwater level.

So, there was also a change in the groundwater level of these city because of the organisation and other factors now you can see another section here which shows the northwest pier which is there the foundation of that and how they are in an oblique manner it is position on the Norman tower. So, it is partly on that. So, of this central tower of the 4 pier two are on the foundation of the Norman pier and the two are outside the foundation of the Norman pier and these it was a lot of structure calculation study analysis was done along with the investigation plan line the depth the settlement.

It was found that this there was definitely an unequal settlement because of this ground strata and the different types of foundation and different types of buildings which were there because it was inhabited right from the beginning. So, different types of constructions were happening on the same site now what was done is that to diagnosis what was the cost it was understood that it was a due to a different settlement.

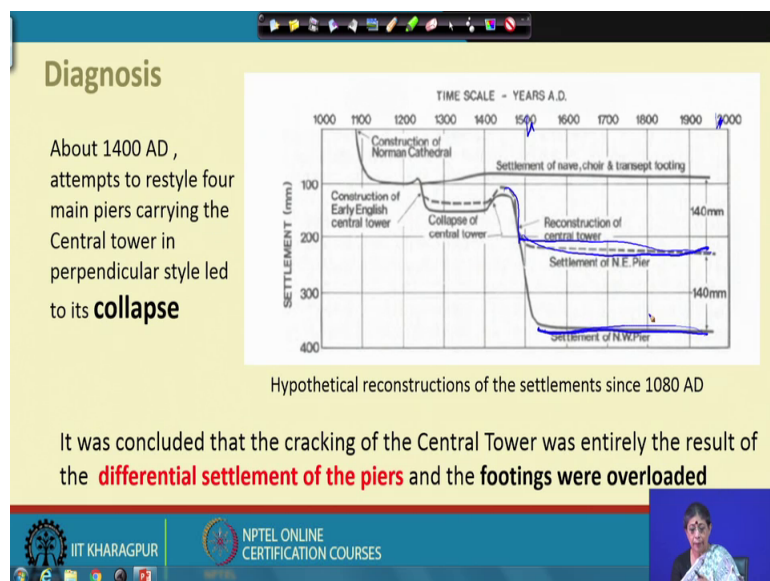
What is done here that is an hypothetical reconstruction of the settlement since 1080. So, this was done according your timeline and that what was the settlement the churches are very good in keeping the records. So, they had their record and if you see that the in initially this sort of a settlement was there during the construction of the normal cathedral and then there was a time when it was a sort of almost it changes it becomes slower ah, but again in this time there was also collapse when the of the because about 1400 AD, there was a style, the main power and there was a central towers collapse. So, that is the history which you found there.

But also then after that that certain settlement happen, but again as we can see here that at this point that there was a differential settlement of the north east and the northwest piers. So, I mean, but that also stabilize over this period of 1502, almost middle of a 1900, it almost settled, but around that time in 1960, suddenly it was found that the settlement was certainly sharply happening. So, this was became us, but it was from all these reconstruction and diagnosis and various types of investigation excavation which happened it was found that it was I mean decided or they came to the conclusion that the cracking of the central tower was entirely the result of a differential settlement of the piers and the footings were over loaded.

So, this was the diagnosis after a sort of a multidisciplinary team working for a long time and different types of investigations which happen now the question comes of the diagnosis investigation was there then the diagnosis was done now the question come what can be done what are the remedial measure because otherwise this type of crack happen, it is definitely bound to collapse.

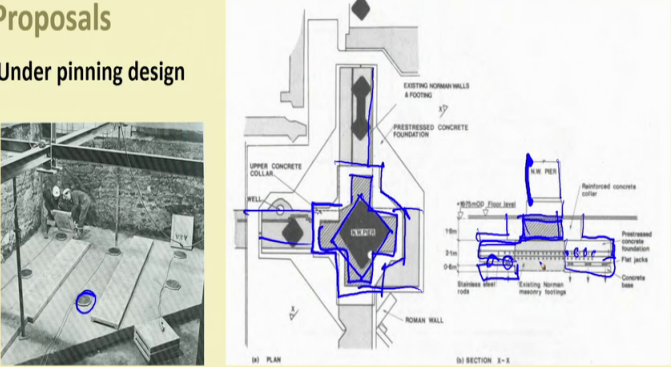
Under pinning design

Flat jacks used for pre stressing

Plan and section of N.W. Pier foundations of Central Tower showing new concrete and existing masonry

So, if you see this section here. So, this is the northern pier and this is the Norman church Norman, this is the old sort of a foundation which was there. So, now, what is being done is that this extra sort of a part which was constructed and these extra part which was constructed at two parts one is this part and another is a lower part of platform in between this flat jacks which were inserted and they had a sort of lubricant.

So, the moment is trying to sort of settle down and put a pressure on the sort this flat jacks with sort of give a pressure. So, that the differential settlement is not happening and also there were sort of a bar pre stress bar which should be horizontal bars which will be put through the old foundation and the new foundation. So, that as a whole they work unition.

So, most of the thing in the available solution in such cases is underpinning underpinning is that you sort of strengthen the foundation construct foundation from beneath and make it stronger because it is not able to take the load any further and for the underpinning also there is a different alternative scenarios are there they were discussed the various options were tried I mean discussed about that and then ultimately a particular solution was decided and in this case, it was realised that because this type of composites, all in a huge structure is there the moment the underpinning will be done.

There this will also create a further stress on the surrounding condition of the adjacent structures of the parts of there and that you can create a further problem. So, the thing is that even if I strengthen the foundation from beneath the underpinning that will create a stress on the soil, but how to sort of reduce that impact became a challenging situation and for that it was decided that there will be pre stress what actually done if you can see here that this is the northern pier which was existing this is the Norman foundation.

So, what was decided that to put or put it in a sort of a concrete collar and widen the foundation from beneath and from the site and then so that these new portion and the old portion can work in unition and whenever it will like to press the soil and there will be a settlement the moment there is a settlement happening there will be a sort of an adjustment. So, that the differential settlement is not much it will sort of adjustment will

be there and that adjustment we done by the flat jacks which were inserted and that flat jacks will again try to counter balance the settlement which will happen.

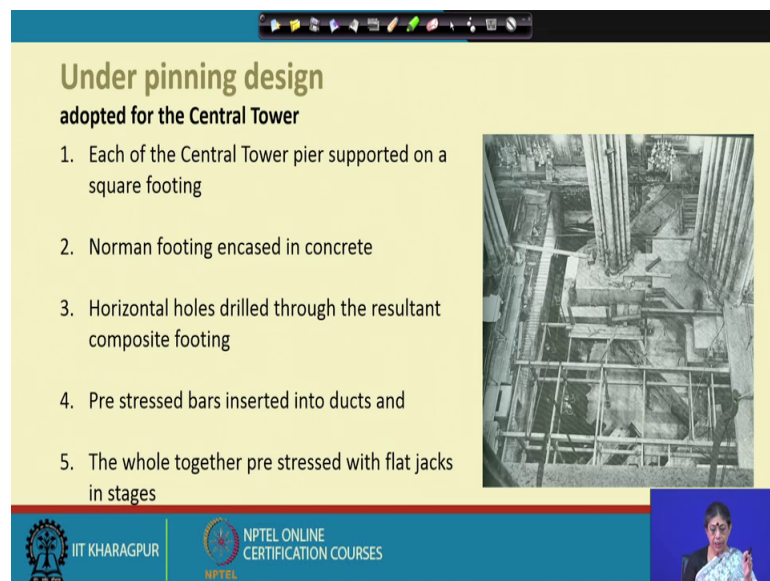
Under pinning design
adopted for the Central Tower

1. Each of the Central Tower pier supported on a square footing
2. Norman footing encased in concrete
3. Horizontal holes drilled through the resultant composite footing
4. Pre stressed bars inserted into ducts and
5. The whole together pre stressed with flat jacks in stages

So, this is a clear picture of the clearer picture that what is happening to the old foundation and the new foundation the underpinning the pre stress what has happened and you can see that this is the old section and then the new section has is coming up there and there were these horizontal time members or the things which was going through that and in this new section also there are two parts in between there are flat jacks which were again try to because whenever there is a pressure on the soil, it there will be some adjustment happen there will be settlement when the question here is to

So, now what is the process each of the central tower pier was supported on a square fitting footing and the Norman footing was encased in the concrete as I showed in the section and the horizontal holes drilled through the resultant composite footing. So, that they work in unition and the pre stress bar were inserted into the ducts and the whole together pre stressed with the flat jacks in stages and this was happening in stages not at one go.

So, that it takes time, but it will try to settle and the practice and happened further and there is no further differential settlement it was marvellous bit of structure genius it was done with all of associate and filled it as a teamwork and this was really appreciated all over and it became an exemplary work of foundation strengthening and saving York Minster from collapsing.
