**Architectural Conservation and Historic Preservation**  
**Prof. Sanghamitra Basu**  
**Department of Architecture and Regional Planning**  
**Indian Institute of Science, Kharagpur**

**Lecture – 29**

**Investigation and Conservation of Historic Structures Case Study 2 (Part b)**

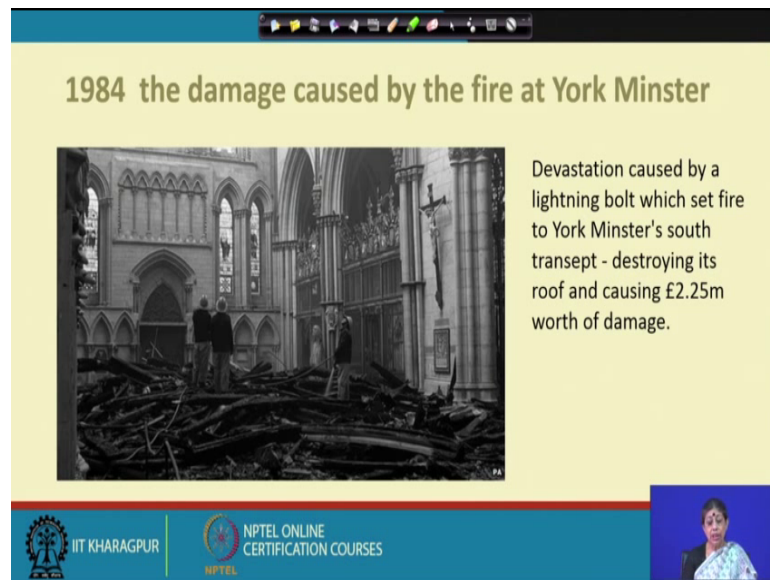
**1984 the damage caused by the fire at York Minster**

Devastation caused by a lightning bolt which set fire to York Minster's south transept - destroying its roof and causing £2.25m worth of damage.

The devastation as you can see the devastation caused by a lightning bolt it happened due to lightning. So, nobody can help that, which set the fire to York minister's south transept and it destroying, it is roof the entire roof collapse and causing the 2.25 million of pounds worth of damage and, this is the scenario which happened.

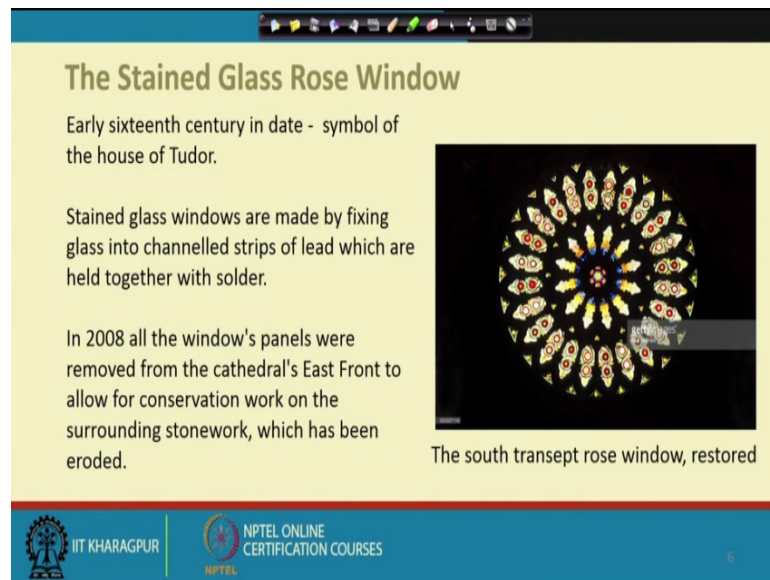
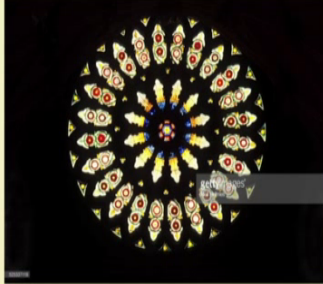
**The Stained Glass Rose Window**

Early sixteenth century in date - symbol of the house of Tudor.

Stained glass windows are made by fixing glass into channelled strips of lead which are held together with solder.

In 2008 all the window's panels were removed from the cathedral's East Front to allow for conservation work on the surrounding stonework, which has been eroded.

The south transept rose window, restored

But before we discuss that what is happen, what are the desaturation measure was taken for this stain glass window? Let see what is this about and what is the importance of the stain glass window. This goes back to early 16th century in date, it was the symbol of the house of Tudor, these are generally made by fixing of glass into channel strips of layered, which are held together with the solder, as you we are already discuss the solder melted, but the late in place because of the very recent strengthening of that.

In 2018 all the windows panels were removed from the cathedrals east front to allow for conservation work they replace some of the broken parts, or replace the parts which are not in how many because, even in a glass when it breaks somebody choice to change that. So, if see or fifteenth centuries angel head probably or 12th centuries, or 16th centuries a head will be replace of there was some sort of anomaly, which was there during this conservation process they are all taken care of and this conservation was in done in 2008 that is very recent.

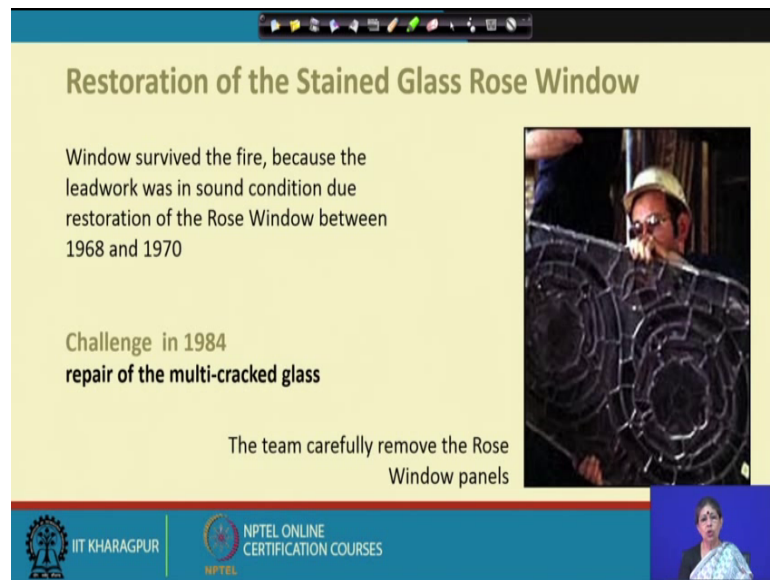
**Restoration of the Stained Glass Rose Window**

Window survived the fire, because the leadwork was in sound condition due restoration of the Rose Window between 1968 and 1970

**Challenge in 1984**  
repair of the multi-cracked glass

The team carefully remove the Rose Window panels

As we discussed the window survived the fire, because of the leadwork it was in sound condition, because of the restoration between 1968 in 1970 the challenge in 1984 was the repair of the multi cracked glass, as you can see that the team is carefully removing the rose window panels from that what we this also after the fire.

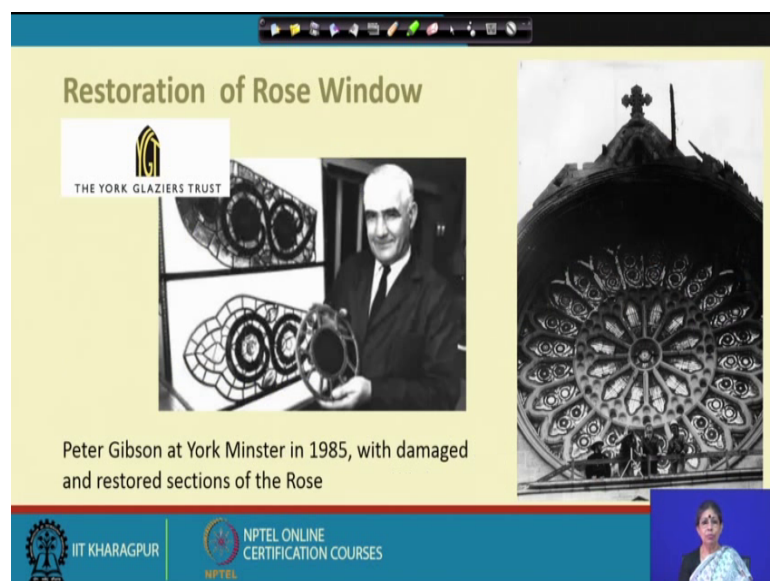
**Restoration of Rose Window**

Peter Gibson at York Minster in 1985, with damaged and restored sections of the Rose

So, according to him what happened I mean we listen to him and he has a different write ups and other when his certain, start recollecting the incident that happened, is it when his was called that this is happened during the fire, the fabric it personal putting on the ladder and he went up and inspected closely to see that what is happen to this stain glass. He fall that the glasses are in position, but there are minute crafts in the glass because of the temperature, but they were in place and they were not fall in apart.

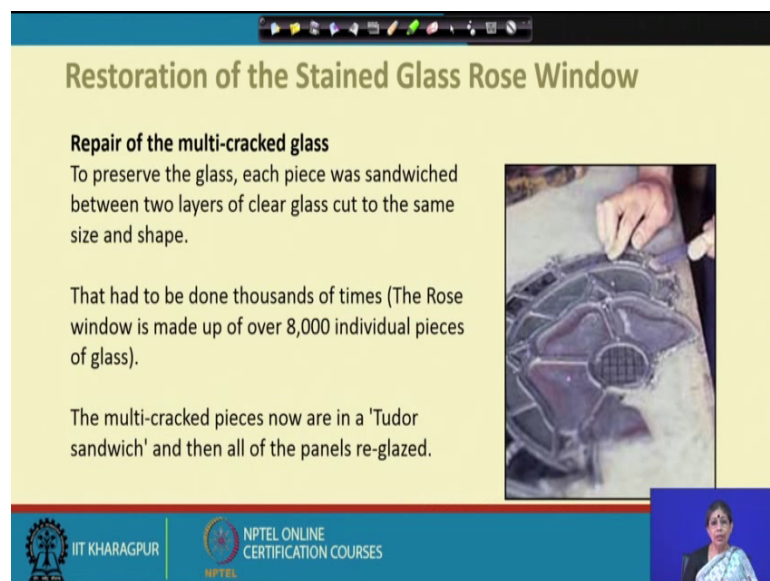
**Restoration of the Stained Glass Rose Window**

**Repair of the multi-cracked glass**  
To preserve the glass, each piece was sandwiched between two layers of clear glass cut to the same size and shape.

That had to be done thousands of times (The Rose window is made up of over 8,000 individual pieces of glass).

The multi-cracked pieces now are in a 'Tudor sandwich' and then all of the panels re-glazed.

And finally, what was decided is to repair the multi cracked glass not to replace the multi cracked glass. So, repair the multi cracked glass how what how it can be happened. So, what he did is that to preserve the glass each piece of the original glass which is cracked, it is conciliated by injecting adhesive and, then that glass was sandwiched between 2 layers of clear glass and cut to the same size and shape.

So, that original glass remained consolidated with injecting and adhesive fluid and, then it was put in between sandwich in between the 2 clear glass and for each and every piece,

it was done that has to be 1000 of time because it is rose window was made up of over 8000 individual pieces of glass.

So, each part has to be taken down consolidated by injecting and, then it has to be sandwich and, then it has to be put path. So, very laborious process it took years, but that was decided not to take the easy option to replace the glass with the new one. Because if you go back to the ethics of conservation it is that if is possible to repair when do that, it is possible to consolidated it then do not disturb. So, the consolidation was done. So, the multi cracked pieces now, or in a Tudor sandwich and then all the panels were reglazed and, then put back into the position.

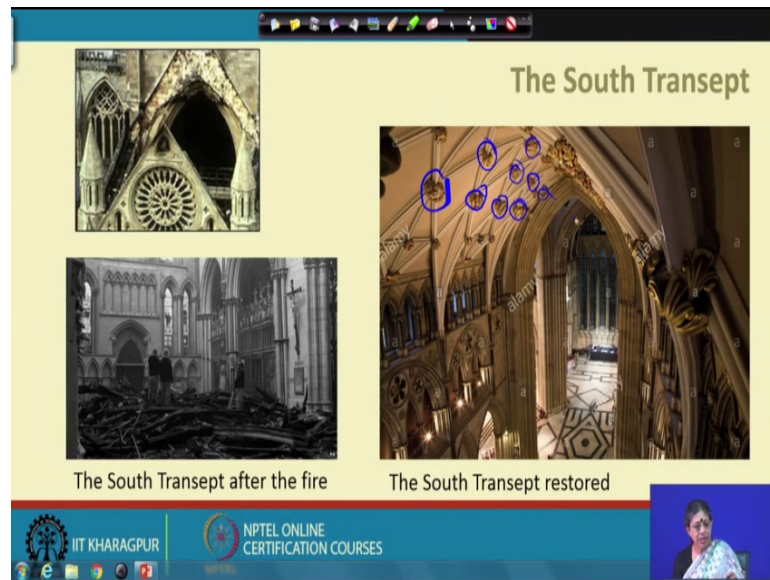
So, this is the south transept when there you can see the entire roof is as collapse. And this is what it is today entire thing has been restored to with it is full flori with all the decorations and everything.

But there is also interesting story, in when the decoration was happening, you see that there are this bosses the roof bosses which is called a roof bosses that this one, this has to be made the entire roof have to be made according to the original design, but there is something which very interesting thing happened while doing this roof bosses.

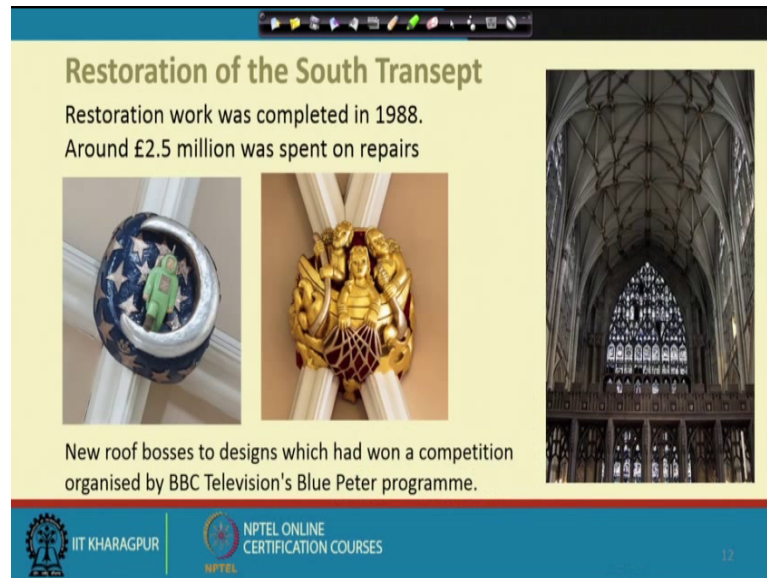
**Restoration of the South Transept**  
Restoration work was completed in 1988.  
Around £2.5 million was spent on repairs

New roof bosses to designs which had won a competition organised by BBC Television's Blue Peter programme.

The wanted to include something new and to include the younger generation so, there was a design competition, which was organised by BBC's television blue peter programme, where the design for this bosses or us from many people and specially the children and as you can see a very interesting we cannot change the size, but they can change the designs. So, very interesting design which you can see here is the a man going on to the moon and this was accepted.

Why because from that is at great height you cannot really make out the full design the shape size and the colour and all this thing matters, but you one cannot make out. So, the purpose of that is to involve the future generation, involve the people to incorporate their design. So, in that sense the design is not authentic. And it was new design came up, but keeping the shape size the position and everything held.
