Disaster Recovery and Build Back Better
Prof. Ram Sateesh Pasupuleti
Department of Architecture and Planning
Indian Institute of Technology - Roorkee

Lecture - 10
Rock Shelters at Risk

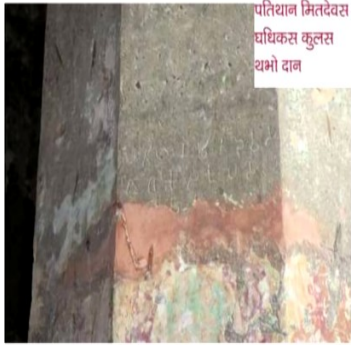
The pillar is a donation of Mitadeva (Mitradeva), of the Gadhika (perfumers?) family, a resident of Patithana (Pratishthana, modern Patthan)

On the right-hand side in the photograph, you can see some small text which has been written in either Pali or and this is saying that the pillar is the donation of Mitadeva which is a Mitradeva of the Gadhika family, a resident of Patithana which is Pratishthana the modern Python. So, it says, these inscriptions are telling actually about who is the family who have donated to the construction the pillar, so which means and from where they belong to.

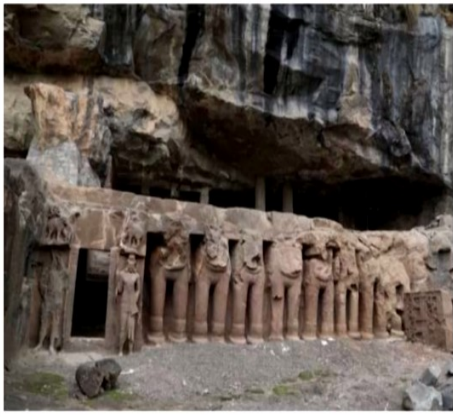
Elephant – Conception
Bull – nativity
Horse – Great departure
Lion – Sakya- Simha

And there are also some iconographic aspects of science and symbolic aspects of it where you can find some sculpture as well where in their time elephant is referred to the conception, bull is referred to nativity, horse is referred to great departure, lion is referred to Sakya and Simha you know. So, like that there are some different meanings associated to these symbolic expressions.

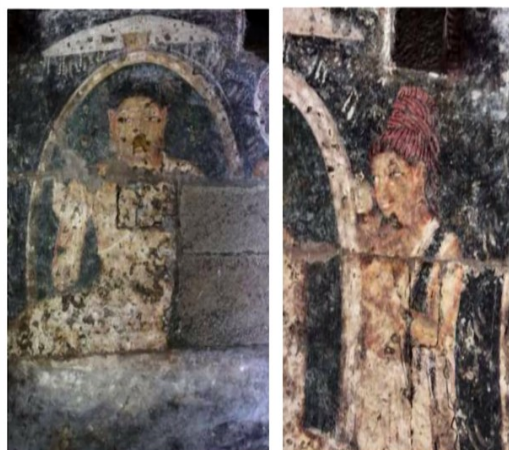
The Mahayana Phase of Buddhism at Pitalkhora is discernable only in the form of painted Buddha figures. It is evident that the paintings of the Mahayana Phase were drawn when the Caves were occupied by the followers of Mahayana sect.

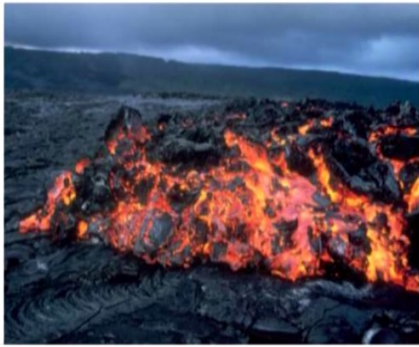
'A 'a also spelled aa, a'a, 'a'a, and a-aa; from Hawaiian meaning "stony rough lava", but also to "burn" or "blaze") is one of three basic types of flow lava. 'A 'a is basaltic lava characterized by a rough or rubbly surface composed of broken lava blocks called clinker

In Pithalkora, one would notice a thick layer of **Tacheletic Basalt** at the lower proximity of the hill, which have restricted the scope of excavation as per projected plans.

Now, in Pitalkhora we actually notice a very thick layer of Tacheletic Basalt at the lower proximity of the hill, which have restricted the scope of excavation as per projected plans because you know this is about this Basalt which actually sometimes it becomes a very soft material when keeps making an excavation it breaks into the pieces you know, that is how there is a chance that the evidence will also be losing, we will be losing some evidence.

Like now what you see here is a kind of lava where we talk about the 'Aa' which is the basaltic lava which is characterized by a rough or a rubbly surface and these lava blocks also we actually extract the clinker from this kind of rough and rubbly surface lava is called 'Aa'.

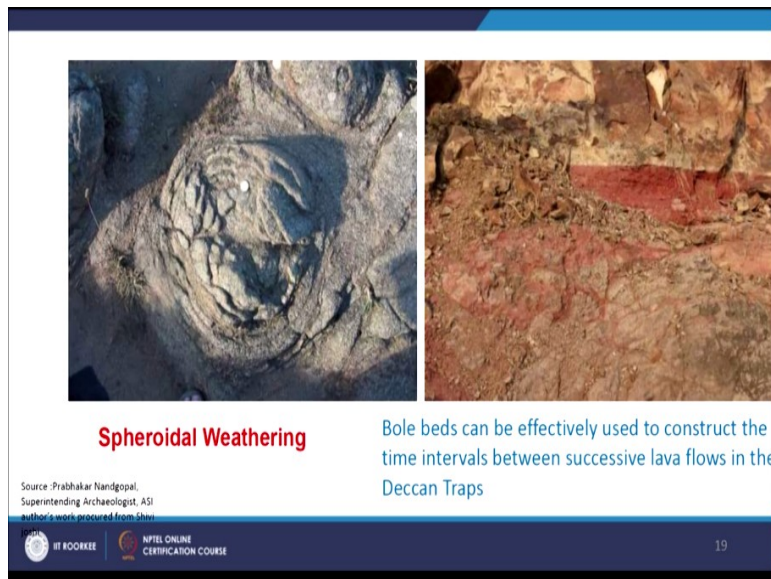
And on the left-hand side, you see an example of how the whole rock formation and because of the weathering aspect how it chips down. On the right-hand side what you see is a kind of Bole beds which is actually look at the time intervals of how these successive lava flows have been trapped in the Deccan Trap you know.

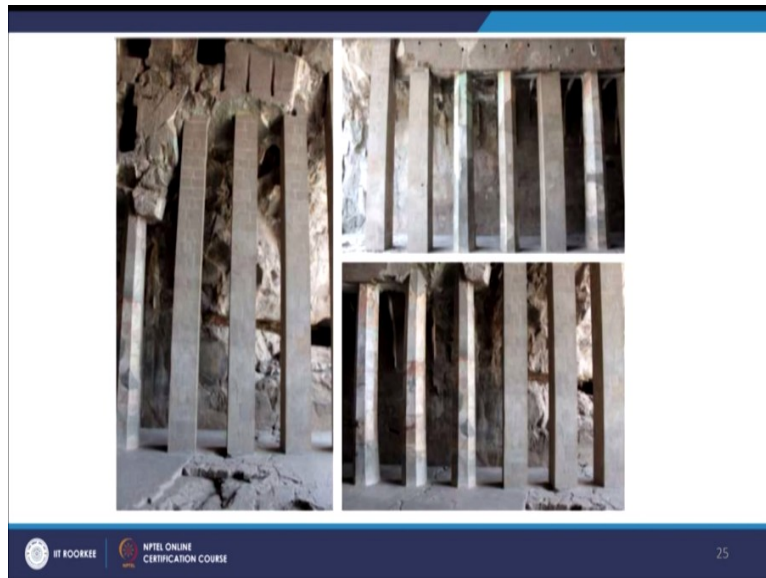
Also, what you can see here is whatever the columns they already have and now retrofitting them and giving a kind of support to the ceiling as well.
