**Chemical Process Safety**  
**Professor Shishir Sinha**  
**Department of Chemical Engineering**  
**Indian Institute of Technology Roorkee**  
**Lecture – 50 Jaipur Terminal Fire, India**  
**October 29, 2009**

Now, welcome to this module related to the fire and we are going to discuss a case study of Jaipur terminal fire took place at IOCL terminal facility at Jaipur on 29th October, 2009 and after the flex (())(0:45) this is one of the most dangerous most devastating and most capped catastrophic accident related to the fire. So let us have a background of this particular facility by the description of the facility.

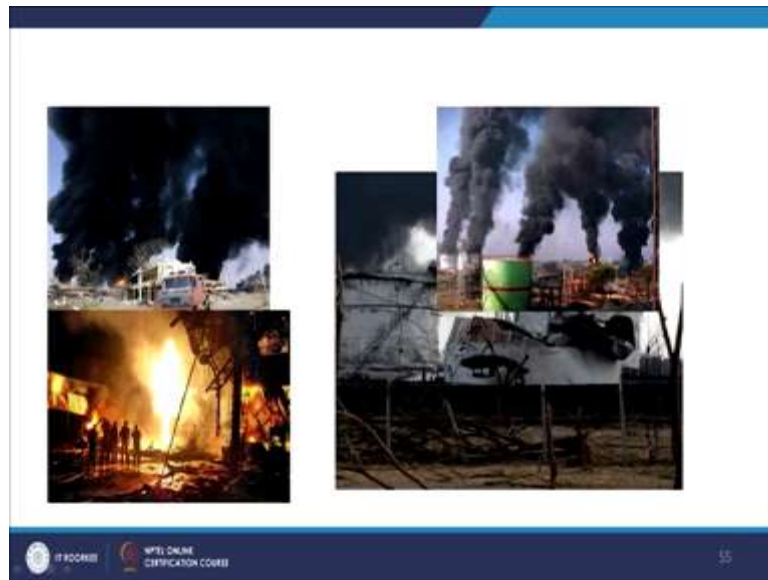
Now you can have a look of the gravity of this particular accident through these photographs. Now these tanks they were burning and the car in the nearby location it is burnt out. Now you can see that this is the storage tank facility how much pressure being built up so that it the entire tank which is so strengthen installation is collapsed.

Now you can see like this, this is the firewall,

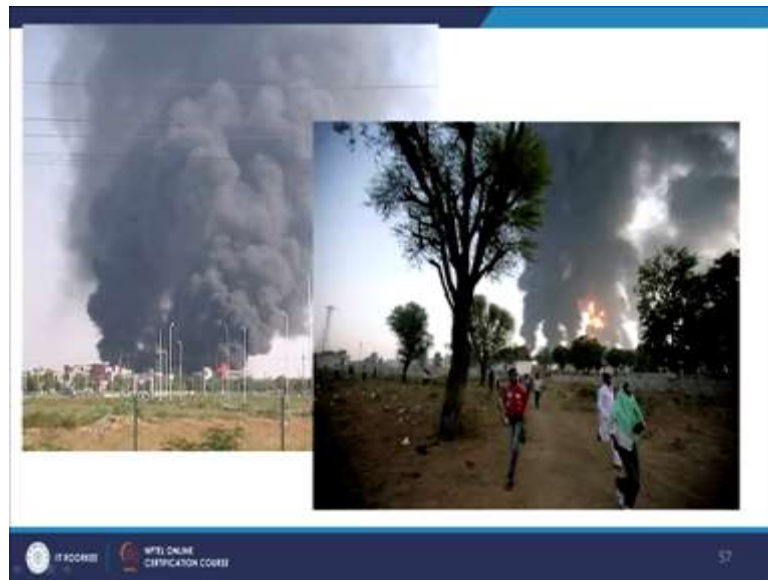
Now, this is the highway nearby that installation so you can see the gravity of this particular accident.

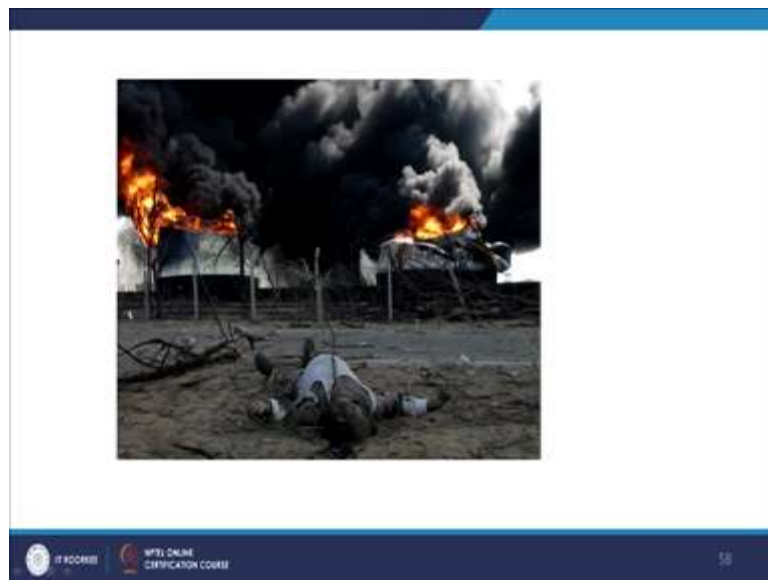
The people were running around now unfortunately we should not install like this.

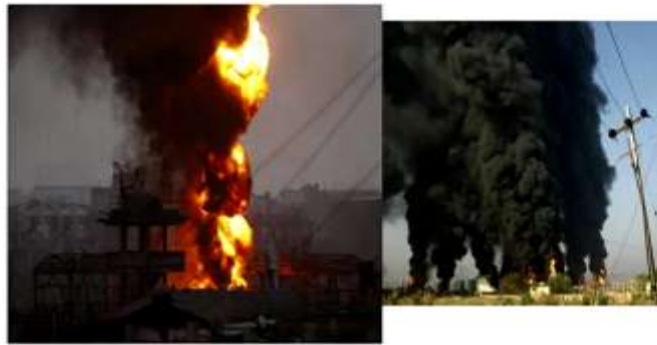
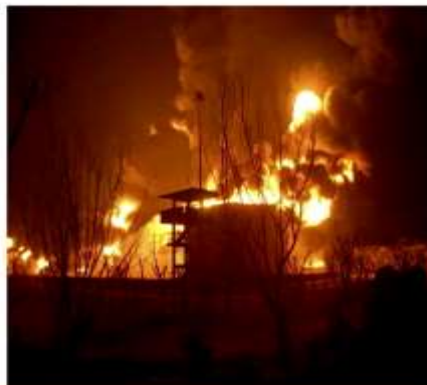
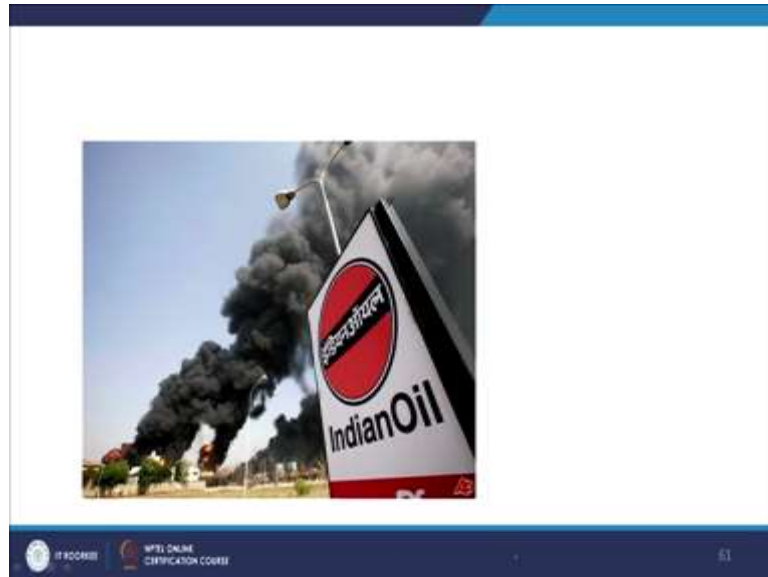
So, these are the couple of the photographs which looks they are so which depicts that how much the gravity of that particular accident.
