**Chemical Process Safety**  
**Professor Shishir Sinha**  
**Department of Chemical Engineering**  
**Indian Institute of Technology, Roorkee**  
**Module 11**  
**Lecture 51**  
**The Flixborough UK Cyclohexane Disaster**  
**(June 01, 1974)**

**Introduction**

Flixborough disaster was an explosion at a chemical plant owned by Nypro (UK) Ltd.

Occurred in Flixborough, England on Saturday, 1st June 1974 at about 4.53pm.

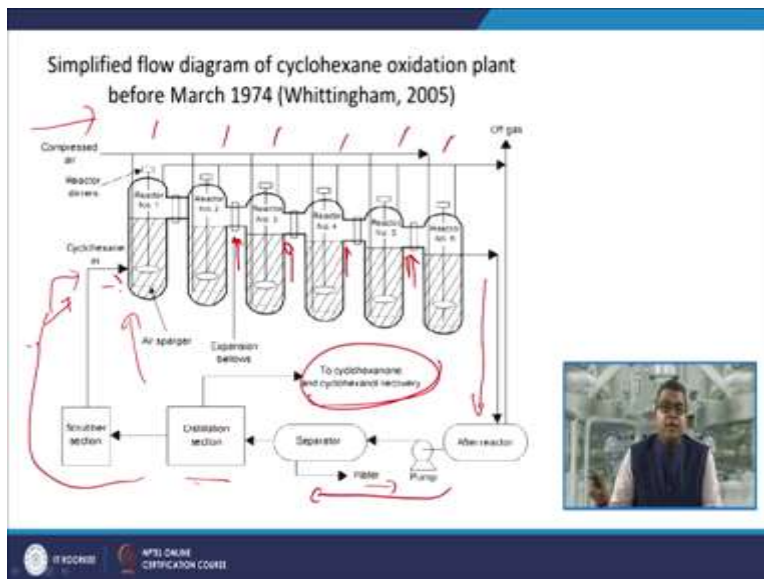
Now this is the simplified diagram of cyclohexane oxidation plant, here they were having 6 different reactors 1, 2, 3, 4, 5 and 6 and the cyclohexane, they were injecting from the first plant with the help of an air sparger and the compressed air was supplied from the air supply utility line and they are, these reactors are connected in series. Now, whenever there is a problem then what they used to do, they used to draw one reactor from problematic reactor from the main battery and then they used to repair and then they re-insert it.

So there are certain every reactor was connected with the expansion bellows like this to overcome any kind of pressure imbalance. Now the product whatever product they coming out from the after reaction they used to the pump and then separator water is separated and they send to the distillation section and this is subjected to the cyclohexanone and cyclohexanol recovery and whatever left behind this unreacted cyclohexane, it is sent back to after scrubbing it is sent back to the main reactor battery.

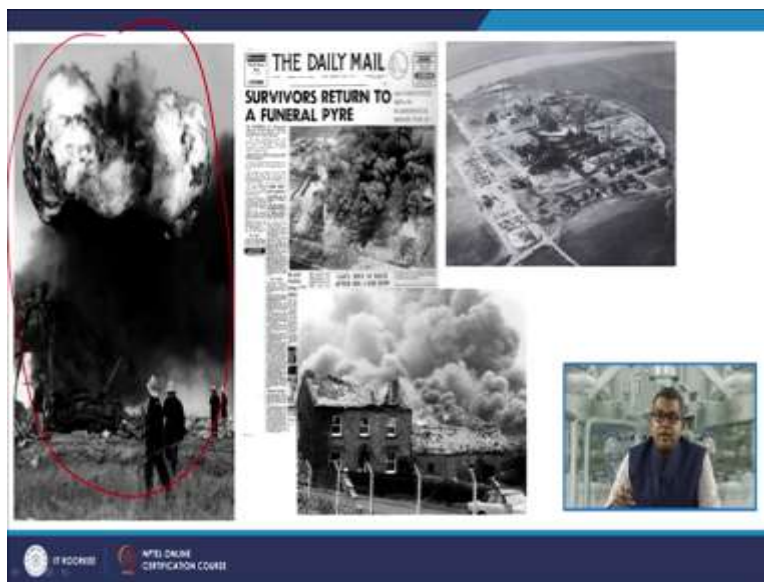
Now you can see that the various newspaper clipping and accident sites in these figure. So this is the scenario of vapor cloud explosion and the daily mail they reported that survivor return to a funeral pyre. So this was the whole scenario.

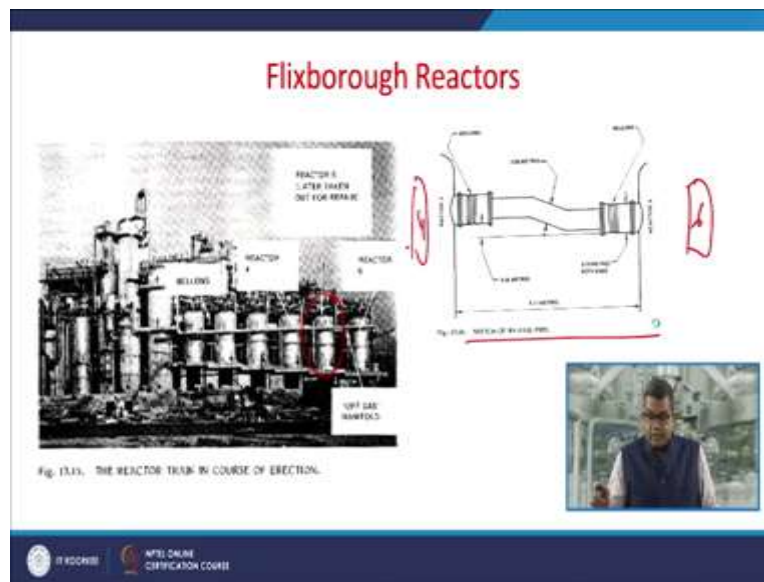
So this higher pressure and higher temperature, this is this was a main reason these two parameters were the main reason for this particular reactor apart from the mechanical or deliberated failure. Now, this is the actual photograph of the reactor train or reactor battery in the course of during the course of the erection. Now, this was the reactor which was taken out for the repair and this was the sketch of the bypass pipe. So there was a reactor number 4 and this was a reactor number 5, reactor number 6, so they were connected through this bypass pipe.

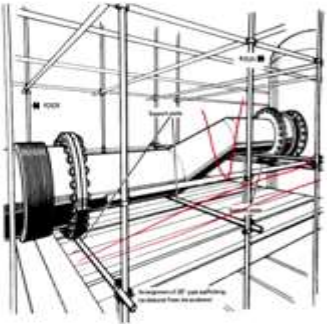
### BY-PASS PIPE GEOMETRY

The by-pass pipe was fabricated from stainless steel

Now this was the structure of scaffold and this you can see the scaffold which was supported the reactor number 4 to reactor number 6.
