**Chemical Process Safety**  
**Professor Shishir Sinha**  
**Department of Chemical Engineering**  
**Indian Institute of Technology, Roorkee**  
**Module 11**  
**Lecture 54**  
**Bhopal Gas Tragedy**  
**(December 03, 1984)**

**Bhopal Gas Tragedy**

Occurrence: 3<sup>rd</sup> December 1984.

Company: Union Carbide Corporation.

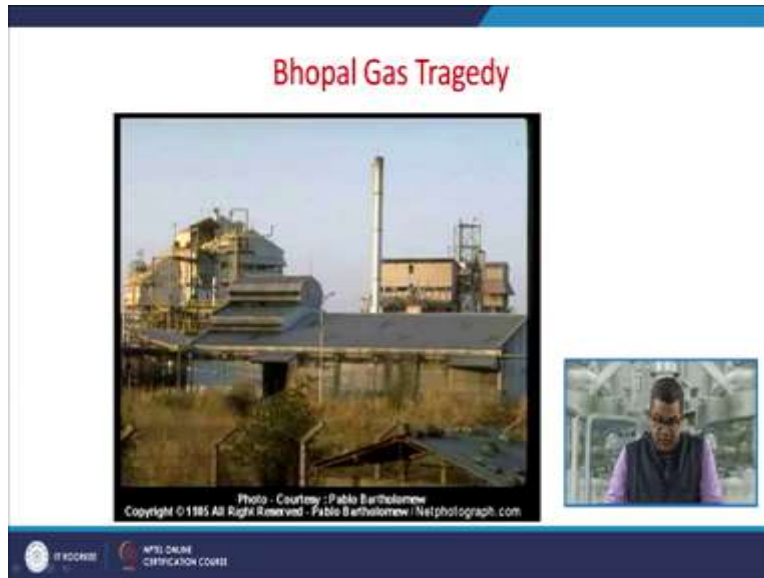
Now, this is the photograph of Union Carbide Bhopal facility.

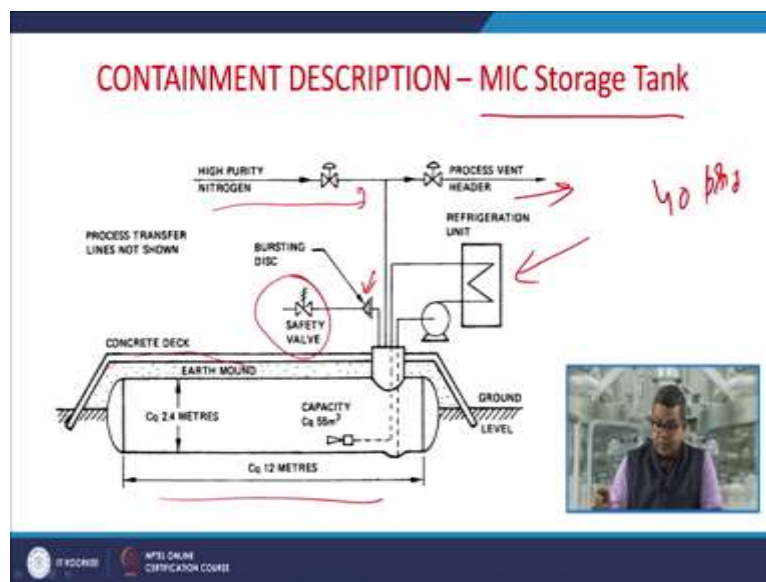
So when it was entered into the storage tank, so let us have a containment description that is the MIC storage tank. Now this MIC storage tank was having the diameter of 2.5 meter the length of 12 meter, it is duly supported by the safety valve with the busting disc, this is equipped with the refrigeration unit. It is having the ground level concrete deck and we have already discussed that

the design pressure was 40 PSIG and it is having the high purity nitrogen blanketing system and there was a process vent had a line.
