**Safety in Construction**  
**Prof. Uma Maheswari**  
**Department of Civil Engineering**  
**Indian Institute of Technology-Delhi**

**Lecture-07**  
**A Case Study on Construction Safety**

I will be sharing a construction safety case study with you which will highlight the importance of following the correct construction sequence and strict supervision at site

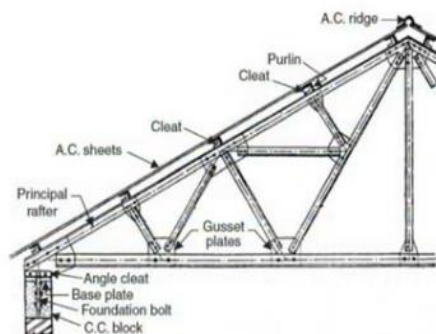
The subcontractor was tasked to place the truss on the column by the contractor. The details of the connections were overlooked. The protruding reinforcement of RCC column was used for anchoring the truss by the subcontractor.

Having understood the background now we will look into the scientific reasons behind this accident and what our lab says led to this mishap. The figure shows the typical cross section of truss with connection details. The support details include the foundation boards embedded in reinforced cement concrete and the base plate at the top of RCC column.

In our case the contractor did not purchase the j-hooks or anger boards which was supposed to be embedded in column or he forgot to do it before casting the tip of the column. When it was time to lift the truss using crane it was too late and the fabricator found a quick solution by welding the base plate with the reinforcement of the column after inserting it through the holes provided in the base plate.

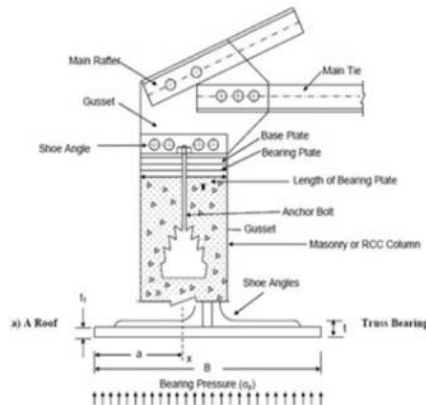
The axial forces are supposed to be transferred through the base plate to the support of the truss and that is achieved by high strength friction grip bolts.
