**Fracture, Fatigue and Failure of Materials**  
**Professor Indrani Sen**  
**Department of Metallurgical and Materials Engineering**  
**Indian Institute of Technology, Kharagpur**  
**Lecture 55**  
**Failure Analysis-Case Study-ALK**

Hello everyone, we are at the 55th lecture of this course fracture fatigue and failure of materials. And today also we will be discussing about a very real-life incident a case study on capsizing of Alexander L. Kielland. So, let us see what we have in store for this lecture.

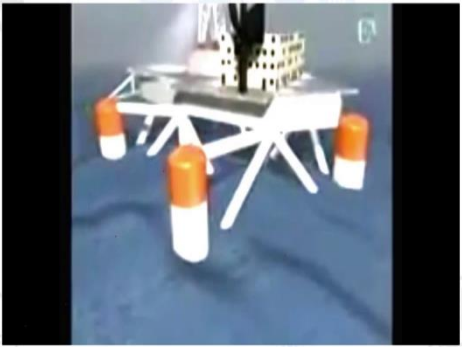
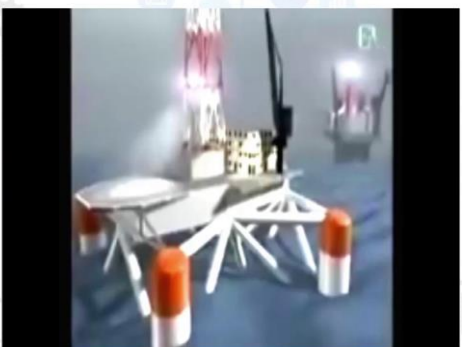
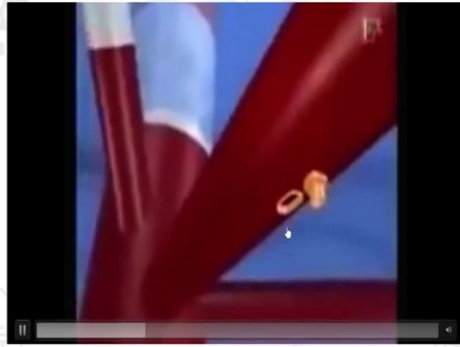
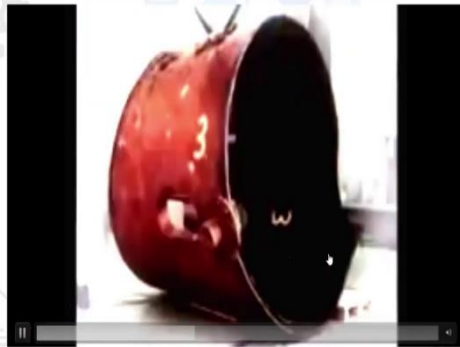
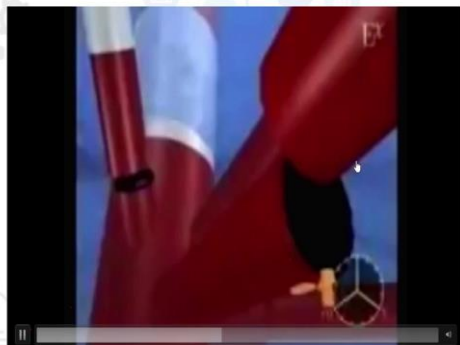
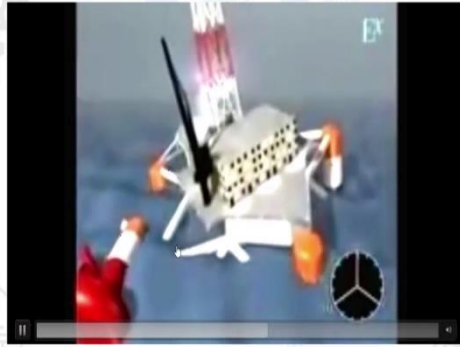
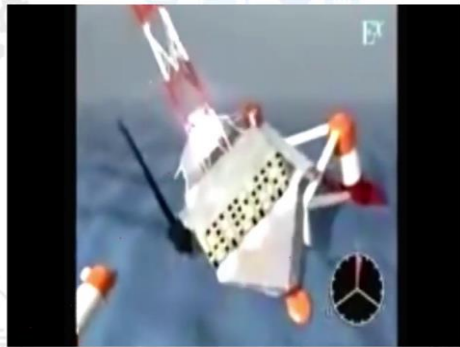
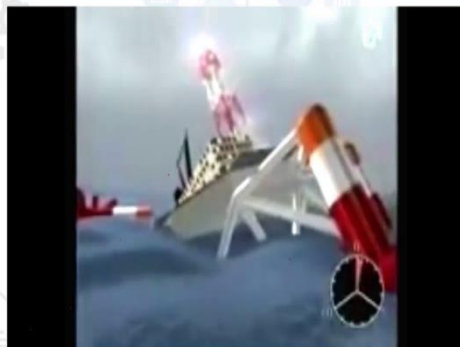
**Location of defect in Alexander L Kielland**

So, the critical failure analysis indicated that it must have initiated at a defective well bead in an inserted hydrophone tube. So, the entire structure has been very thoroughly scrutinized after the incident to find out that what exactly could be the reason and they have located a defective weld bead in the hydrophone tube. So, remember, we were talking about the hydrophones and the how the hydrophone is being placed by welding.

So, that has a huge impact here. The hydrophone tube first located in a robust brace designated as D 6, we have already seen that and the fillet weld at the hydrophone fitting was inspected for cracks after the incident using the dye penetrant method and when it has been done to this nondestructive method.

Thorough investigation has been done. The weld had poor adhesion to the base metal in some places the form of the weld was also unfavorable with contact angles of up to 90 degrees. So, the welding had some problem it has not been properly done, the contact angles were not up to the requirement, no preheating was done and that led to initiation of some defect.

So, here is one another video for you to understand where exactly the defect has started. So, you can see how the entire structure has been capsized based on a defect at some interior location. So, these are the 5 legs of the Pentagon structure. Of course, these are all simulated structure and if we are looking into the underwater part of this, you see at this D 6 bracing, we can see the small hydrophone locations.

And actually, this part is what has broken apart and you can see this has been recovered later on you can see the position on the hydrophone and this holes here. And how that has ripped apart the entire leg, you can see that it is floating here this one is healing down and finally it laid on the other legs or other columns also broke apart and that led to the entire capsizing of the structure upside down.

But in this case, at least, they could figure out that what is the starting point from which it has the crack has initiated and led to the final fracture of course, that is very, very small this location the size in comparison to the entire superstructure, but still, it is sufficient to lead to the capsizing of this entire giant structure.
