**Glass Processing Technology**  
**Prof. Ramu**  
**Department of Civil Engineering**  
**Indian Institute of Technology, Madras**

**Lecture - 46**  
**Insulating Glass Unit (Process and Lab Tests)**

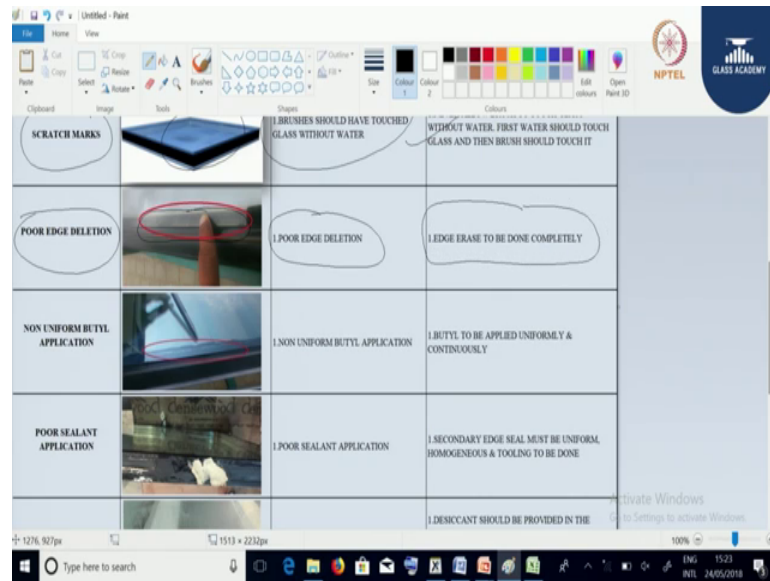
(Refer Slide Time: 02:21)

If there is a poor edge deletion you can see the traces of the coating. Our intention is the coating surface should be completely removed, and the surface should be as good as a clear glass. This is because the reason being because, of poor edge deletion and we can overcome this issue by properly doing the edge deletion and with the proper wheel to be used with proper pressure.

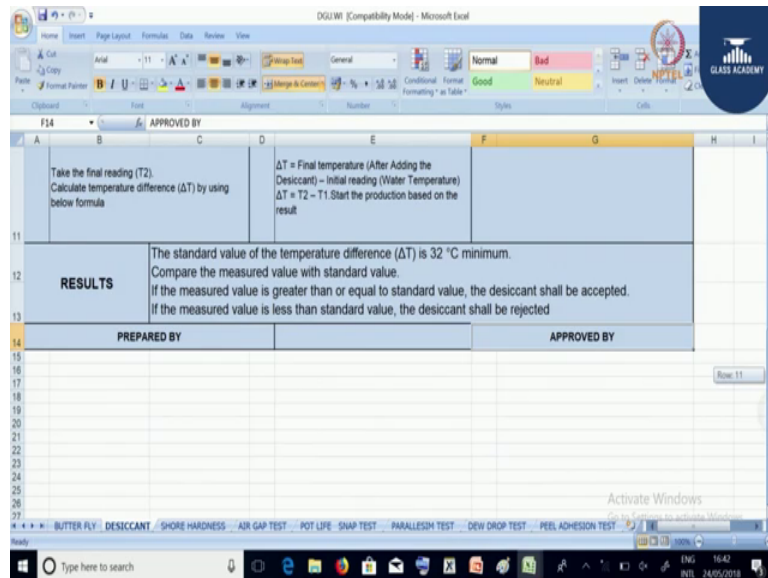
(Refer Slide Time: 07:50)

And it should be minimum 32 degrees centigrade. You can see the standard value for temperature difference is 32-degree centigrade minimum, ok.
