Recent Advances in Transmission Insulators
Prof.B. Subba Reddy
Department of Electrical Engineering
Indian Institute of Science – Bangalore

Module No # 01
Lecture No # 05
Field experience of Ceramic/ Glass and Polymeric Insulators

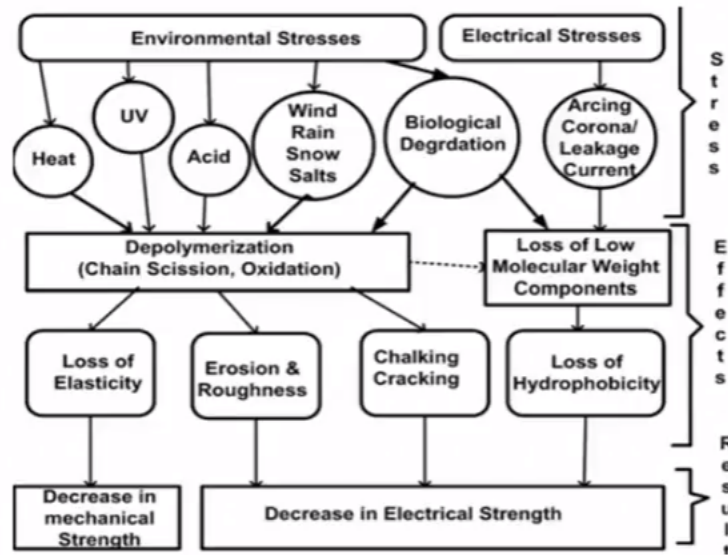
(Refer Slide Time: 18:05)

This gives the main information about how various stresses whatever we have discussed in detail about the polymer insulator or composite insulators being degraded how the failure could happen. So you can see that the various stresses which are shown this stresses could be because of environmental issues or could be the electrical stresses.

So environmental issues as discussed environmental stresses could be because of the temperature where the climatic condition of that area where transmission system is in place it could be of various temperature the insulators have to perform during the temperature. Ultra violet again as again I mentioned ultra violet could be from the there is ultra violet radiation from the sun in case of very high temperature the sun radiation could make the surface insulator brittle over a period of time or the ultra violet radiation which are being generated because of the corona control rings.

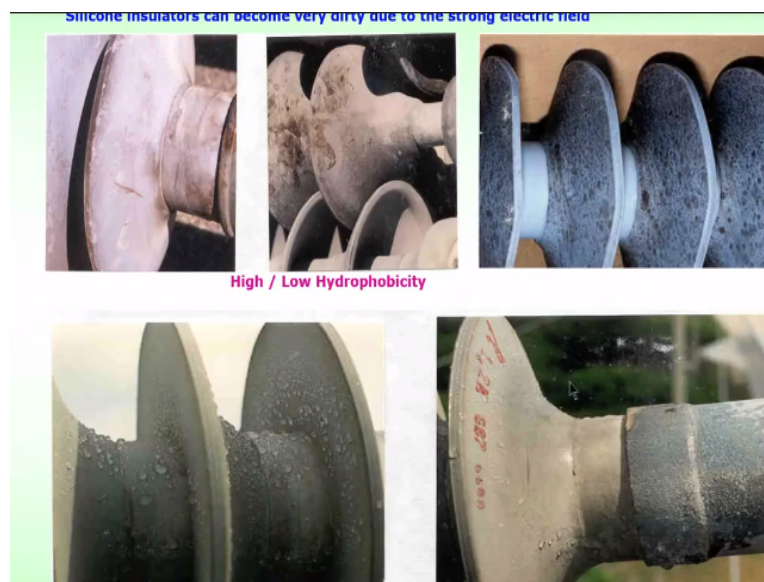
(Refer Slide Time: 30:57)

There are several again failures which were reported earlier it could be because of the hydrophobicity loss accumulation of dust the accumulation of dirt mold or because of it becomes dirt over a period of time. Similarly you have lost of hydrophobicity the sheds being mechanically weather where this shows again the hydrophilic nature where the water drop lets starts accumulating over the surface.

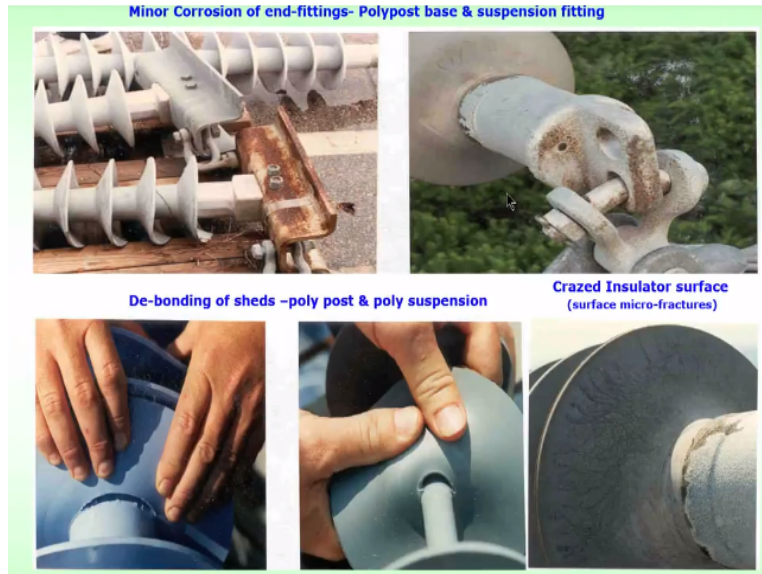
(Refer Slide Time: 31:45)

So here you see the corrosion of end fittings this could lead to the failures of the post insulators or the suspension type of insulators. Similarly the de-bonding of the sheds so this again if it is not properly taken care during the manufacturing period this de-bonding of the sheds could lead to the failures to the period of time. So special case has to be looked taken into considerations there are failures in some of the countries where due to the gun shots where the failures happen to the fiber glass or the post insulators where it is damaged by the bullets it is spread.

Similarly as mentioned earlier you can see the small water or sorry air pockets which are during the manufacturing period. So this if it is left unnoticed over the electrical stress because of the environmental aspects these air pockets may damage or break this further lead to the water seepage or the moisture seepage inside could lead to the failures. So care has to be taken to see that no air pockets or the present air bubbles present on the surface of the insulators.

Similarly here there is a fiber glass rod exposure because over a period of time the pilling of material are taken place in both the places here. So this exposed due to the continuous stress or cracking or damage to the insulator surface.

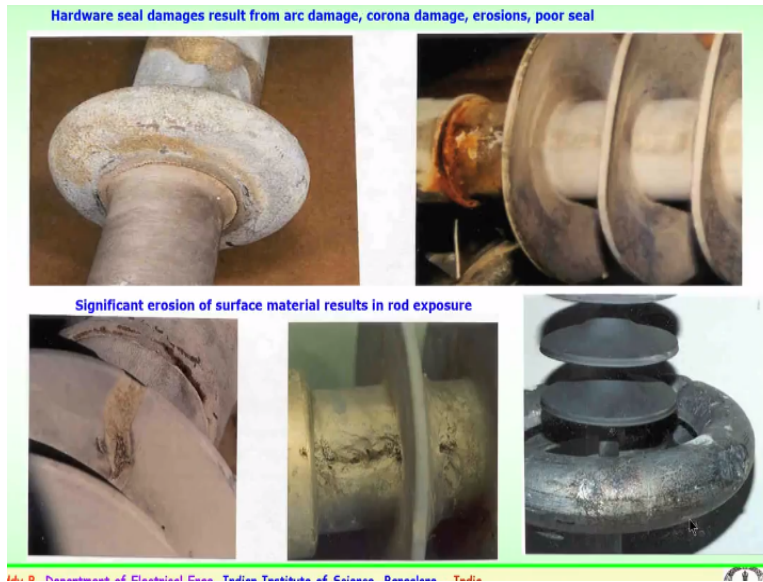
(Refer Slide Time: 33:26)

There are further reports about the hardware damages you can see here the corona control ring or end fitting which is fixed to the insulator surface degraded over the period and becomes highly corrosive and this leads to the failure of the insulators over the period of time. You can see again this failure of the corona ring due to the lightning surges or over a period of time in the service where failures have been noticed.

Again here there is a tracking or a surface erosion which is happened in both the cases this could results in the failure of the rod exposure.

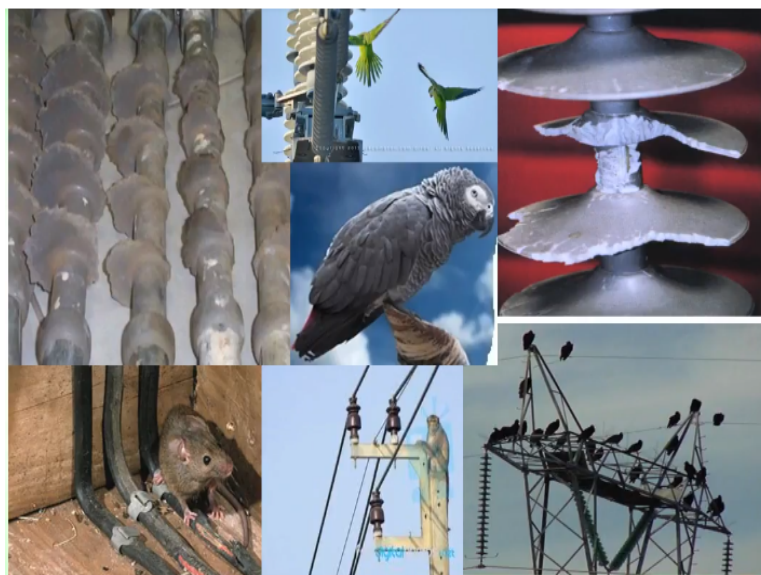
(Refer Slide Time: 34:10)

There are again failures due to several of this aspects because of the bird or because of the animals which have to be properly considered or to be taken care during the transportation or storage so here the insulators has you see many of the insulators surfaces are being chipped of either by bird or by rodents this cause the entire creep age to come down and the flash over or you cannot use the insulator for string use.

So be careful not only the manufacturing storage transportation also equal and protecting from the birds large animals is also causing concern to the utilities. So birds like chip the surface of the insulator but this could bring down the creep age and ultimate failures over the period of time. Similarly bird dropping this is again a very serious issue bird dropping on the insulator surface over a period time.

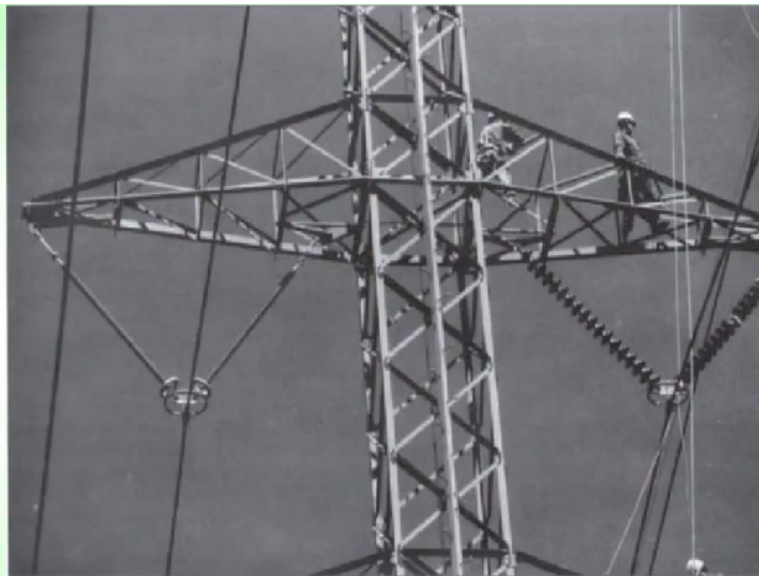
(Refer Slide Time: 42:59)

So I put the slide it is a just to compare how people like to work in the area with the polymer insulator you can see the ceramic and polymer insulators. So the weight reduction is once of the criteria where people like to work in this area whereas stringing is very difficult in case of porcelain or the glass type of insulators. So look more esthetic in comparisons and lesser weight and maintenance could be of less when comparison to the ceramic or the porcelain glass insulators.
