**Architectural Conservation and Historic Preservation**  
**Prof. Sanghamitra Basu**  
**Department of Architecture and Regional Planning**  
**Indian Institute of Technology, Kharagpur**

**Lecture - 27**  
**Investigation and Conservation of Historic Structures Case Study 1**

**The Leaning Tower of Pisa**

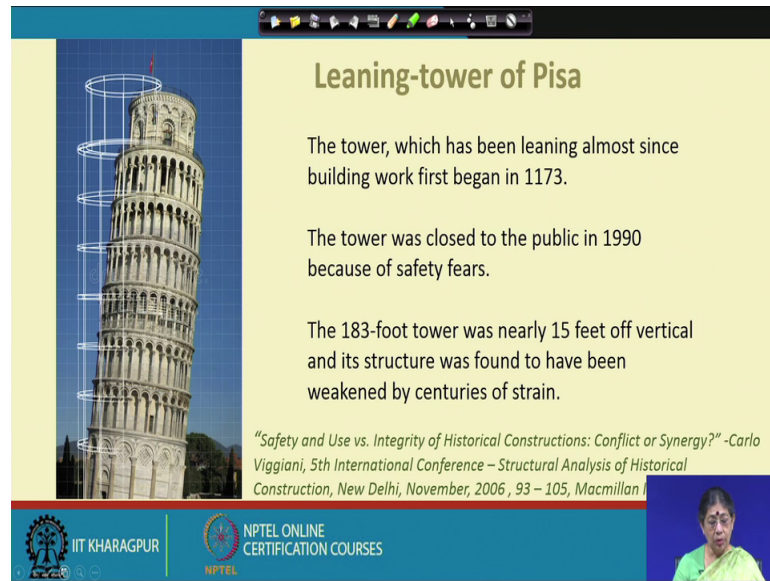
**Leaning-tower of Pisa**

The tower, which has been leaning almost since building work first began in 1173.

The tower was closed to the public in 1990 because of safety fears.

The 183-foot tower was nearly 15 feet off vertical and its structure was found to have been weakened by centuries of strain.

The slide features a photograph of the Leaning Tower of Pisa on the left, showing its characteristic tilt. On the right, there is a text box with the title and descriptive paragraphs. At the bottom right, there is a small video inset showing a person. The bottom of the slide has a blue banner with the IIT KHARAGPUR logo and the text 'NPTEL ONLINE CERTIFICATION COURSES'.

Now, as we can see here that I mean the tilt is quite a lot the tower which has been leaning almost since the building work first began in 1173 and the tower was closed to the public in 1990 because of the safety fears and the 183 foot tower was nearly 15 feet off vertical and its structure was found to have weakened by centuries of strain.

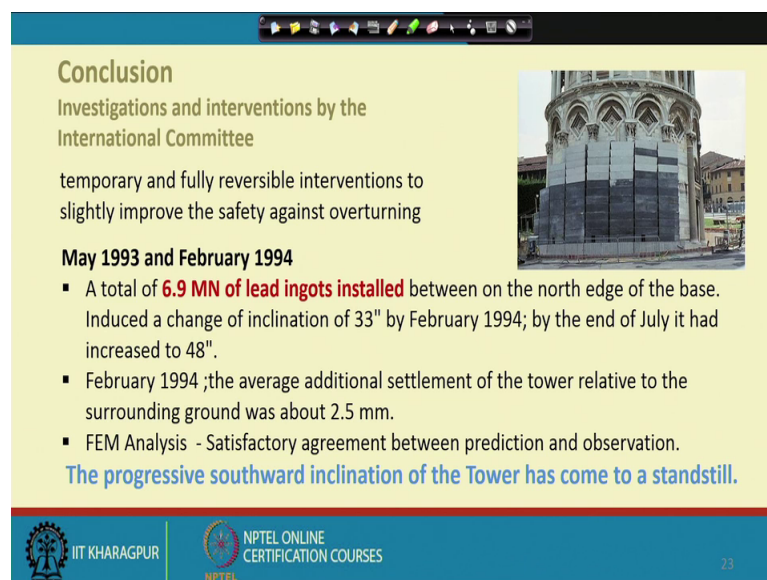
**Conclusion**  
Investigations and interventions by the International Committee

temporary and fully reversible interventions to slightly improve the safety against overturning

So, it was creative on one side of the tower and another side. So, it was creating a load on that side of the structure because it was leaning on the south side and by the by the end of the July, it is found that there was a change in the inclination and it is improving and then the average additional settlement of the tower relative to the surrounding ground was that time was 2.5 mille metre.

So, that temporary solution by putting the lead ingots on one side of the tower so, found that it was improving the situation . So, there is finite element more than analysis first that and there was satisfactory agreement between the prediction and observation. So, there was a scientific way and how it was done there and they found that it can lead to some sort of a solution the progressive southward inclination of the tower because of this putting the lead in store lead ingots actually the tower has come to a standstill; that means, the further inclination was stopped because of the temporary measure and putting an extra weight on the other side.

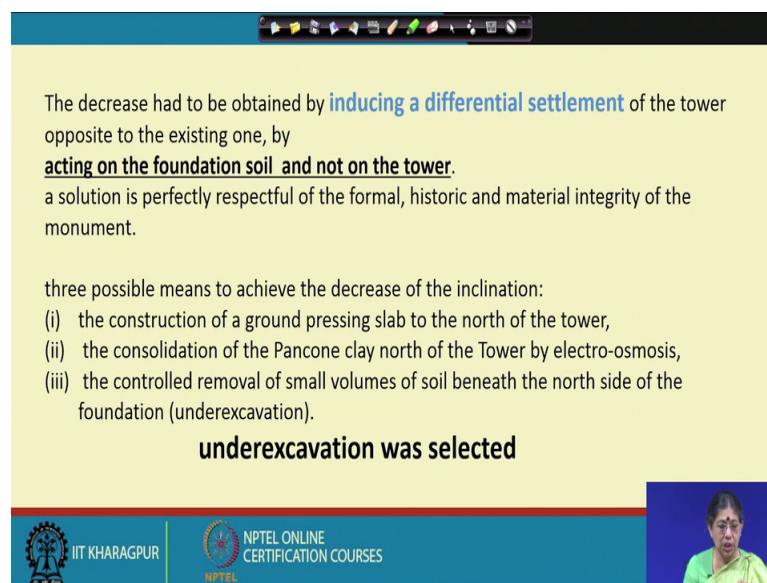
The decrease had to be obtained by **inducing a differential settlement** of the tower opposite to the existing one, by **acting on the foundation soil and not on the tower.** a solution is perfectly respectful of the formal, historic and material integrity of the monument.

three possible means to achieve the decrease of the inclination:

- (i) the construction of a ground pressing slab to the north of the tower,
- (ii) the consolidation of the Pancone clay north of the Tower by electro-osmosis,
- (iii) the controlled removal of small volumes of soil beneath the north side of the foundation (underexcavation).

This the its quite simple it use to induce a differential settlement of the tower to take it to the opposite direction and how do you take this differential settlement acting on the foundation soil and not on the tower it really did not need any intervention of the tower itself, the solution is perfectly respective respectful of the formal historic and material integrity of the monument. So, this was realise and what are the three possible means.

of small volumes of the soil beneath the north side of the foundation no same meaning, but taking out the soil extracting the soil from the north side. So, that it starts again a inclining towards that. So, finally, is under excavation that is taking the soil from the foundation of the north side, this was selected as a method.

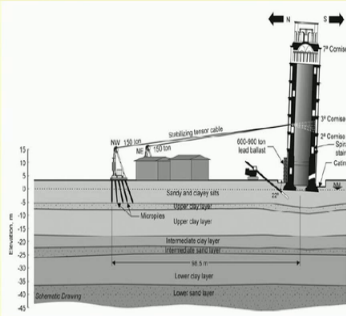
**Measures adopted**

- Three lead ingots removed, and since then the tower exhibited negligible further movements.
- February 21, 2000 and June 6, 2001 full underexcavation carried out with 41 holes, removing a total of 38 m<sup>3</sup> of soil (70% below the catino, i.e. outside the perimeter of the foundation). In the same period all the lead ingots have been removed.
- In June 2001 the steel cable stays have been dismantled, without having been ever operated.

So, this is some of the cases as you can see the stages there which sort of holding that in case something happened there were the two stage of two sides and you can see the soil structure there and the lead ingots were gradually remove and this is how the drilling was happening to take a excavative soil.

So, the first it was done in a face manner the three lead ingots first remove and since then the tower exhibited negligible further movements and then in 2001, and 2000 and 2001, the full under excavation was carried out in an sufficient amount of soil which was calculated and which was a done through the modelling and structure analysis, it was taken out outside the parameter of the foundation in the same period all the lead ingots have been removed.

And for that what was done is that this is what actually done the on the two sides of that it was the stages were put up there and. So, that there was a some tie was there and through the dealing process the soil was extracted and as I say the safe guard structure was put up if the horizontal stay on the two sides of the tower and February and June 1999, preliminary under excavation happened twelve inclined drill was there and removing a total of 7 cubic metre of soil 70 percent of which was the north of the tower and 25-29 percent was from beneath the foundation.
